BRIDGE SAFETY INSPECTION REPORT

Facility 4 3/4 MILE RD	Latitude / Longitude 43.5688 / -84.3455	MDOT Structure ID 56314H00009B010	Structure Condition Good Condition(7)
Feature PINE RIVER	Length / Width 131.2 / 31.17	Owner County: Midland(56)	
Location @ GORDONVILLE RD	Built / Recon. / Paint / Ovly. 1997 / / /	TSC Mt. Pleasant(4A)	Operational Status A Open, no restriction(A)
Region / County Bay(4) / Midland(56)	Material / Design 5 Prestressed Concrete / 05 Multiple Box Beam	Last NBI Inspection 09/10/2015 / JC06	Scour Evaluation 5 Stable w/in footing

Midland County 2015 Bridge Inspections
4 3/4 Mile Rd over Pine River
SN 7004
GLEG Project No. 1015-2-336
September 10, 2015

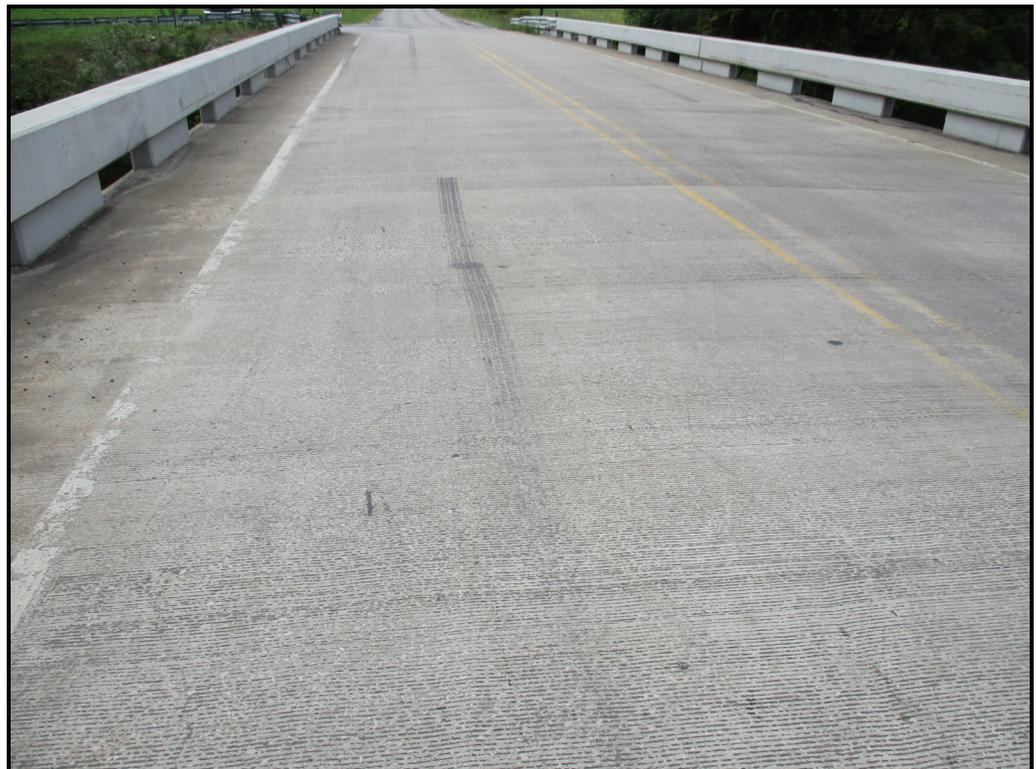
09/11	09/13	09/15	
1. Surface (SIA-58A)	7	7	6	Concrete deck covered with healer/sealer in 2011. Only shoulders have healer/sealer left. Visible cracks in both spans. (09/15) Concrete deck covered with healer/sealer in 2011. Estimate 60% of healer/sealer worn off, visible cracks are sealed. (09/13) Concrete deck covered with healer/sealer in 2011. No visible cracks in surface (09/11)

*Concrete
surface with
worn off
healer/sealer*

Recommendation Type	Priority	Description
Railing Repair	L	Fix NW and SE approach rail
Joint Repair	L	Reseal joints
Overlay	M	New healer/sealer within next 4 years

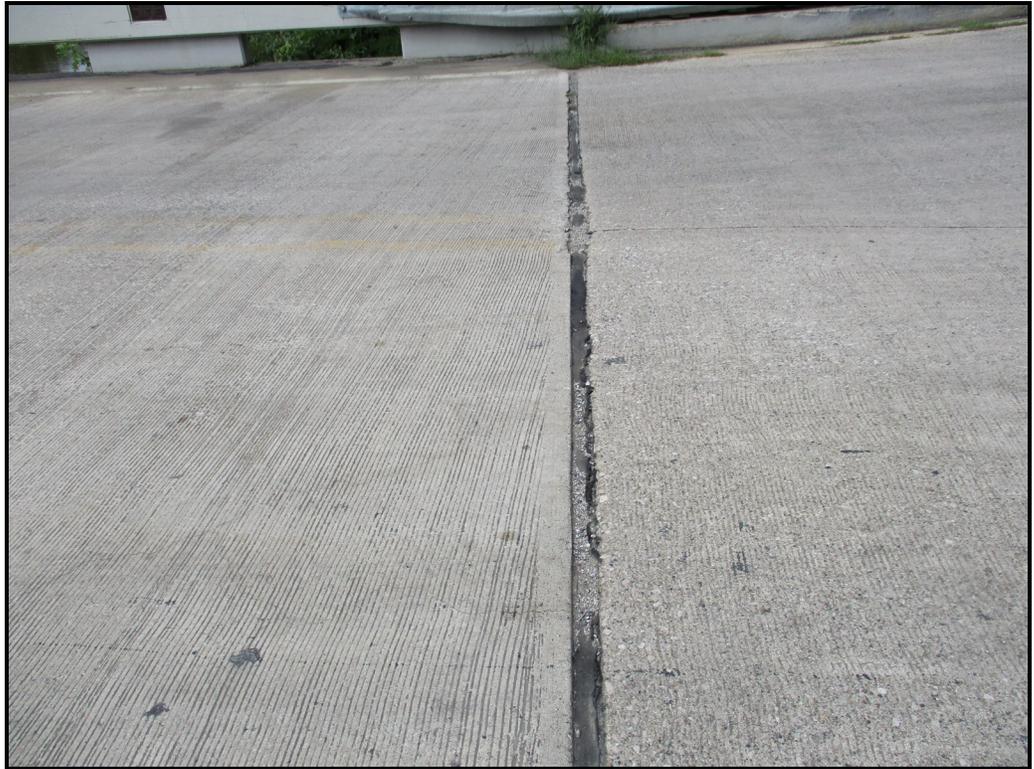
End joint

2. Expansion Joints	7	6	6	E3 joints at both reference lines. Sealed construction joint at pier with chip in concrete adjacent to joint. 5% adhesion loss at joints. (09/15) E3 joints at both reference lines with joint material intact. Sealed construction joint at pier leaks. (09/13) At both joints, joint material is intact. (09/11)

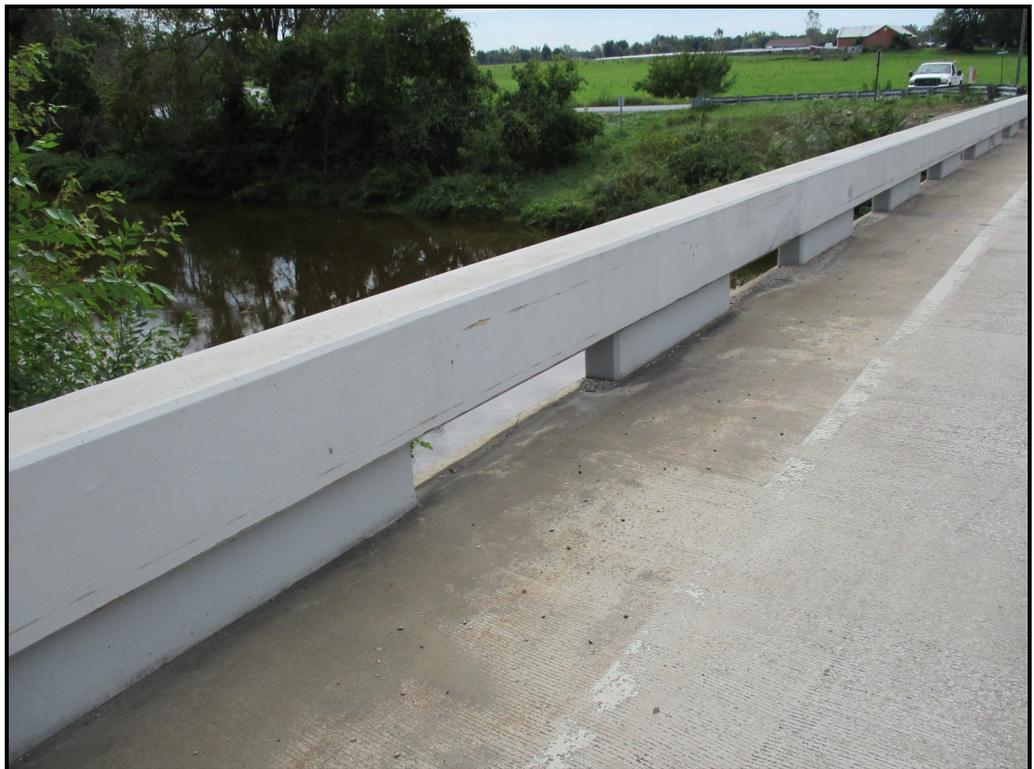
Bridge railing

3. Other Joints	6	N	N	(09/15) (09/13) Leakage on pier indicates joint over pier leaks (09/11)
4. Railings	7	7	7	Surface sealer on concrete railing, vertical cracks reflecting through sealer. (09/15) Surface sealer on concrete railing, cracks reflecting through sealer. (09/13) Surface sealer on concrete railing, cracks reflecting through sealer. (09/11)

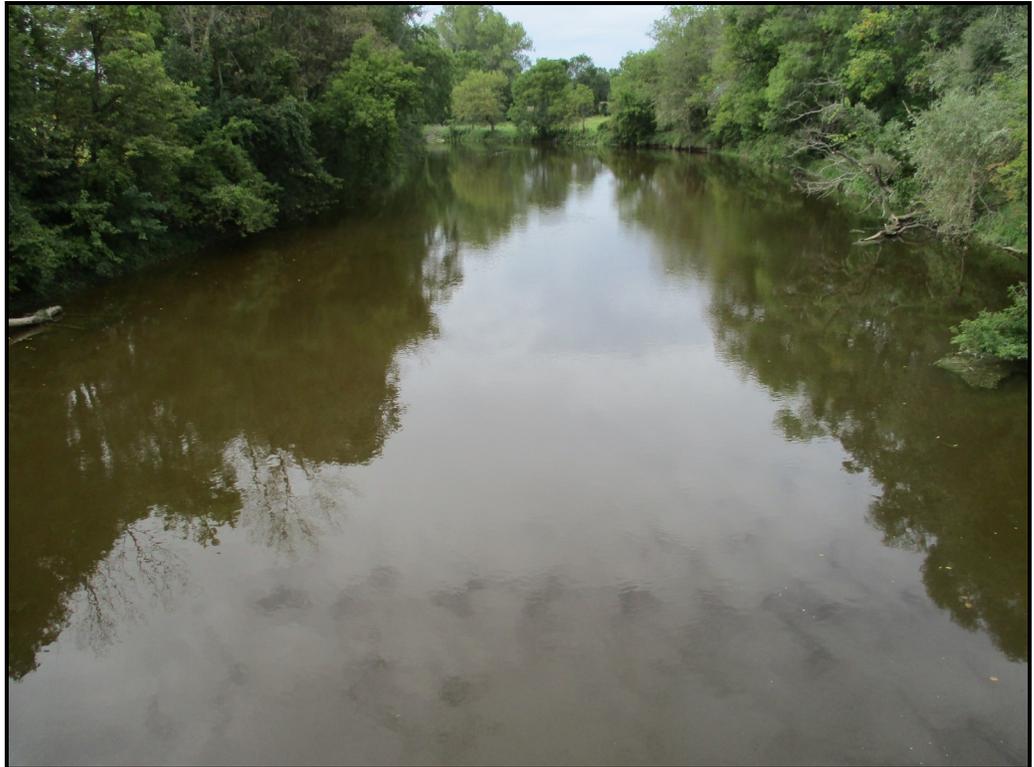
19. Utilities				Overhead west of bridge (09/15) Overhead west of bridge (09/13) None noted on bridge (09/11)
20. Channel (SIA-61)	7	7	7	Channel has vertical banks and flows through wide flood plain (09/15) Channel has vertical banks and flows through wide flood plain (09/13) Channel has vertical banks and flows through wide flood plain (09/11)

*Upstream
channel section*

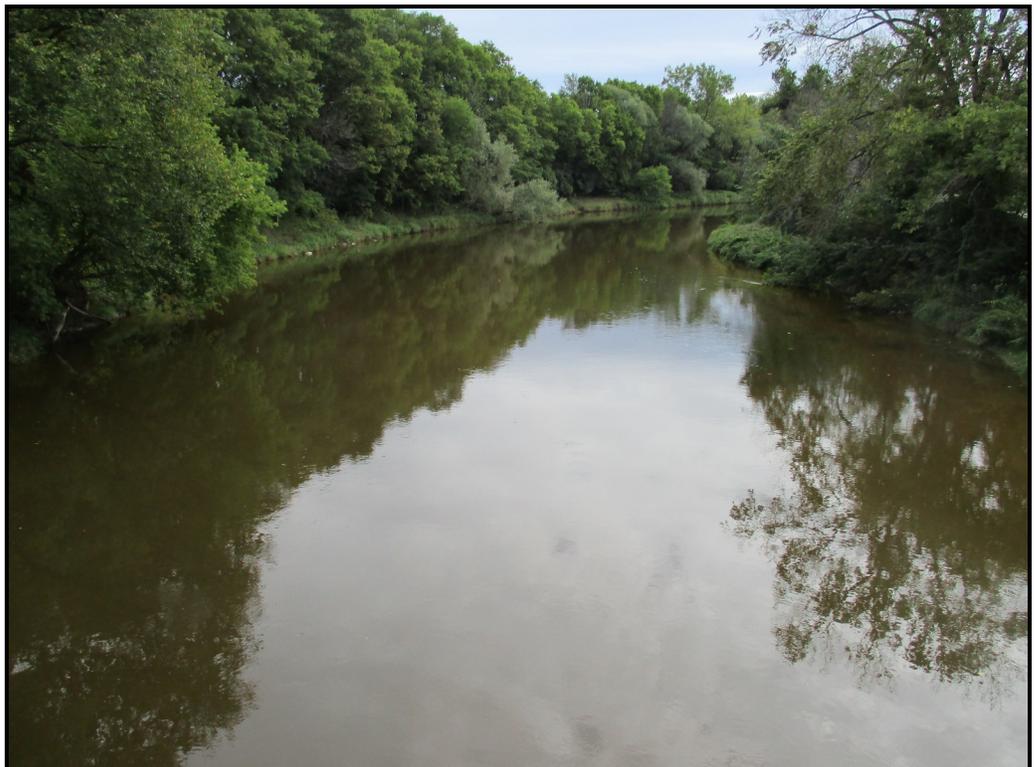
*Downstream
channel section*

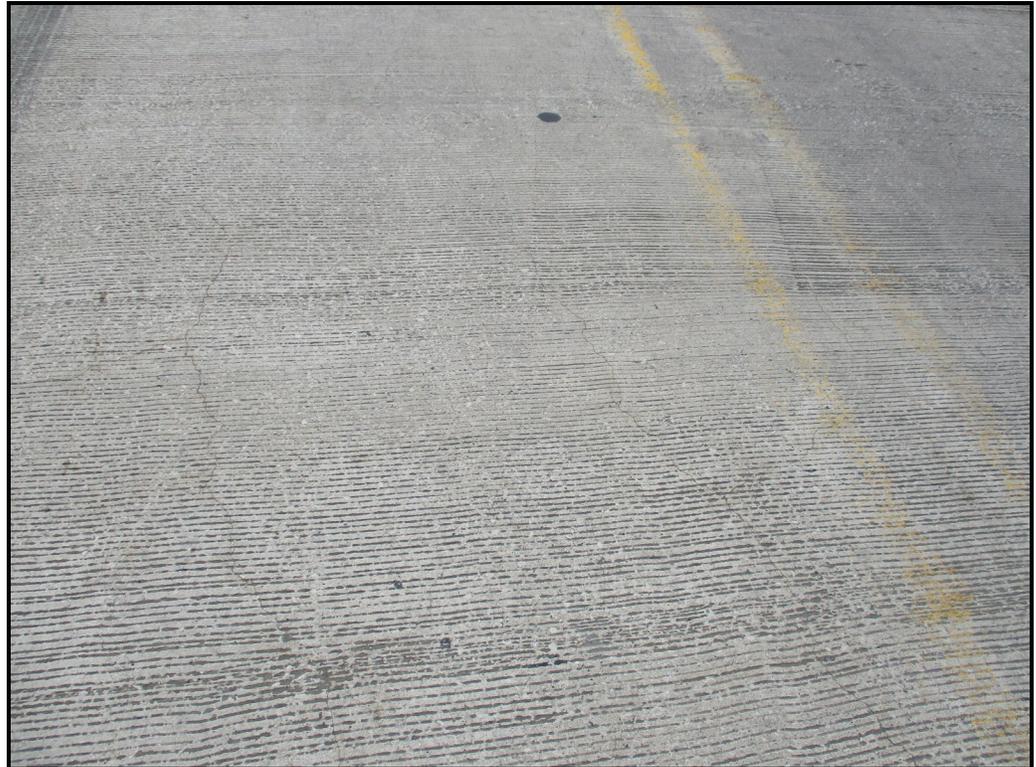
*Hairline cracks
in concrete
surface*

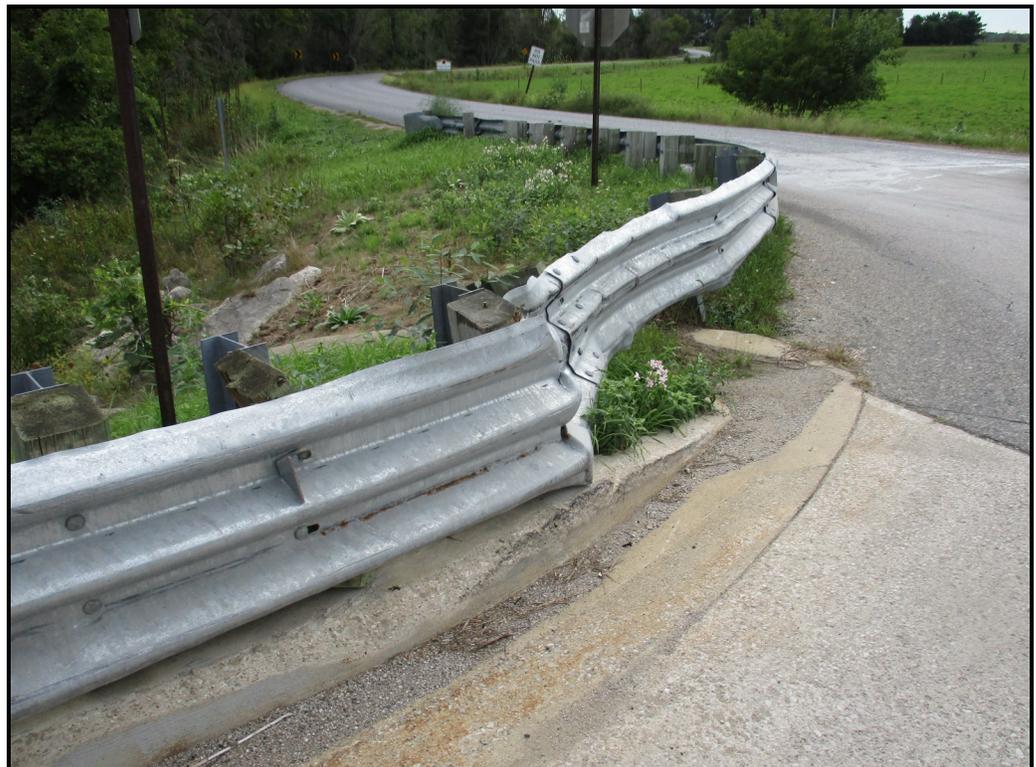
17. Approach Shoulders Sidewalks	7	7	7	Gravel/grass shoulders (09/15) Gravel/grass shoulders (09/13) Gravel/grass shoulders (09/11)
18. Approach Slopes				Radius rail in SE and NW damaged (09/15) Radius rail in SE and NW replaced (09/13) Radius rail in SE and NW damaged by traffic. (09/11)

*Damaged
approach rail
in SE quad*

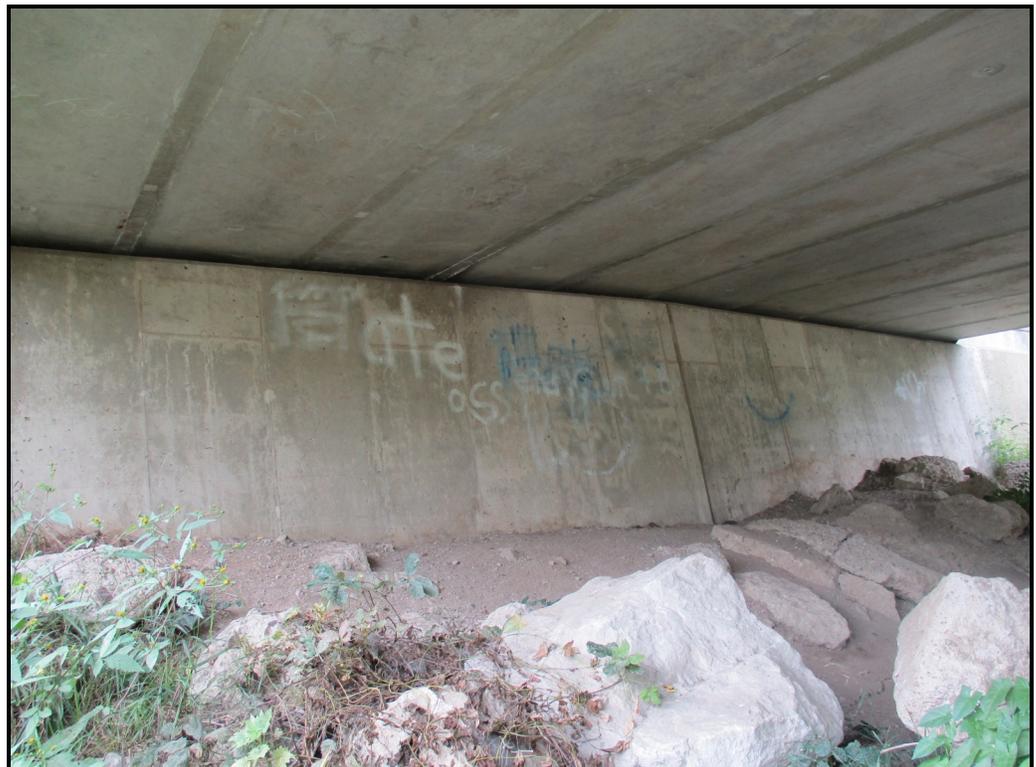
09/11	09/13	09/15	
13. Abutments (SIA-60)	8	8	8	Concrete curtainwall abutments with no visible cracks. (09/15) Concrete curtainwall abutments with no visible cracks. (09/13) Concrete curtainwall abutments with no visible cracks. (09/11)
14. Piers (SIA-60)	8	7	7	Evidence of leakage on both pier faces. Debris stuck on west end of pier removed. (09/15) Evidence of leakage on both pier faces. Debris stuck on west end of pier. (09/13) Evidence of leakage on both pier faces. (09/11)
15. Slope Protection	5	5	5	Estimate 50%-60% of riprap missing at north & south slopes with exposed fabric (09/15) Estimate 50%-60% of riprap missing at north & south slopes with exposed fabric (09/13) Estimate 30%-40% of riprap missing at north & south slopes (09/11)

*South
abutment*

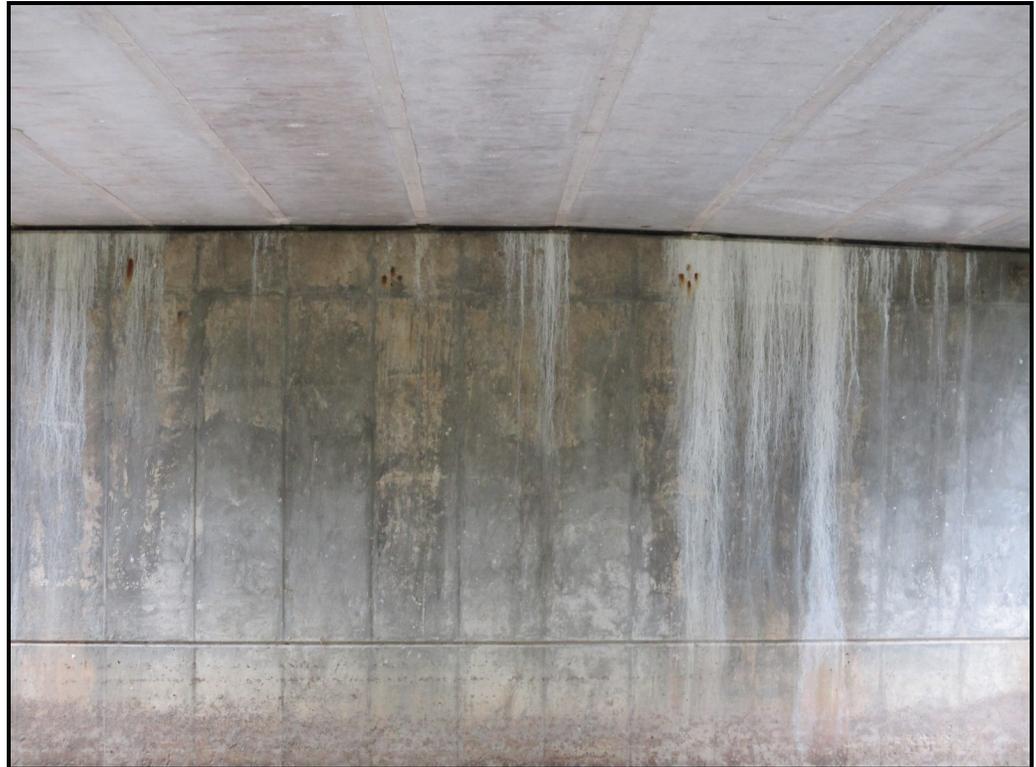
*Leakage on
pier*

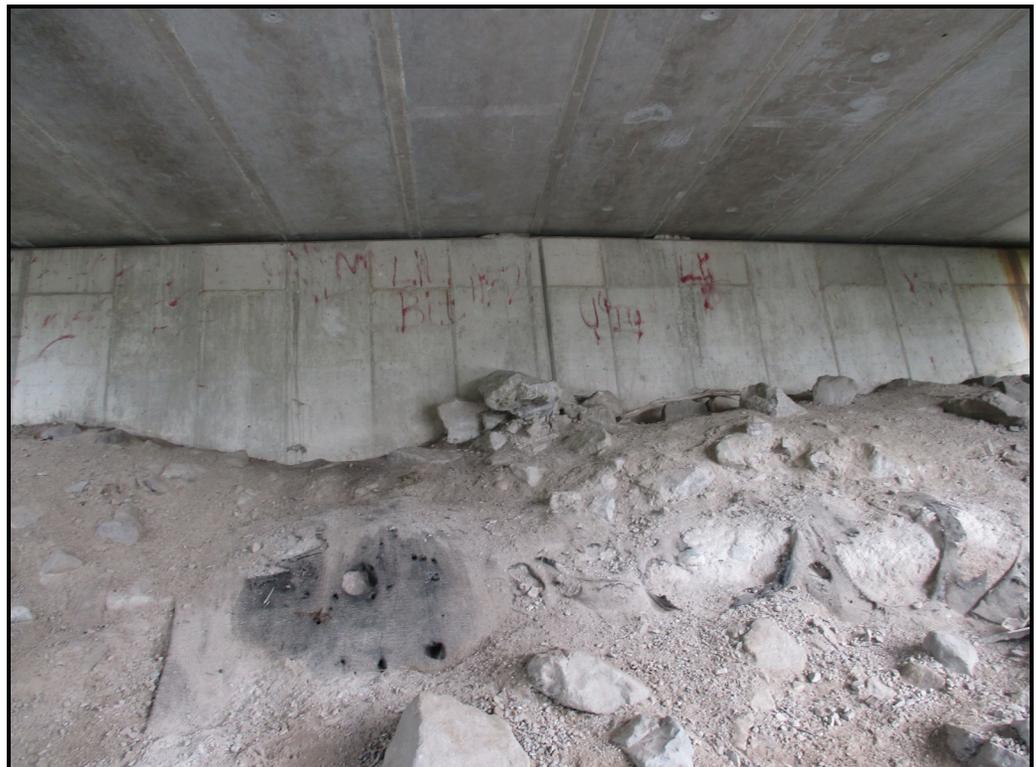
*North
abutment*
