STR 6938

BRIDGE SAFETY INSPECTION REPORT

Midland County 2015 Bridge Inspections
N Saginaw Rd over Big Salt River
SN 6938
GLEG Project No. 1015-2-336
September 10, 2015

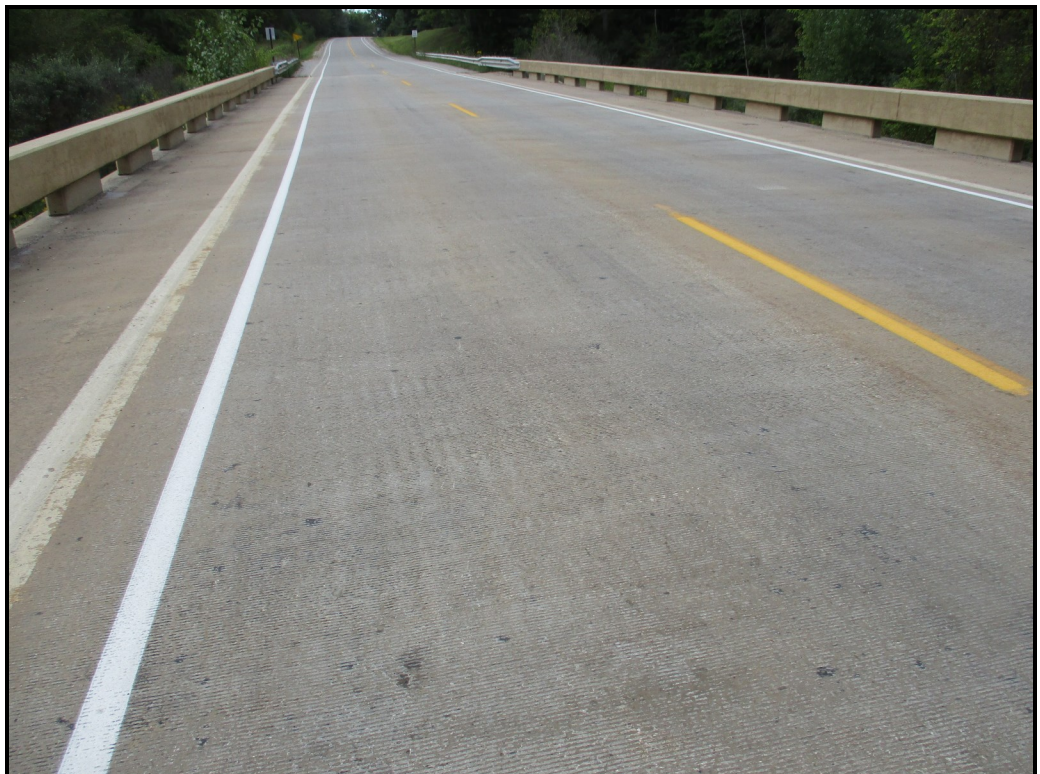
09/11	09/13	09/15	
1. Surface (SIA-58A)	7	8	7	Healer/sealer on concrete deck, 50% worn off, hairline map cracks still visible mainly in span 1W. (09/15) New healer/sealer on concrete deck, hairline map cracks still visible. (09/13) West 20' of deck has hairline map cracking throughout both lanes. Hairline transverse cracks along north and southsides outside of tining every 1'-5'. West 1/2 of center span has map cracks spaced 1'-4'. (09/11)

*Healer/sealer
on concrete
deck*

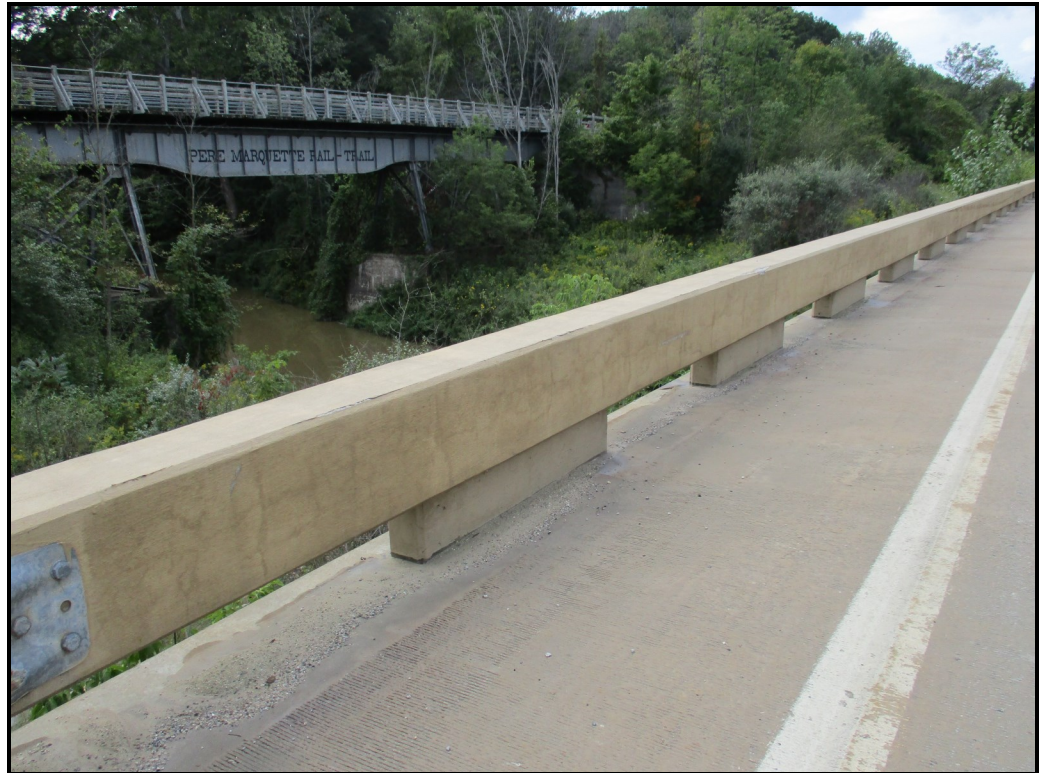
Bridge railing

4. Railings	8	8	8	Surface sealer on inside of rail, hairline shrinkage cracks on outside of railing (09/15) Surface sealer on inside of rail, hairline shrinkage cracks on outside of railing (09/13) New surface sealer on inside of rail, hairline shrinkage cracks on outside of railing (09/11)

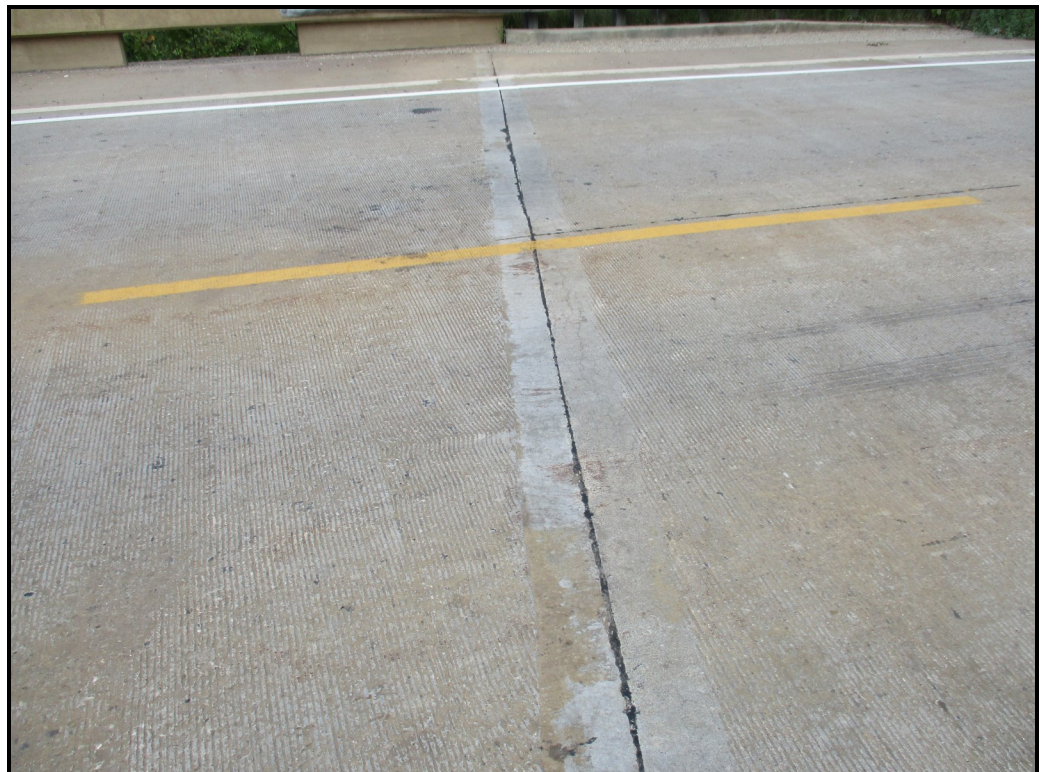
End joint

2. Expansion Joints	N	8	8	Sealed joints, joint material intact. (09/15) Sealed joints, joint material intact. (09/13) (09/11)
3. Other Joints	8	N	N	(09/15) (09/13) Hot poured rubber in place (09/11)

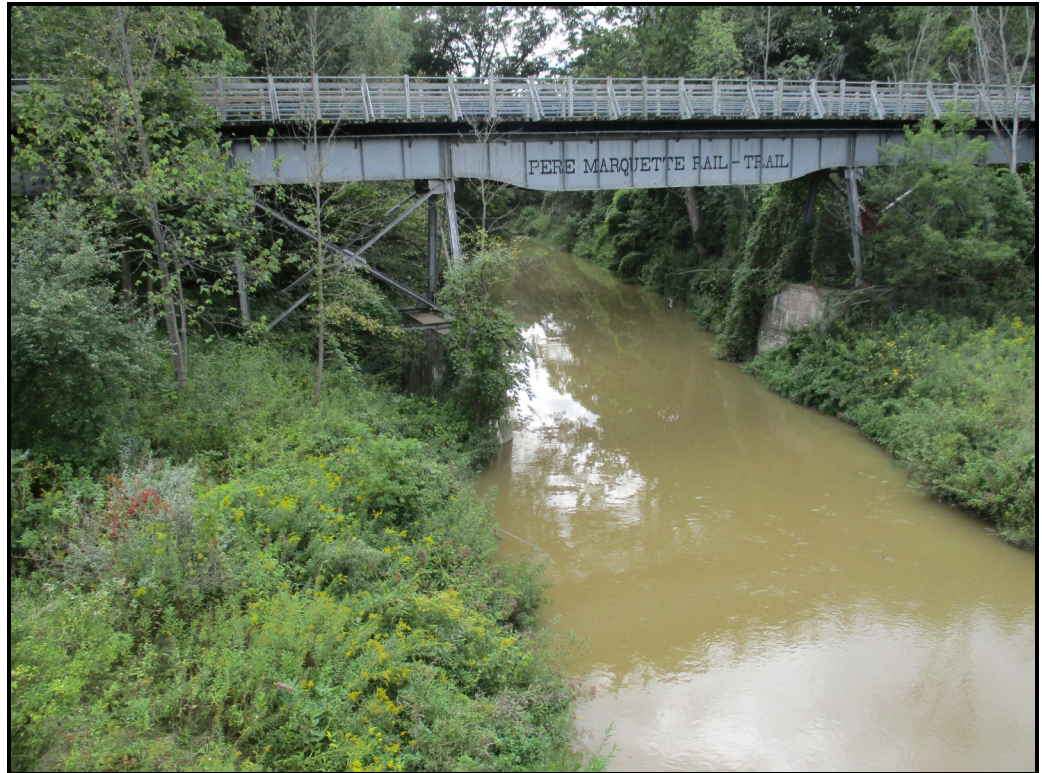
19. Utilities				Overhead north of bridge (09/15) Overhead north of bridge (09/13) None noted on bridge (09/11)
20. Channel (SIA-61)	8	8	8	Tall vegetated banks. (09/15) Tall vegetated banks. (09/13) Tall vegetated banks. (09/11)

*Upstream
channel section*

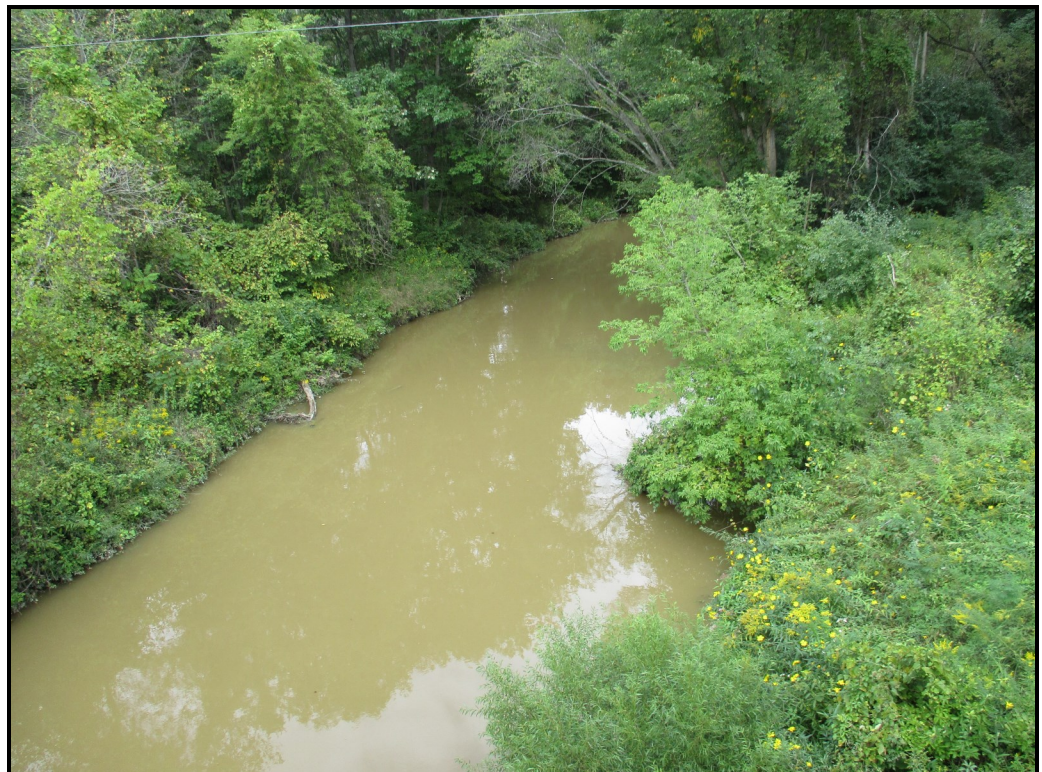
*Downstream
channel section*

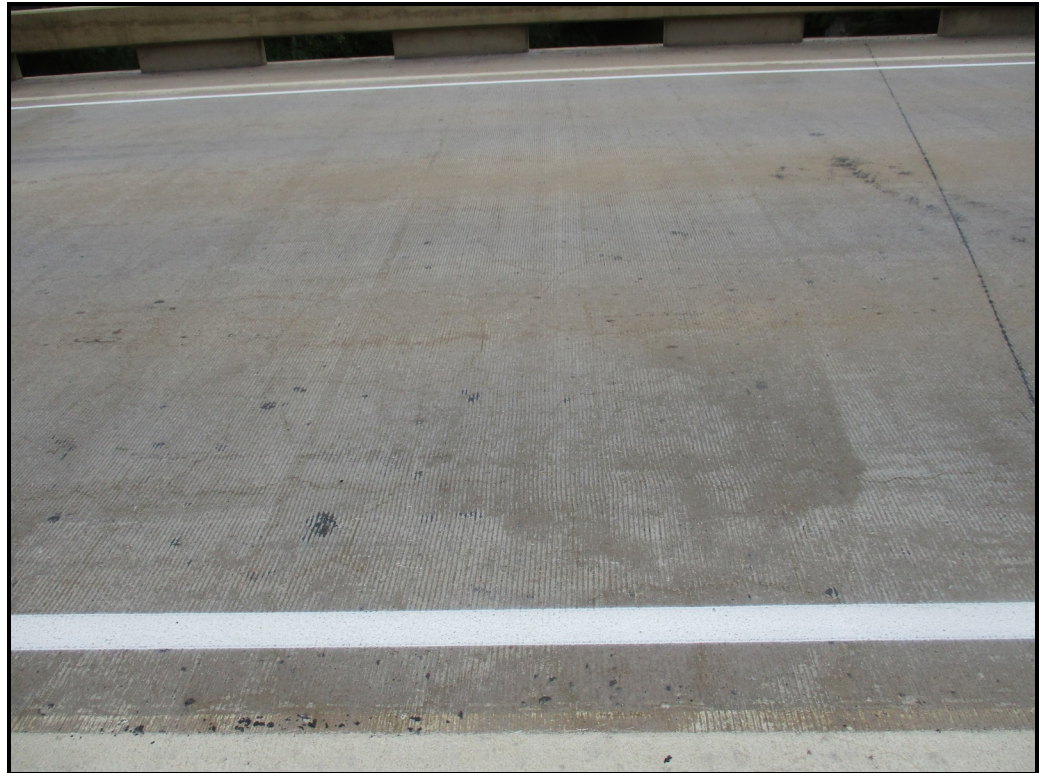
*Hairline cracks
in surface*

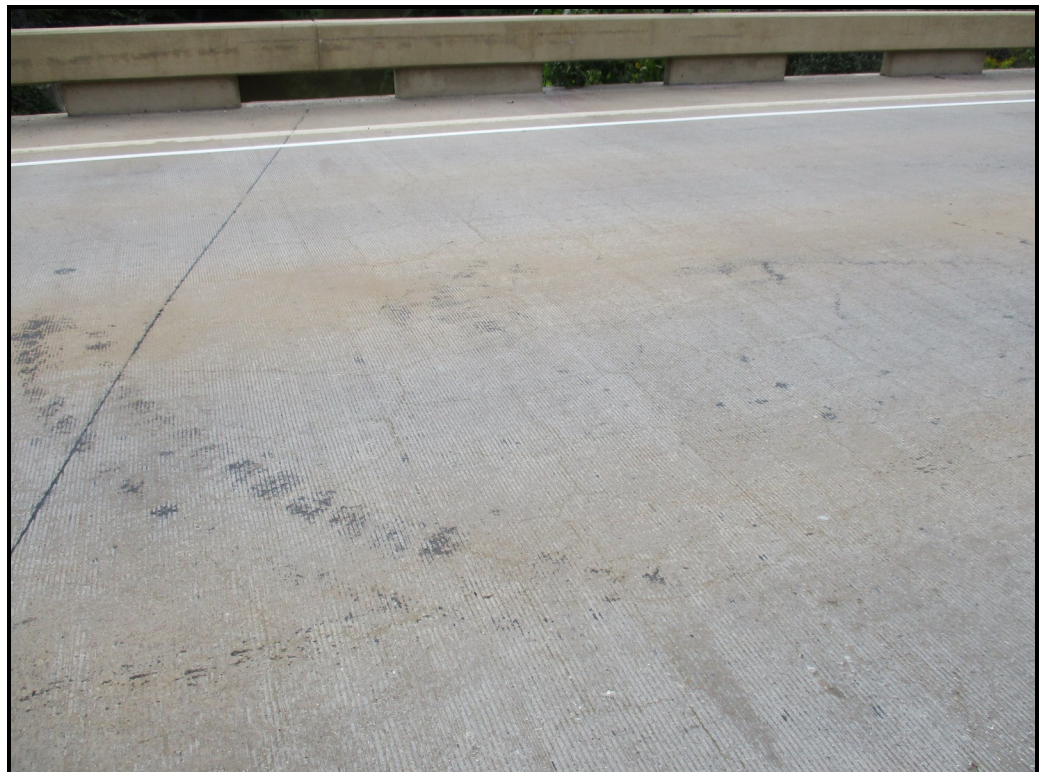
*Hairline cracks
in surface*

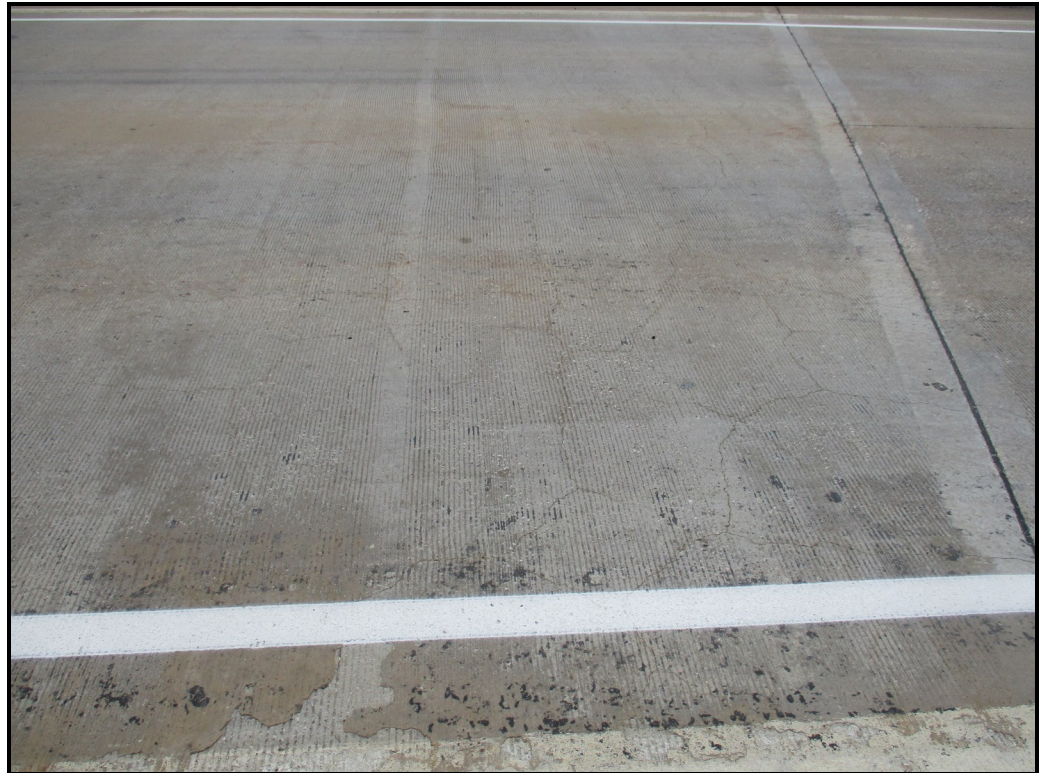
*Hairline cracks
in surface*

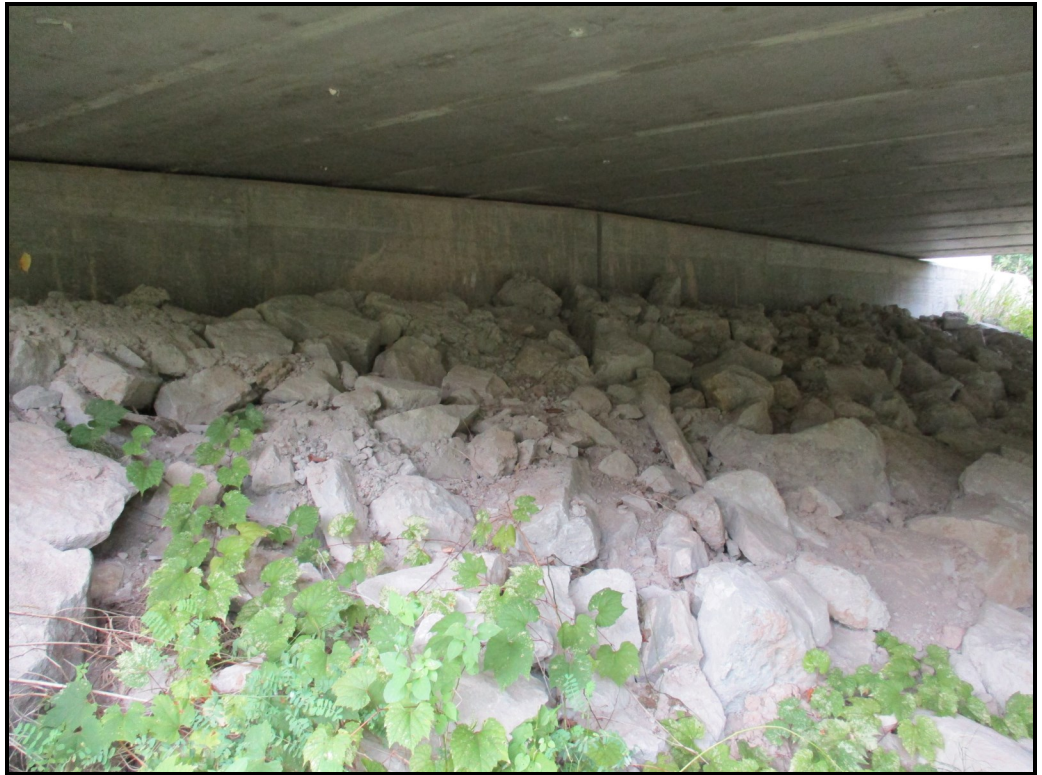
West abutment

09/11	09/13	09/15	
13. Abutments (SIA-60)	8	8	8	Concrete abutments, no visible cracks (09/15) Concrete abutments, no visible cracks (09/13) Concrete stub abutments, no visible cracks (09/11)
14. Piers (SIA-60)	7	7	7	Solid wall piers. East pier has 3 hairline vertical cracks in east face, south end and tight map cracks at north end. (09/15) Solid wall piers. East pier has 3 hairline vertical cracks in east face, south end and tight map cracks at north end. (09/13) Solid wall piers. East pier has 3 hairline vertical cracks in east face, southend. (09/11)
15. Slope Protection	8	8	8	Riprap in place (09/15) Riprap in place (09/13) Riprap in place (09/11)

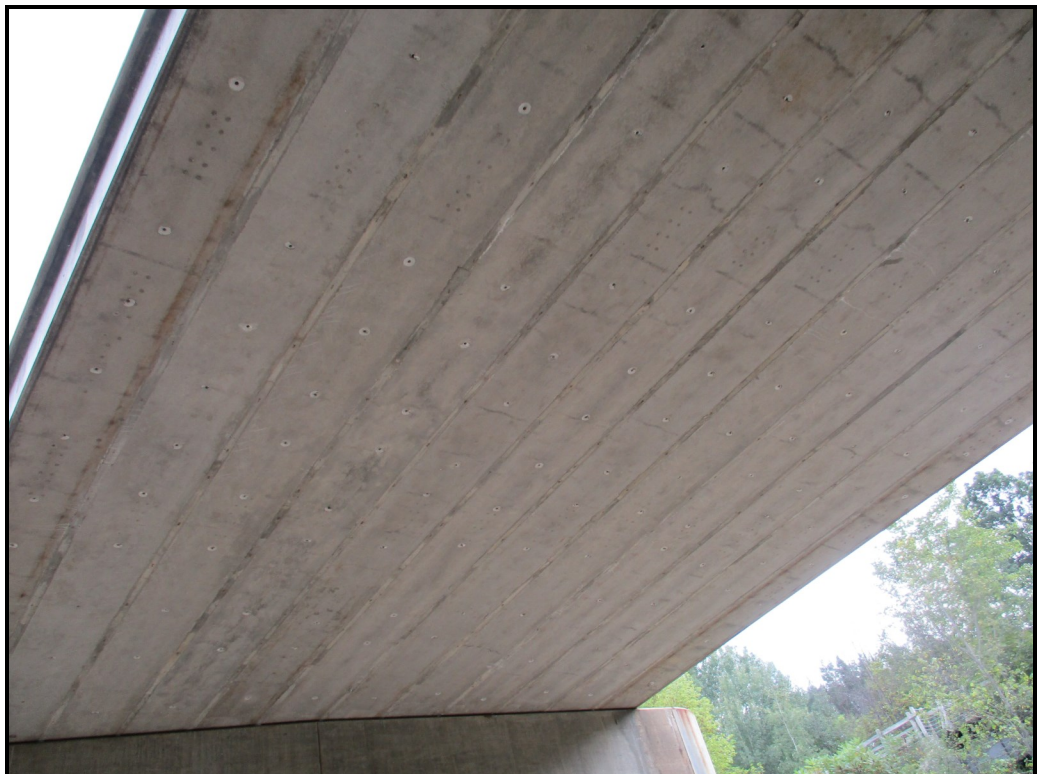
09/11	09/13	09/15	
9. Stringer (SIA-59)	8	8	8	Side by side box beams. Leakage starting at center span grout joints. (09/15) Side by side box beams. Leakage starting at center span grout joints. (09/13) Side by side box beams. Leakage starting at center span grout joints. (09/11)
10. Paint (SIA-59A)	N	N	N	(09/15) (09/13) (09/11)

*Bottom of box
beams*
