**STR 6947**

**BRIDGE SAFETY INSPECTION REPORT**

Midland County 2015 Bridge Inspections  
9 Mile Rd over Pine River  
SN 6947  
GLEG Project No. 1015-2-336  
September 22, 2015

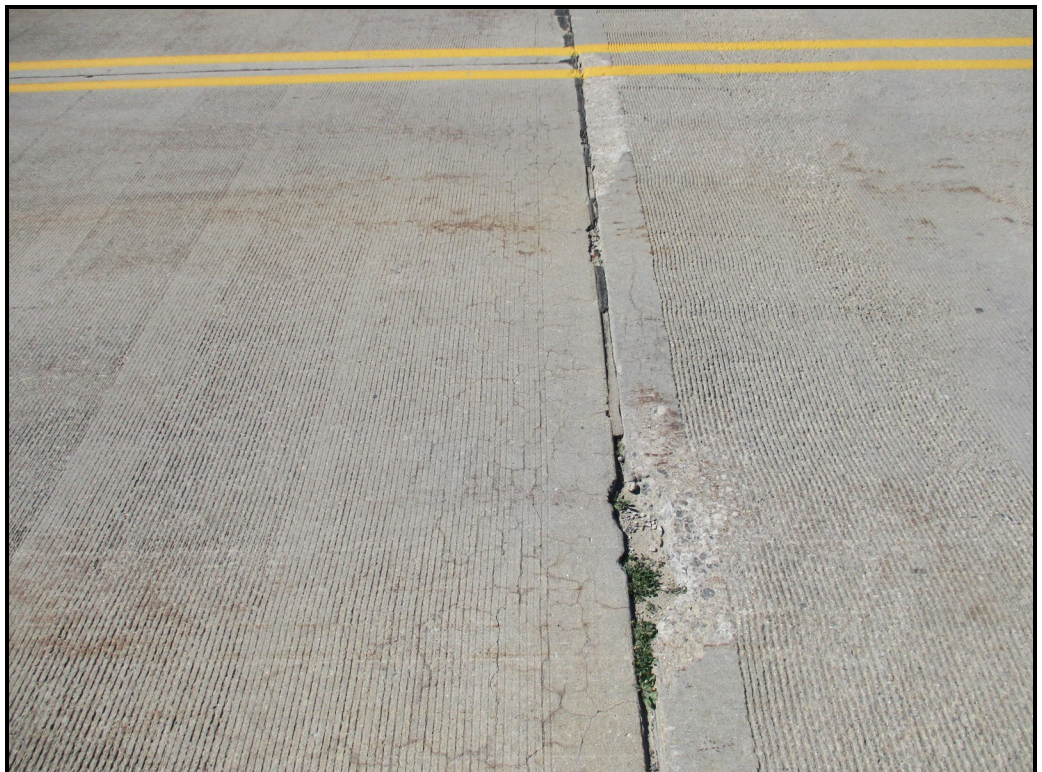
*Spalls along  
south end joint*

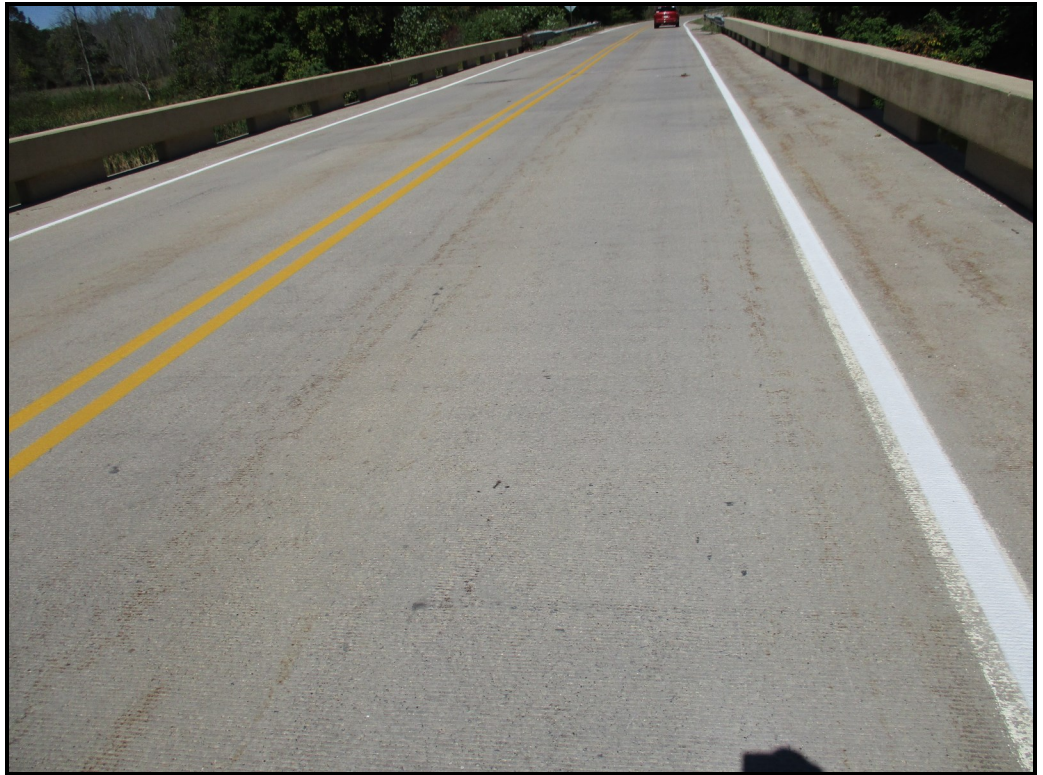
09/11	09/13	09/15	
<b>1. Surface (SIA-58A)</b>	7	7	7	Concrete deck. Noted shrinkage/ASR cracking along both sides under railing. No visible cracks in lanes. In NBD lane at south reference line, 1sft spall, no exposed steel. (09/15) Concrete deck. Noted shrinkage/ASR cracking along both sides under railing. No visible cracks in lanes. In NBD lane at south reference line, 1sft spall, no exposed steel. (09/13) Under railing noted shrinkage/ASR cracking along both sides. No visible cracks in lanes. In NBD lane at south reference line, 1sft spall, no exposed steel. (09/11)
<b>2. Expansion Joints</b>	7	7	6	Hairline shrinkage/ASR cracks in header. Joint is full of dirt and retainers are rusting. Compression joints at abutments. At north abutment, 10% adhesion failure. At south abutment, spall in EBD and estimate 25% of joint material missing. (09/15) Hairline shrinkage/ASR cracks in header. Joint is full of dirt (09/13) Hairline shrinkage/ASR cracks in header. Joint is full of dirt (09/11)

*Concrete  
surface*

<b>Recommendation Type</b>	<b>Priority</b>	<b>Description</b>
Detailed Insp.	M	Investigate cause of cracking in abutments and pier
Joint Repair	L	Blow out joint yearly
Deck Patching	L	Place healer sealer on deck
Substr Repair	L	Patch east end of pier

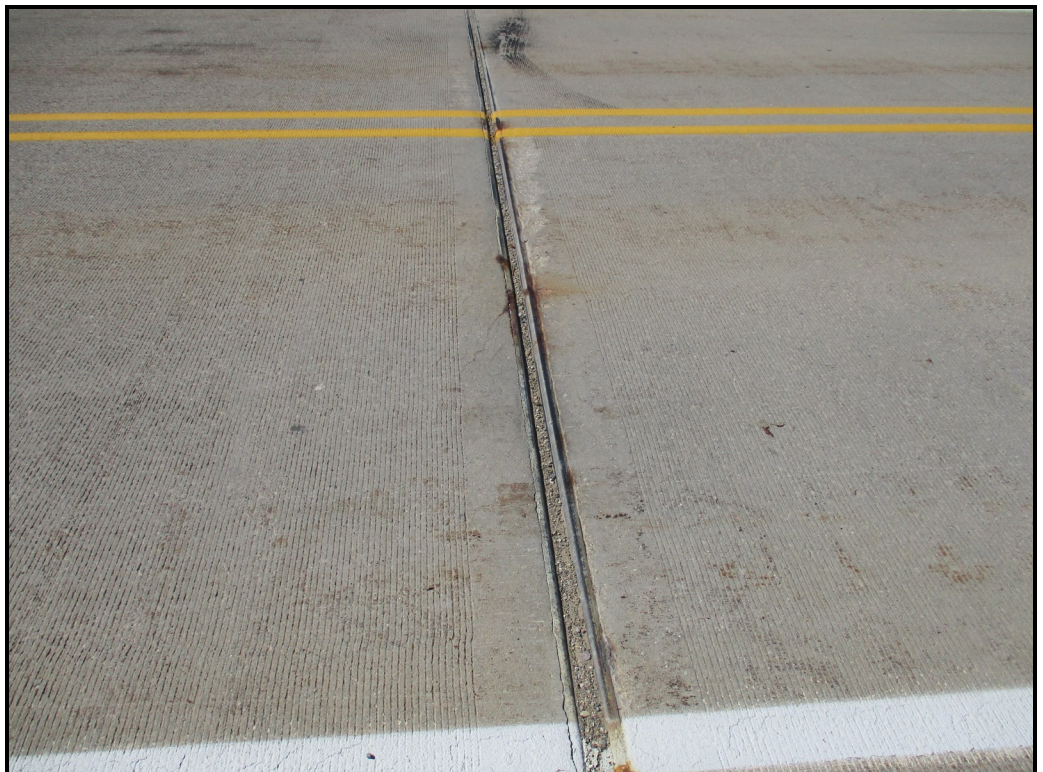
*Expansion  
joint over pier*

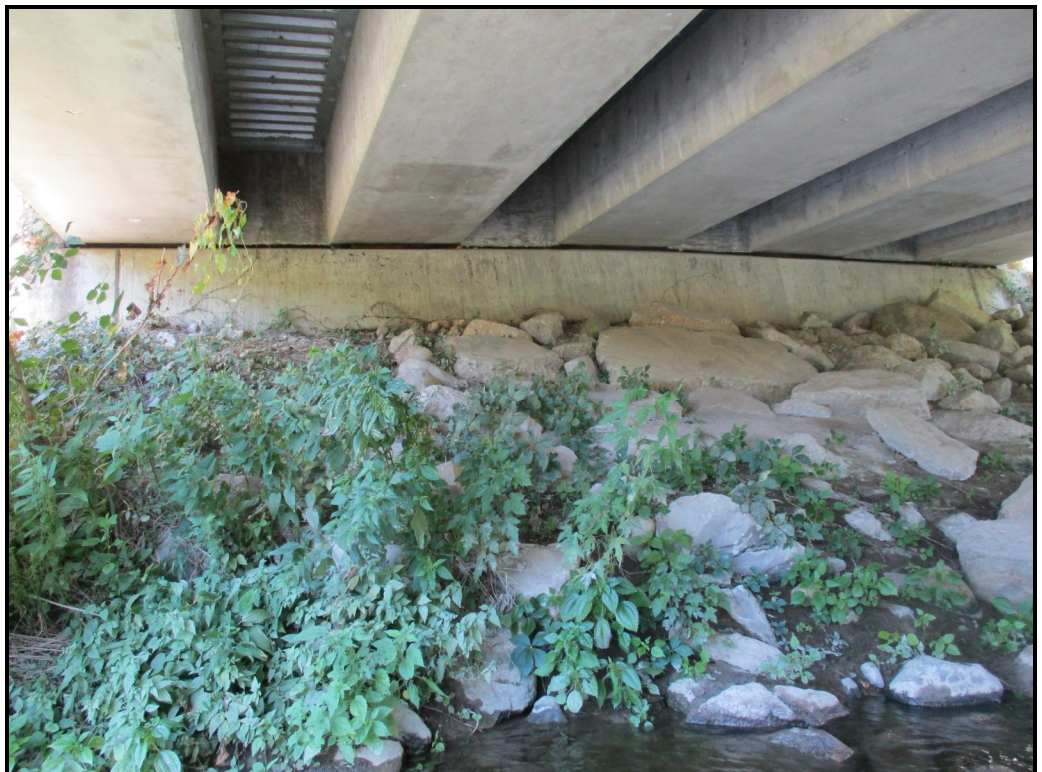
09/11	09/13	09/15	
<b>13. Abutments (SIA-60)</b>	8	8	7	Curtainwall abutments. Shrinkage/ASR cracks in both abutments/slopedwalls outside of bearing area. (09/15) Curtainwall abutments. Shrinkage/ASR cracks in both abutments/slopedwalls outside of bearing area. (09/13) Shrinkage/ASR cracks in both abutments/slopedwalls outside of bearing area (09/11)
<b>14. Piers (SIA-60)</b>	8	7	6	Solid wall pier. East & west 3'-4' and bottom 3'-4' has shrinkage/ASR cracks. East 1' has honeycomb concrete with exposed steel. Riprap around pier. (09/15) Solid wall pier. East & west 3'-4' and bottom 3'-4' has shrinkage/ASR cracks. East 1' has honeycomb concrete. Riprap around pier. (09/13) East & west 3'-4' and bottom 3'-4' has shrinkage/ASR cracks. East 1' has honeycomb concrete. Riprap around pier. (09/11)
<b>15. Slope Protection</b>	7	7	7	Riprap in place. (09/15) Riprap in place. (09/13) Riprap in place (09/11)

*North  
abutment*

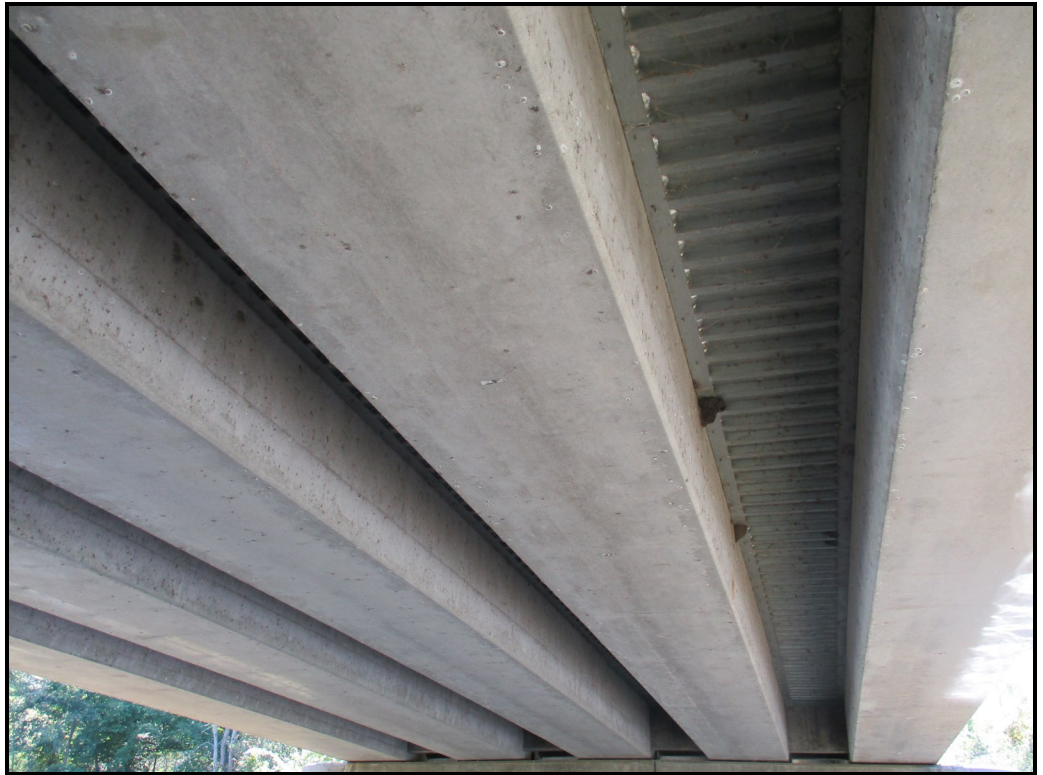
<b>9. Stringer (SIA-59)</b>	8	8	8	4' wide spread box beams. Cracks on ends of fascia beams at pier. (09/15) 4' wide spread box beams. Cracks on ends of fascia beams at pier. (09/13) 4' wide spread box beams (09/11)
<b>10. Paint (SIA-59A)</b>	N	N	N	(09/15) (09/13) (09/11)
<b>11. Section Loss</b>	N	N	3	(09/15) (09/13) (09/11)
<b>12. Bearings</b>	8	8	8	Elastomeric bearing pads in place. (09/15) Elastomeric bearing pads in place. (09/13) Elastomeric bearing pads in place. (09/11)

*Spread box  
beams*

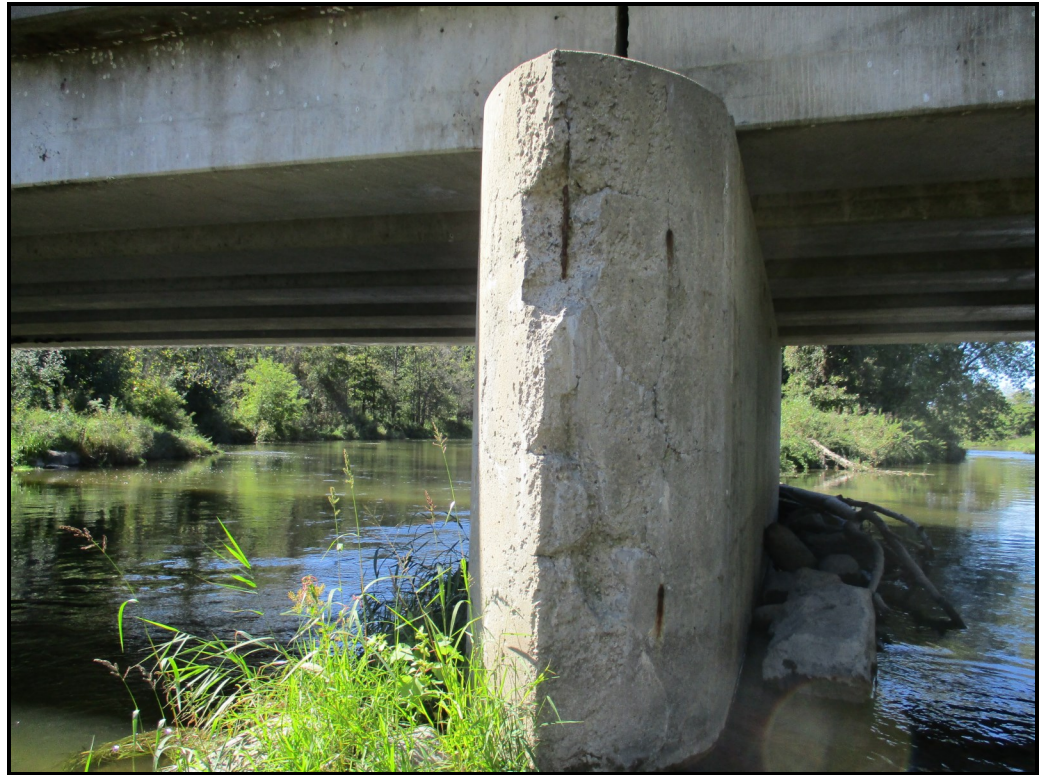
*Spalls with  
exposed steel at  
east end of pier*

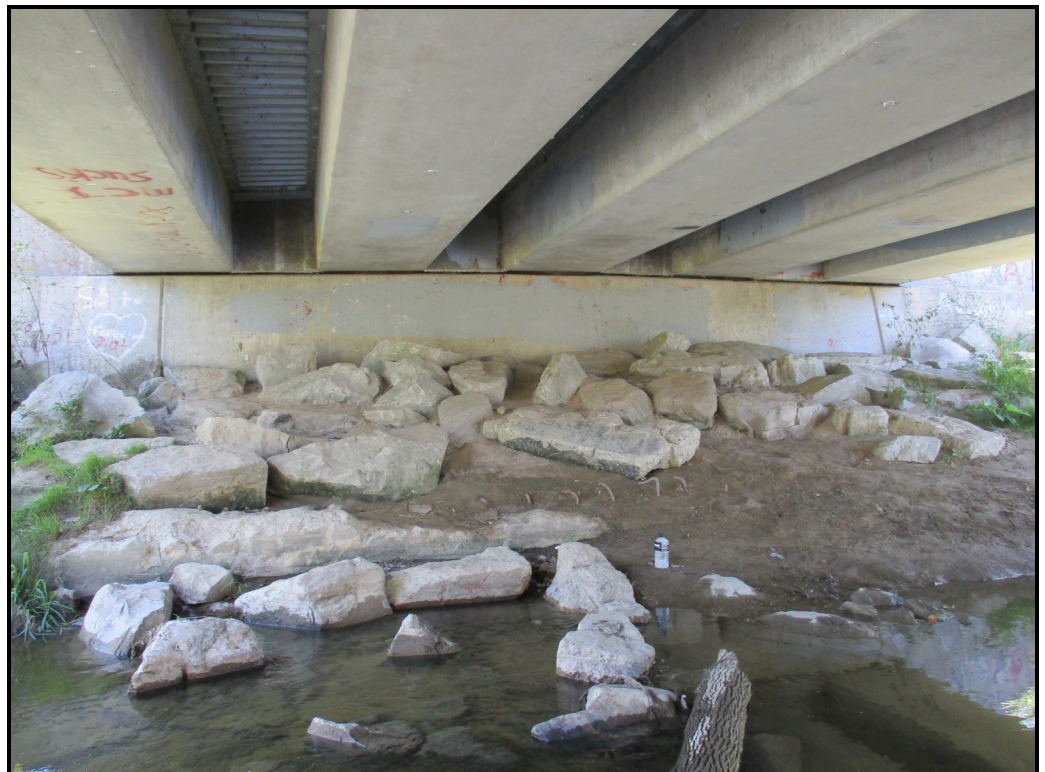
*South  
abutment*
