STR 6937

BRIDGE SAFETY INSPECTION REPORT

Midland County 2015 Bridge Inspections
North Saginaw Rd over Big Salt River
SN 6937
GLEG Project No. 1015-2-336
September 28, 2015

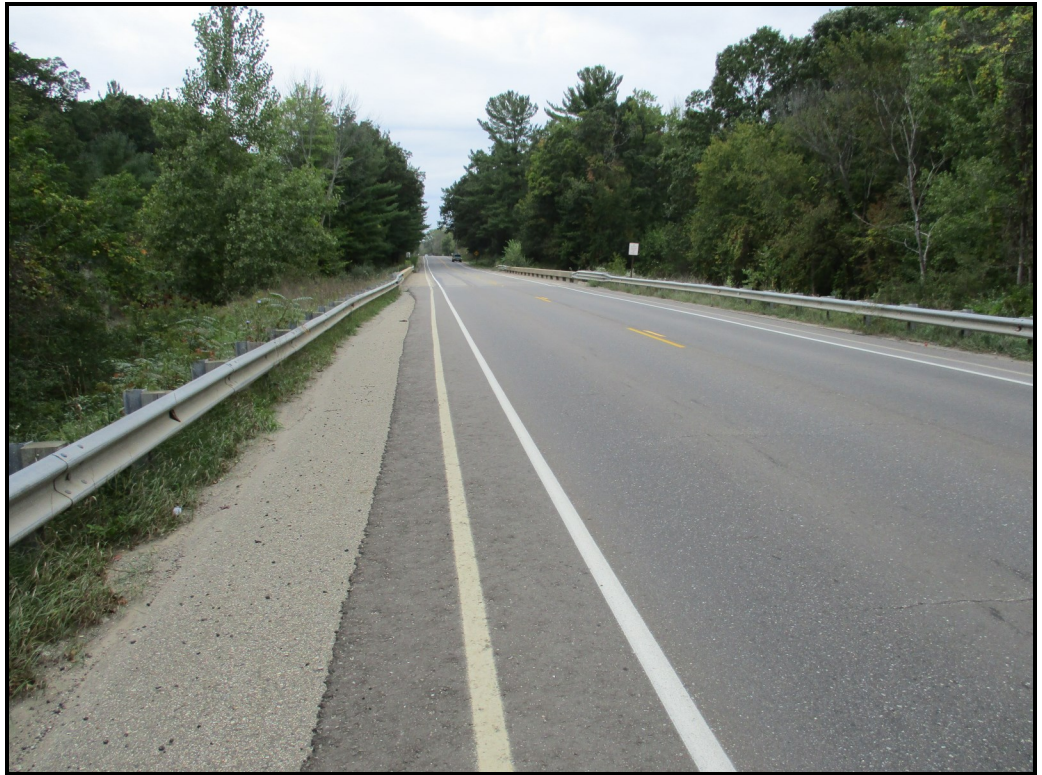
*Road and
bridge section
facing west*

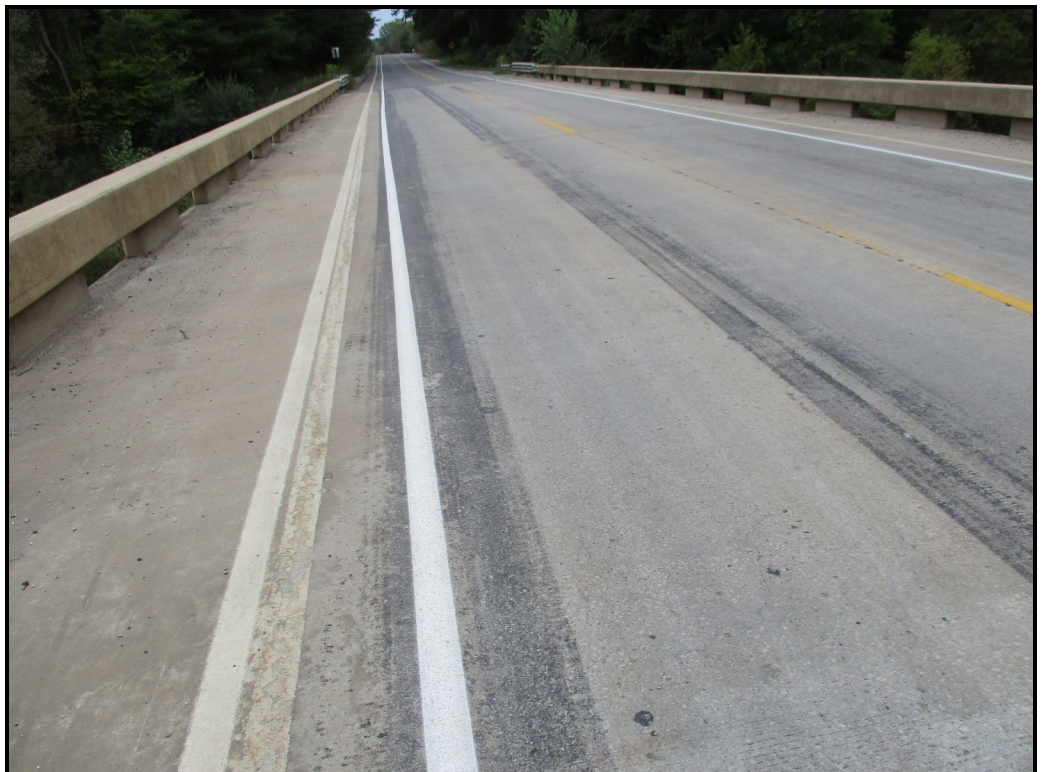
09/11	09/13	09/15	
1. Surface (SIA-58A)	7	7	6	Healer/sealer, estimate 90% worn off in drive lanes, intact in shoulders. Hairline map cracks in east 15 ft. (09/15) New healer/sealer, no visible cracks. Healer/sealer wearing off in wheel lines. Spall at west joint filled with healer/sealer. (09/13) Hairline map cracks at piers outside of tining. 0.5 sft spall at west joint, EBD lane. Noted hairline map cracking throughout east and center spans. Transverse crack in center span at east pier EBD lane. (09/11)

*Healer/sealer
surface*

Recommendation Type	Priority	Description
Appr. Pavement	H	Replace both approaches
Overlay	M	Healer/sealer in 4 years
Super Repair	L	Patch south deck fascia
Substr Repair	H	Apply horizontal surface sealer on top of piers and seal cracks in sloped walls.

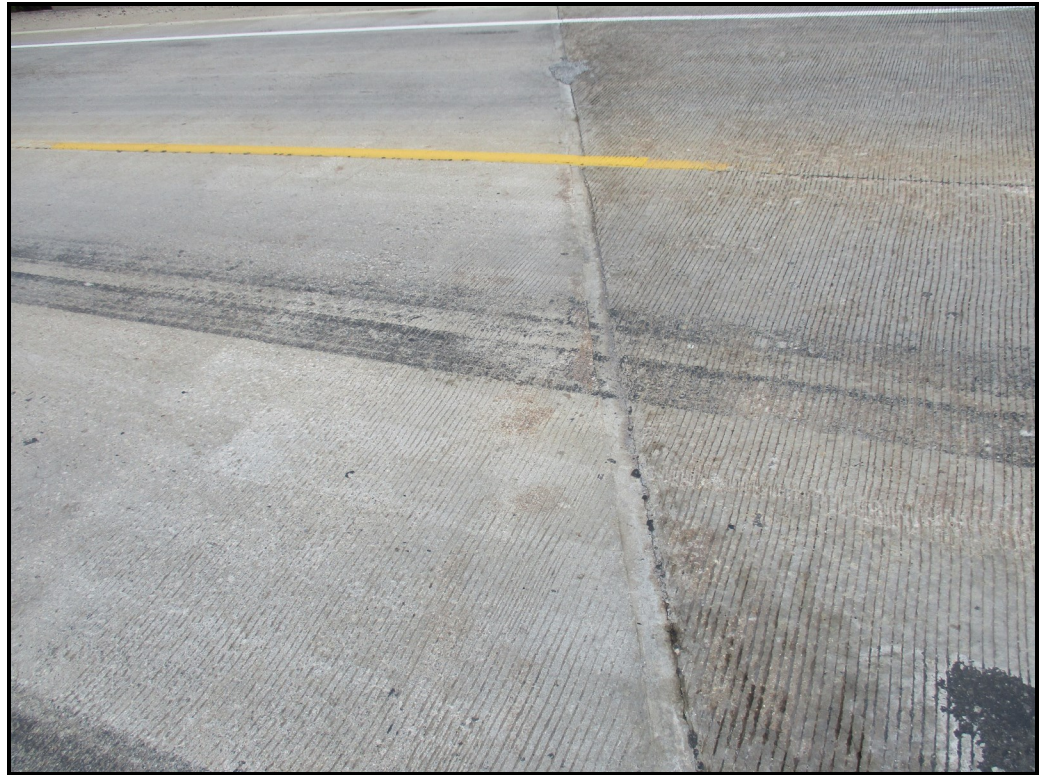
End joint

2. Expansion Joints	N	7	6	Joint material intact. HMA patch at east reference line. (09/15) Joint material intact (09/13) (09/11)
3. Other Joints	7	N	N	(09/15) (09/13) Joint material intact (09/11)

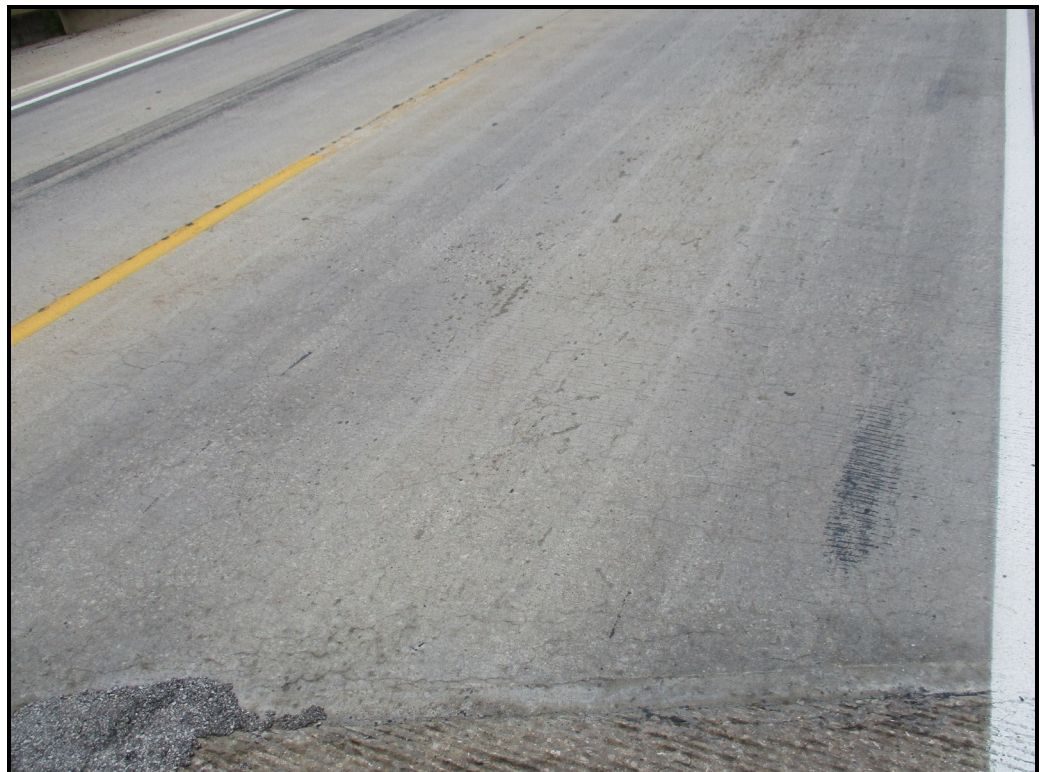
*Hairline cracks
in surface*

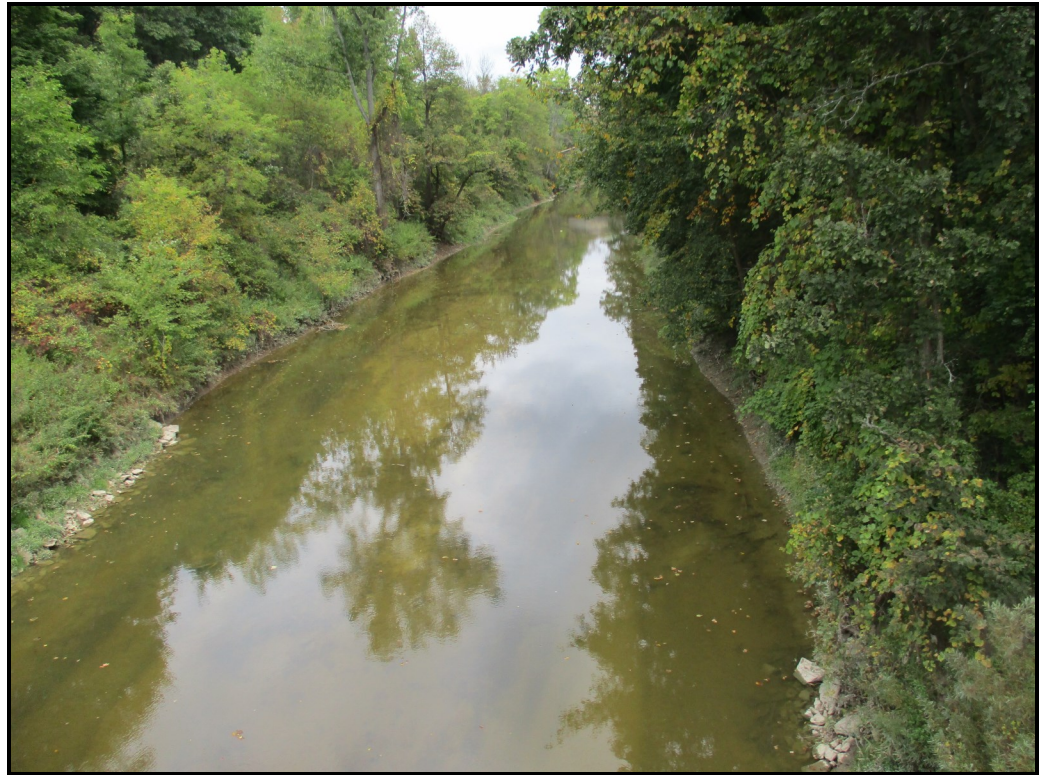
*Upstream
channel section*

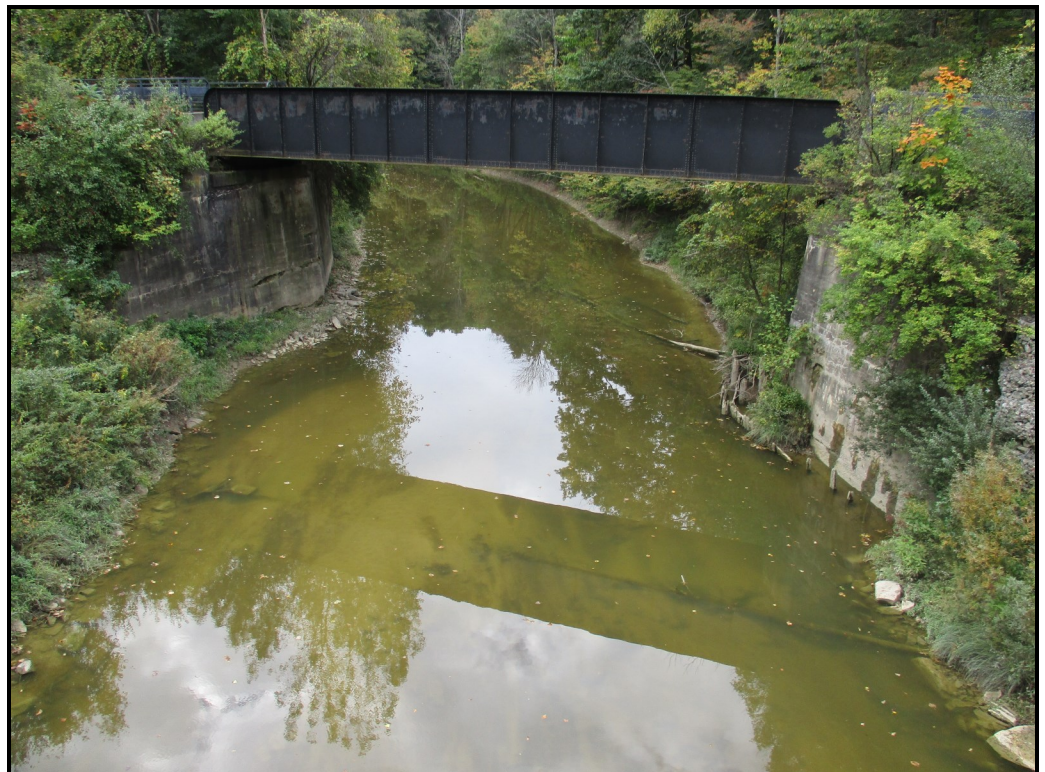
*Downstream
channel section*

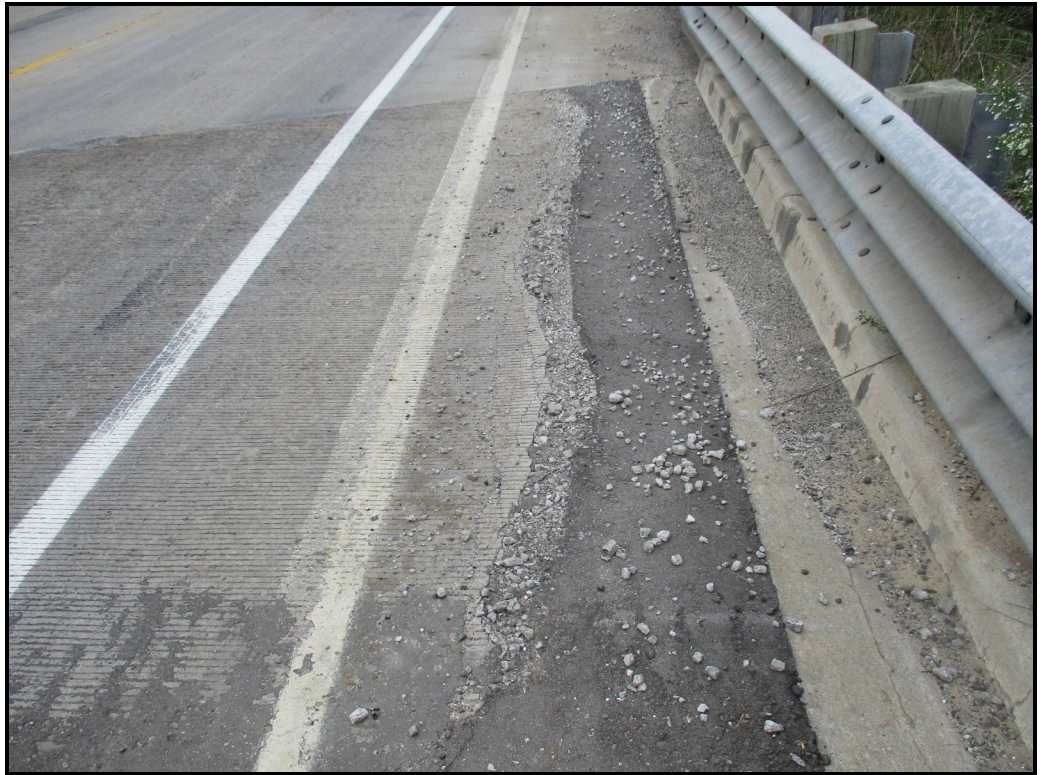
09/11	09/13	09/15	
18. Approach Pavement	6	4	5	East approach: 30% covered with HMA, north and south 2ft has been patched with HMA, longitudinal crack in EBD lane. West approach, 100% patched with HMA. (09/15) East approach: north and south 2ft has turned to gravel, longitudinal crack in EBD lane. West approach, outer 2ft has turned to gravel, HMA patches at reference lines and at west end. (09/13) East approach: the north, south, and east 1ft is spalled/patched/cracked, 4'x'4 delamination in SW corner, longitudinal crack in EBD lane. West approach: outer 1ft at all 4 edges is cracked/patched/spalled. (09/11)

*Spalling/HMA
patch in
approach*

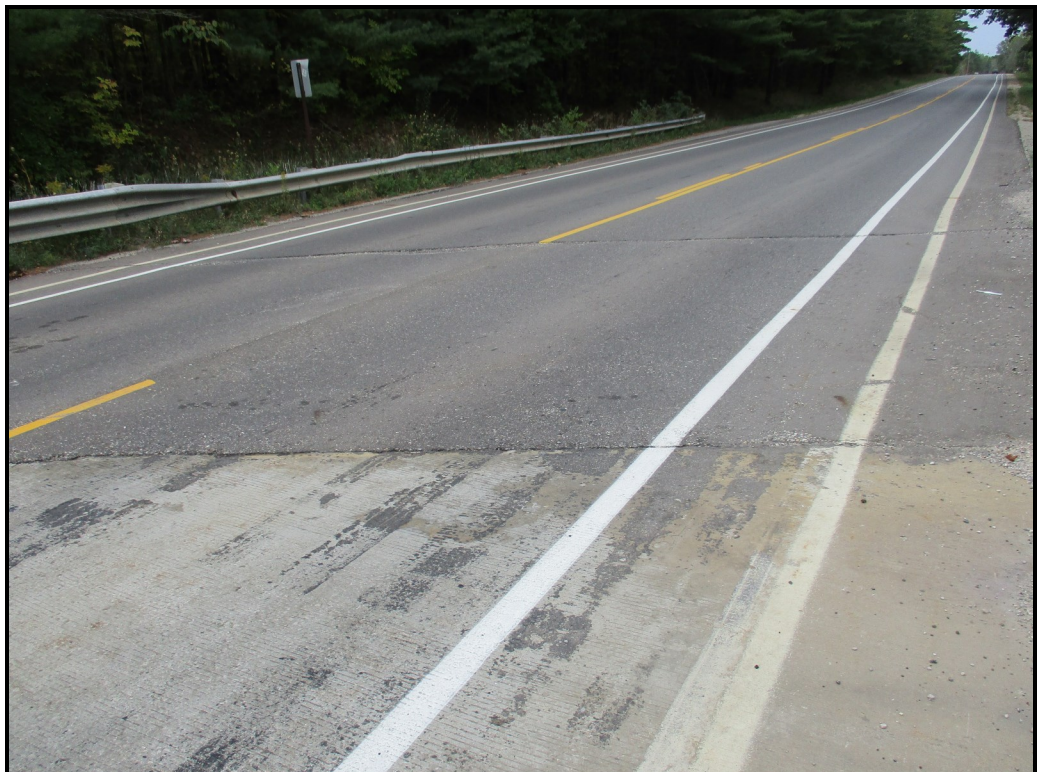
*New HMA
pavement*

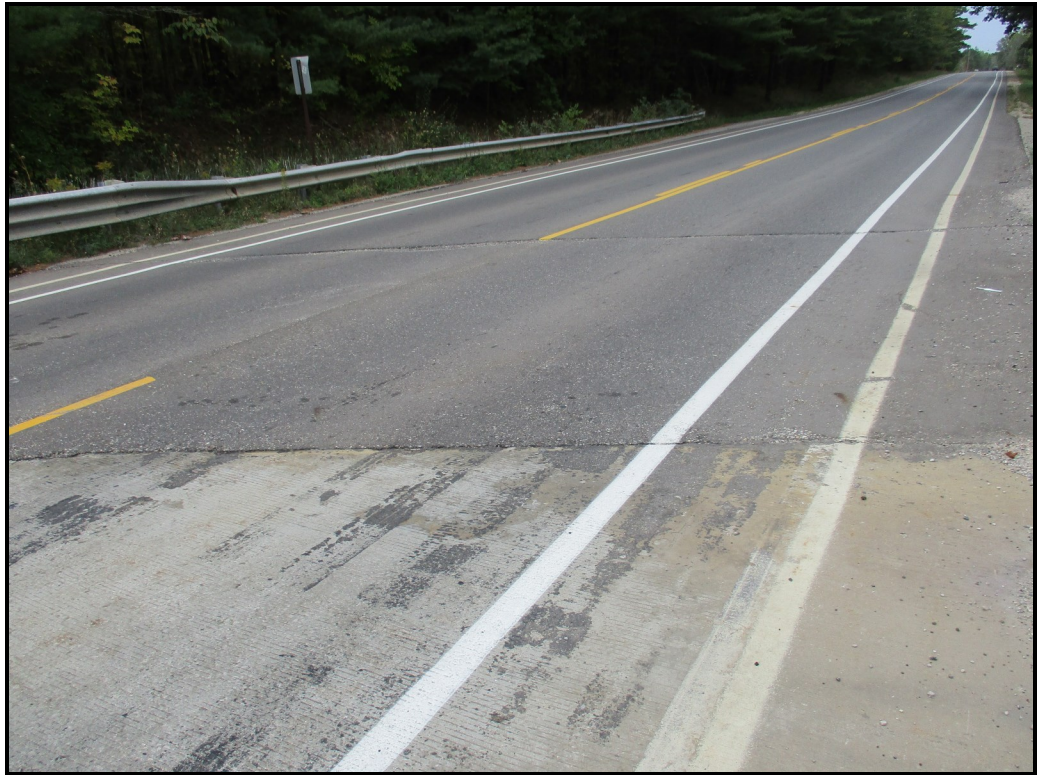
*New HMA
pavement*

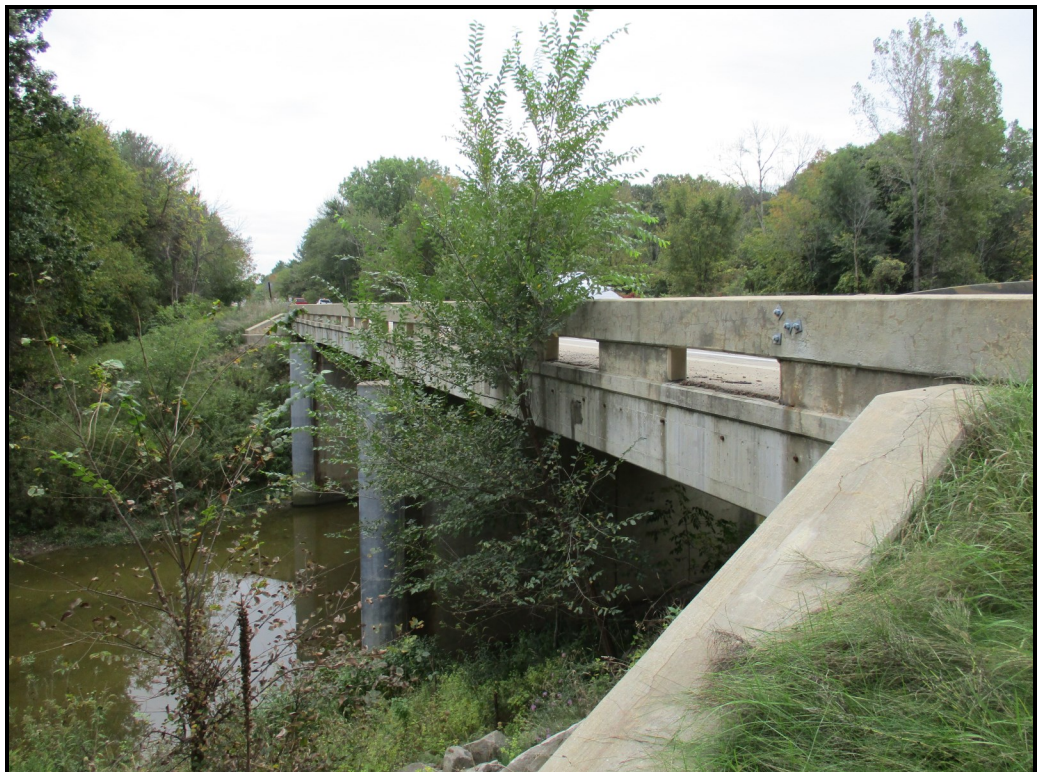
*North elevation
of bridge*

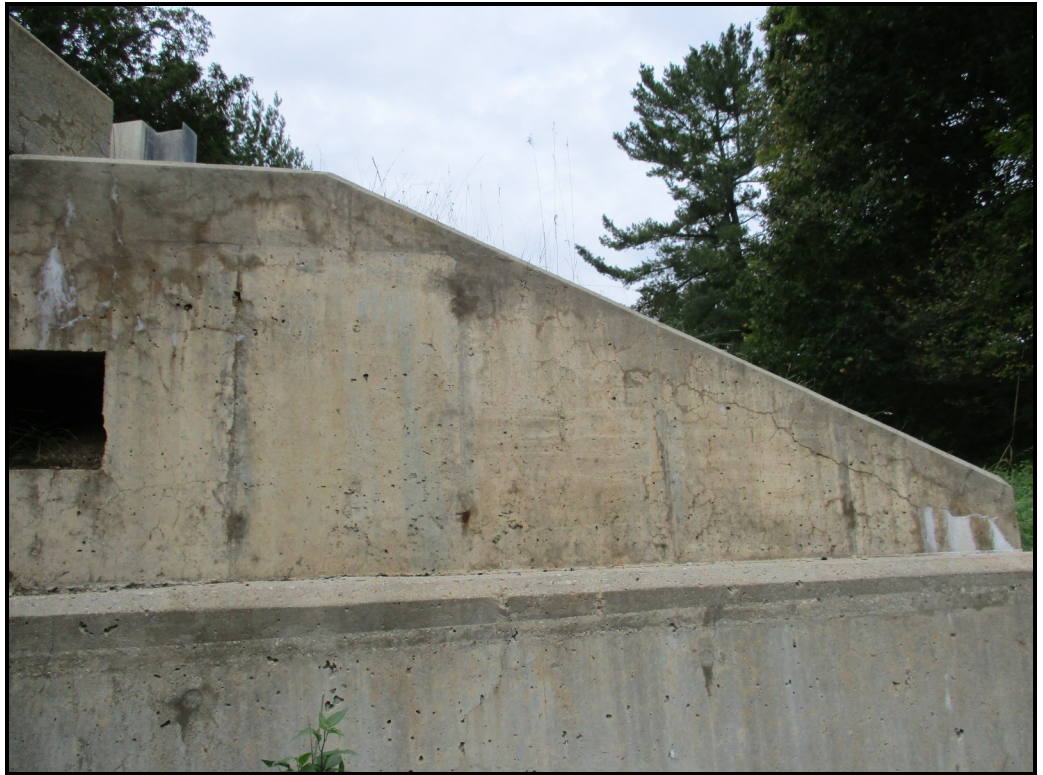
09/11	09/13	09/15	
13. Abutments (SIA-60)	8	7	7	Hairline shrinkage/ASR cracks in slope walls, leaching crack in NW slopewall (09/15) Hairline shrinkage/ASR cracks in slope walls (09/13) Hairline shrinkage/ASR cracks in slope walls (09/11)

*Leaching
cracks in slope
wall*

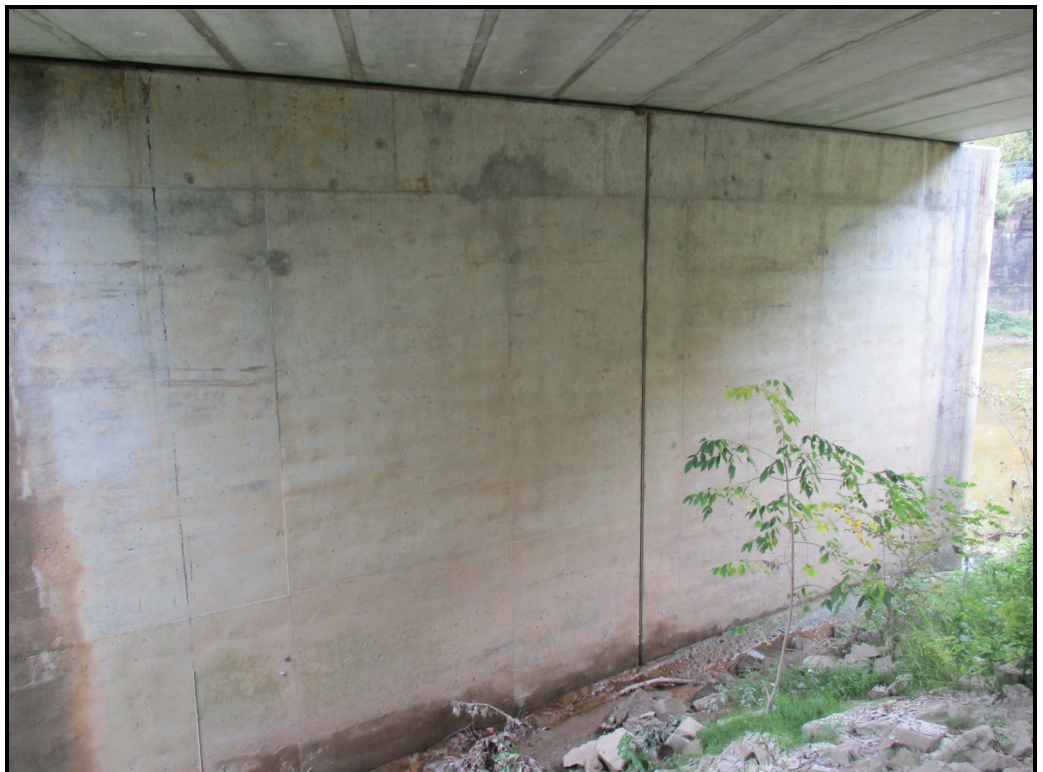
West pier

14. Piers (SIA-60)	7	7	7	Piers have hairline shrinkage cracks at outer 3'-4' on both north and south faces and on top of piers outside of fascias. (09/15) Piers have hairline shrinkage cracks at outer 3'-4' on both north and south faces and on top of piers outside of fascias. (09/13) Piers have hairline shrinkage cracks at outer 3'-4' on both north and south faces and on top of piers outside of fascias. (09/11)

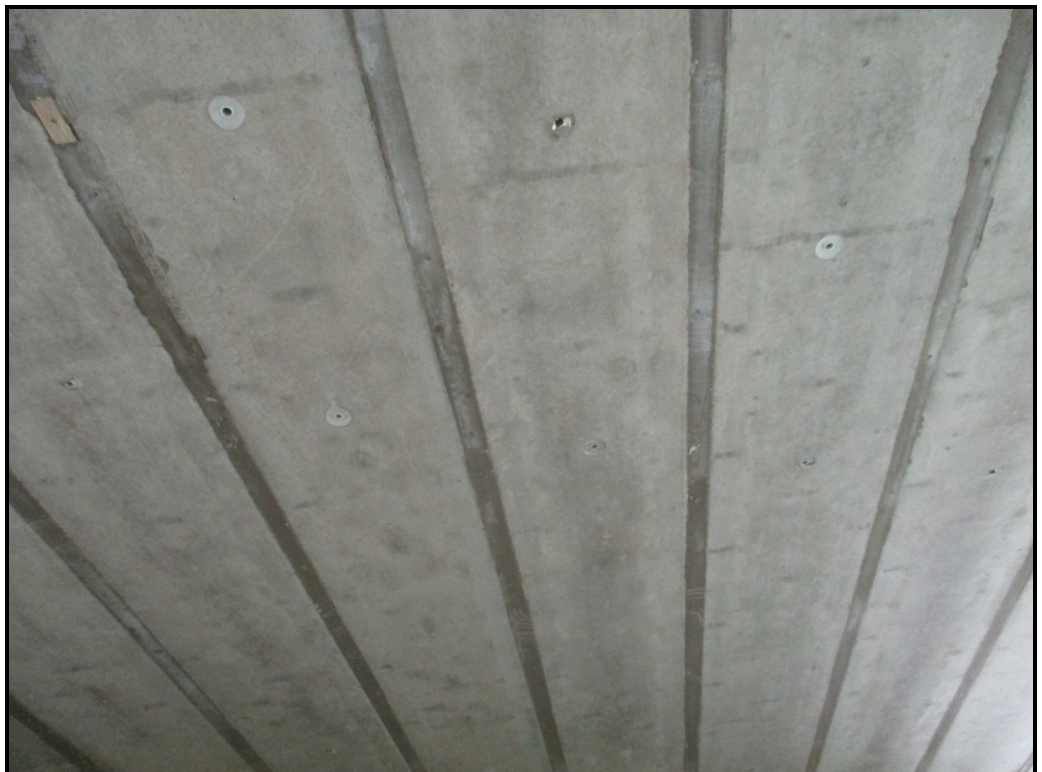
*Bottom of box
beams*

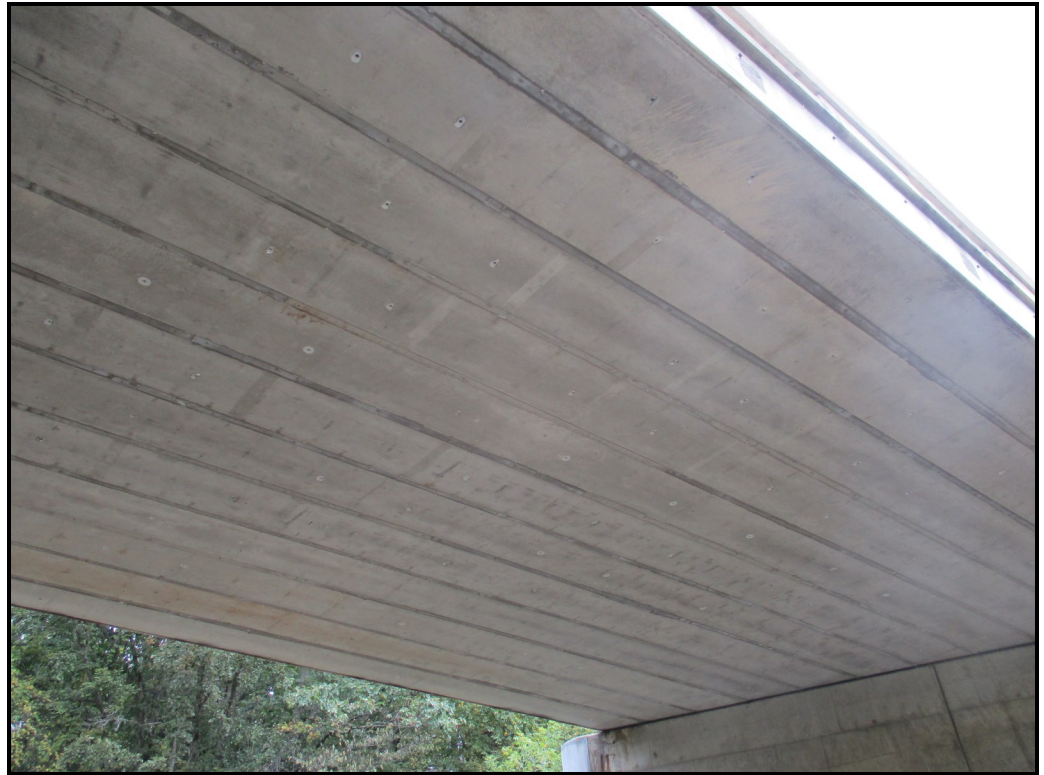
*Bottom of box
beams*

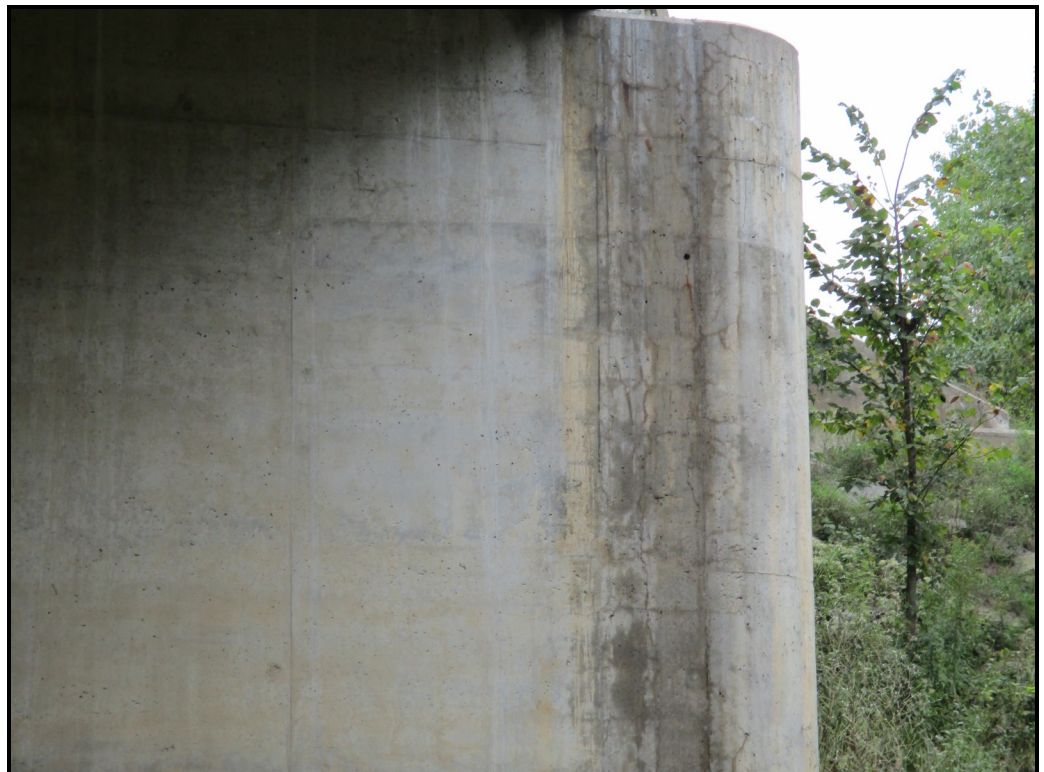
*Hairline map
cracks at end
of pier*

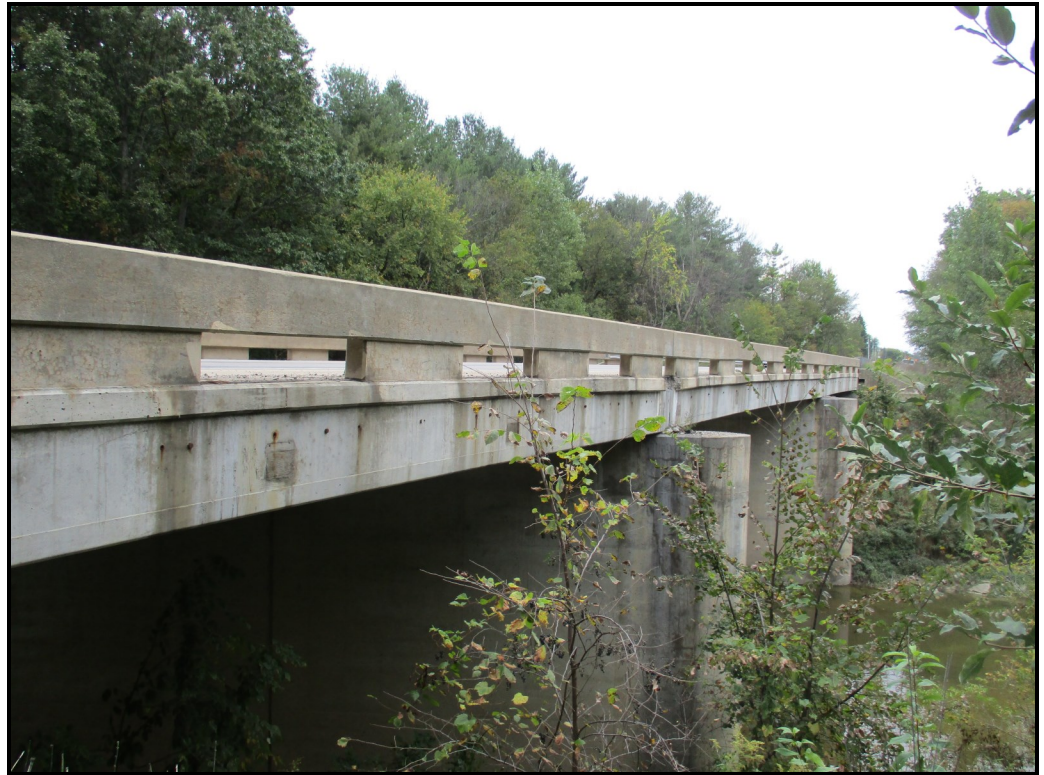
*South elevation
of bridge*

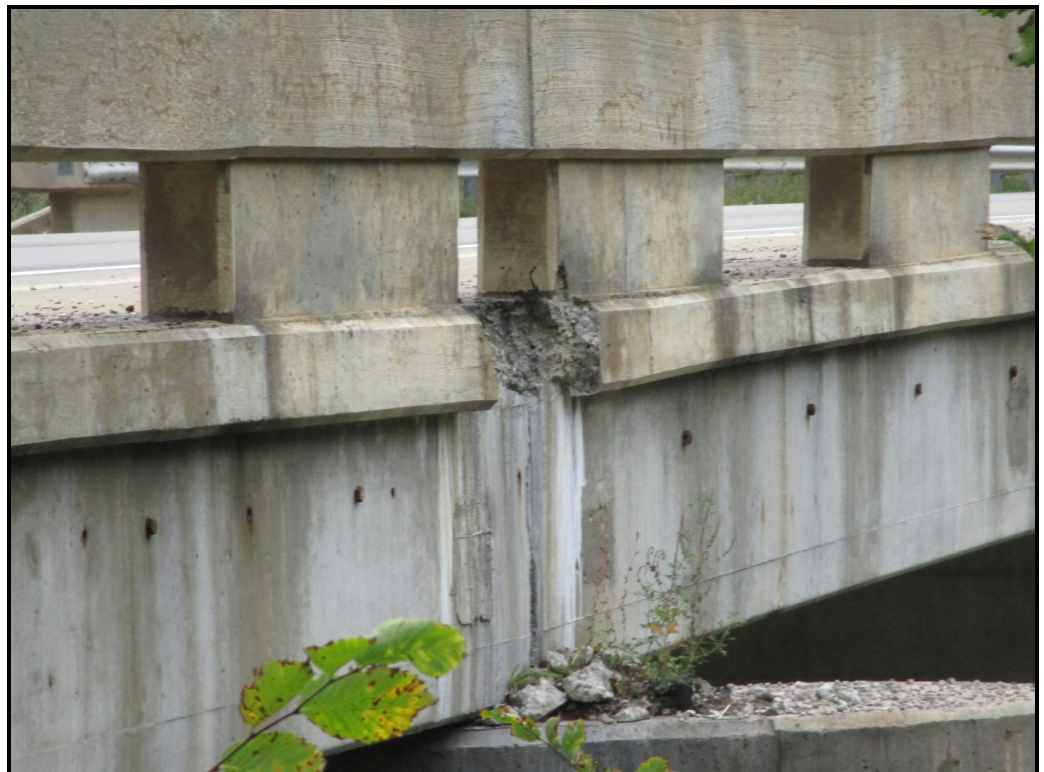
7. Deck (SIA-58)	7	7	7	Healer/sealer wearing off with hairline map cracks visible. South fascia spalled over both piers. (09/15) New healer/sealer on deck. South fascia spalled over both piers. (09/13) Map cracks in east and center spans, spall in south shoulder (09/11)

*Spall in south
deck fascia
over west pier*

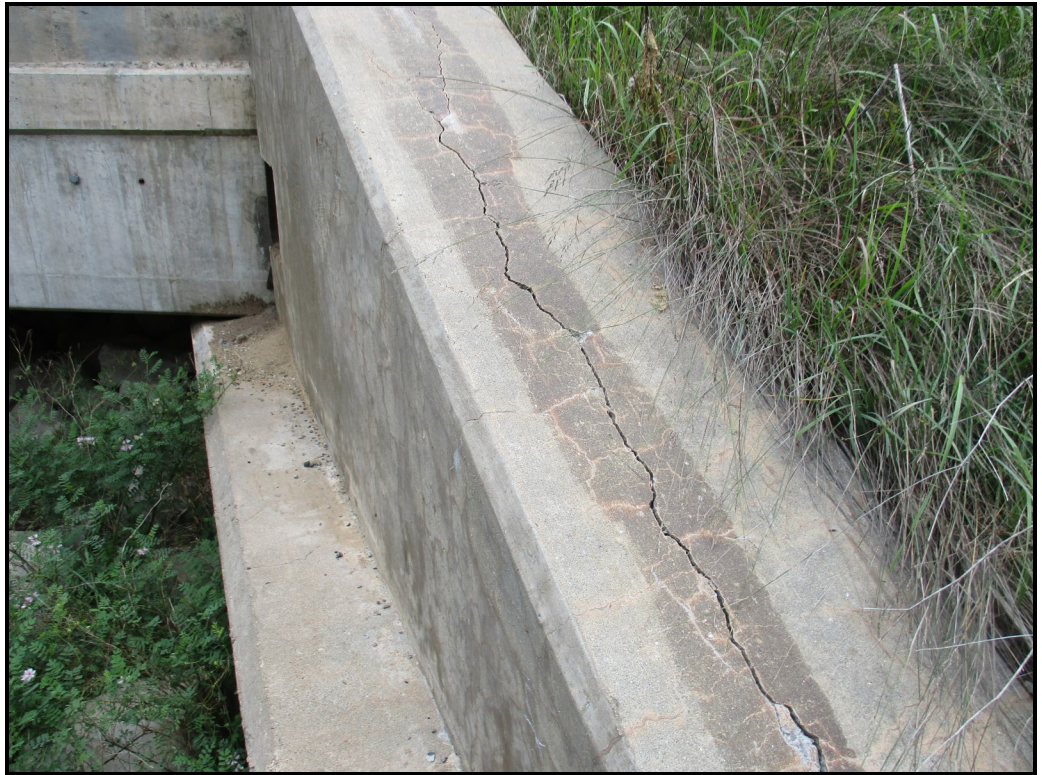
*Open crack in
slope wall*
