STR 6959	BRIDGE SAFETY IN			
Facility	Latitude / Longitude	MDOT Structure ID	Structure Condition	1
SMITHS CROSSING RD	43.487 / -84.1903	56200071000B010	Fair Condition(6)	
Feature	Length / Width	Owner		
WEEKS DRAIN	49.9 / 37.07	County: Midland(56)		
Location	Built / Recon. / Paint / Ovly.	TSC	Operational Status	
0.6 MI S OF LAPORTE RD	1994 / / / 1994	Mt. Pleasant(4A)	A Open, no restriction(A)	
Region / County	Material / Design	Last NBI Inspection	Scour Evaluation	
Bay(4) / Midland(56)	5 Prestressed Concrete / 05 Multiple Box Beam	08/26/2015 / W03J	8 Stable Above Footing

NBI INSPECTION			W03J
Inspector Name	Agency / Company Name	Insp. Freq.	Insp. Date
Eric Rickert	Great Lakes Engineering Group	24	08/26/2015
GENERAL NOTES

Midland County 2015 Bridge Inspections Smiths Crossing Rd over Weeks Drain SN 6959 GLEG Project No. 1015-2-336 August 26, 2015

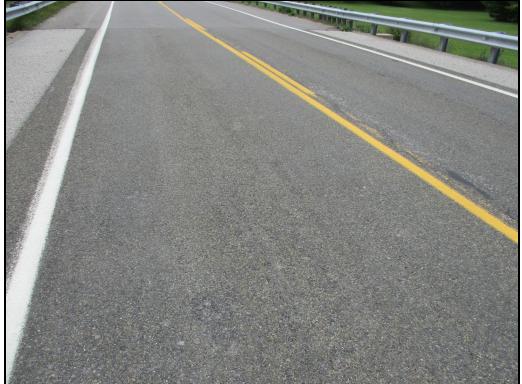
HMA surface

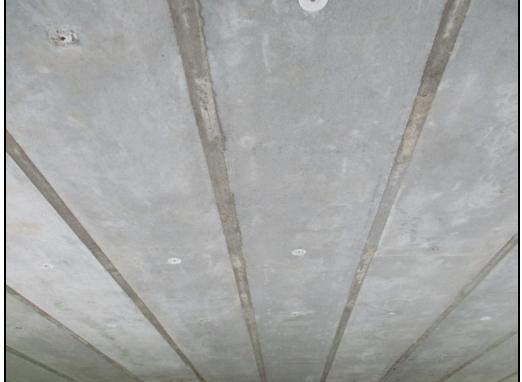
Bottom of box beams

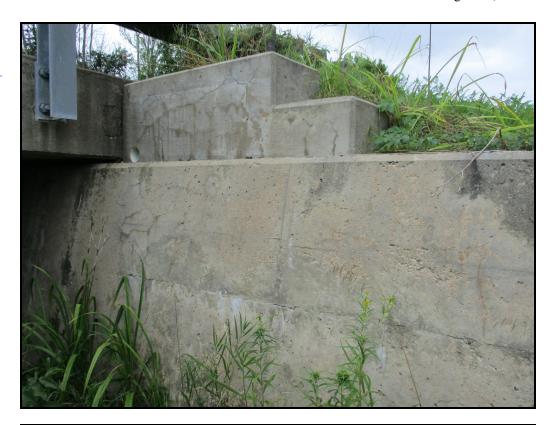
12. Bearings	8	8	8	Elastomeric pads look go Elastomeric pads look go Elastomeric pads look go	od. (08/13)	
SUBSTRUCTURE						
	08/11	08/13	08/15			
13. Abutments (SIA-60)	6	6	6	beams, noted several hai 10"). N abut has a 1/16" v Heavy ASR cracking in bo beams, noted several hai 10"). N abut has a 1/16" v Noted heavy ASR crackin several hairline vertical ar	rline vertical and horiztonal ert crack under beam 5W a oth abutments outside of be rline vertical and horiztonal ert crack under beam 5W a ng in both abutments outside	earing area and in all 4 slopewalls. Under cracks in each abut (spacing approx 3'-

Cracks in abutment outside of bearing

WORK RECOMMENDATIONS			W03J
Inspector Name	Agency / Company Name	Insp. Freq.	Insp. Date
Eric Rickert	Great Lakes Engineering Group	24	08/26/2015
RECOMMENDATIONS & ACTION	ITEMS		
Recommendation Type	Priority	Description	
Detailed Insp.	M	Investigate cause of abut cracking	g and fix accordingly
