**MICHIGAN DEPARTMENT OF TRANSPORTATION**

**STR 6945**

**BRIDGE SAFETY INSPECTION REPORT**

Midland County 2015 Bridge Inspections  
Magruder Rd over Chippewa River  
SN 6945  
GLEG Project No. 1015-2-336  
September 22, 2015

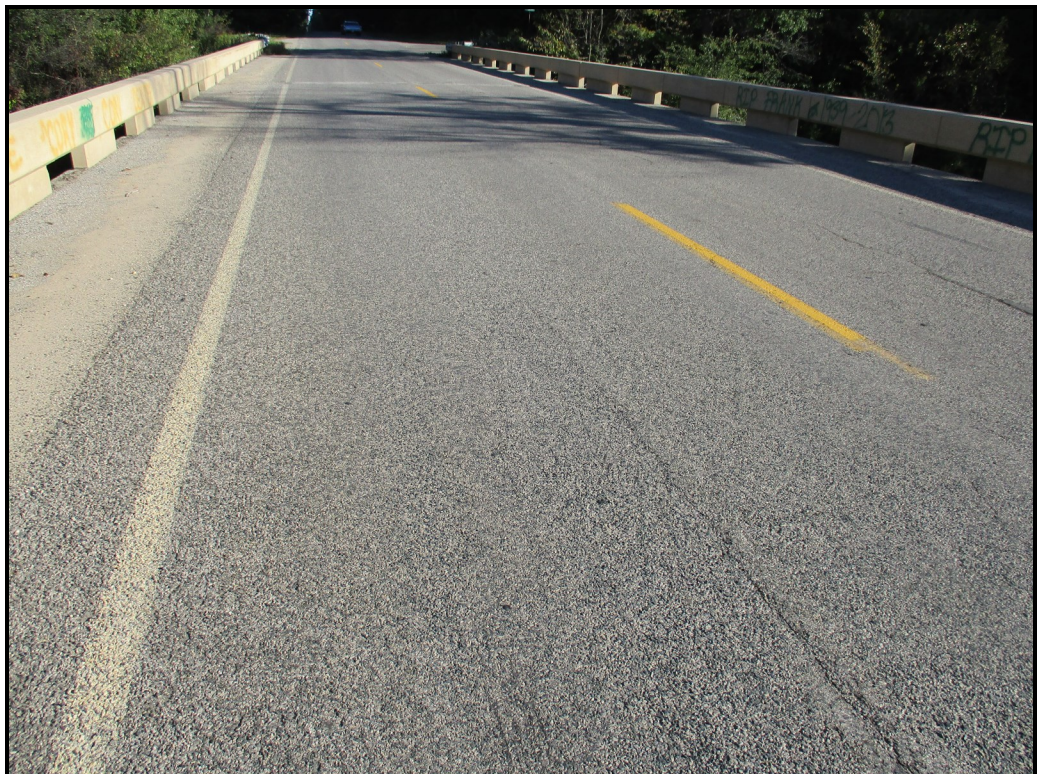
09/11	09/13	09/15	
<b>1. Surface (SIA-58A)</b>	5	5	5	Chip seal with map cracks in north 20 ft of both lanes. (09/15) Chip seal with reflective map cracks in northbound lane in south span. (09/13) In south span, map cracks in bit throughout northbound lane and in half of southbound lane, in north span map cracks in both lanes. Crack spacing 1'-6". (09/11)
<b>2. Expansion Joints</b>	5	5	5	Estimate 75% of concrete header spalled/patched. Joint full of sand. Chip seal over joint. (09/15) Estimate 75% of concrete header spalled/patched. Joint full of sand. Chip seal over joint. (09/13) Estimate 75% of concrete header spalled/patched. Joint full of sand (09/11)
<b>3. Other Joints</b>	N	N	N	(09/15) (09/13) (09/11)
<b>4. Railings</b>	7	7	7	Concrete open parapet rail. Surface sealer on inside of railing, hairline cracks on outside. (09/15) Concrete open parapet rail. Surface sealer on inside of railing, hairline cracks on outside. (09/13) Surface sealer on inside of railing, hairline cracks on outside. (09/11)

*Chip seal  
surface*

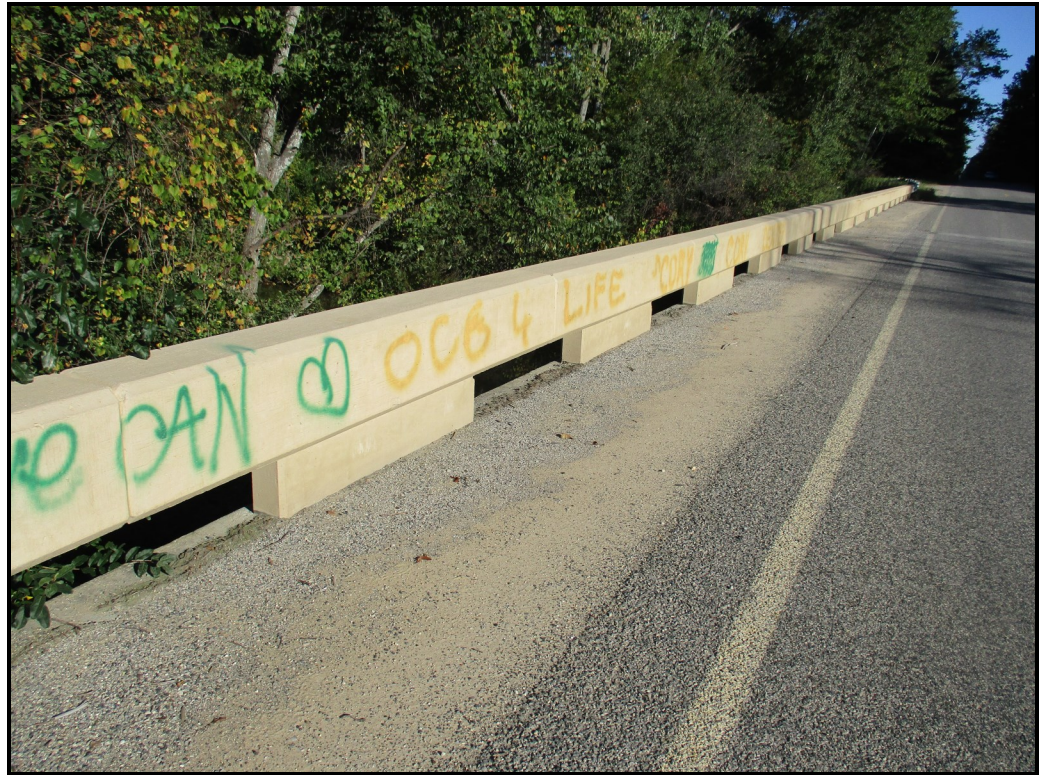
*Bridge railing*

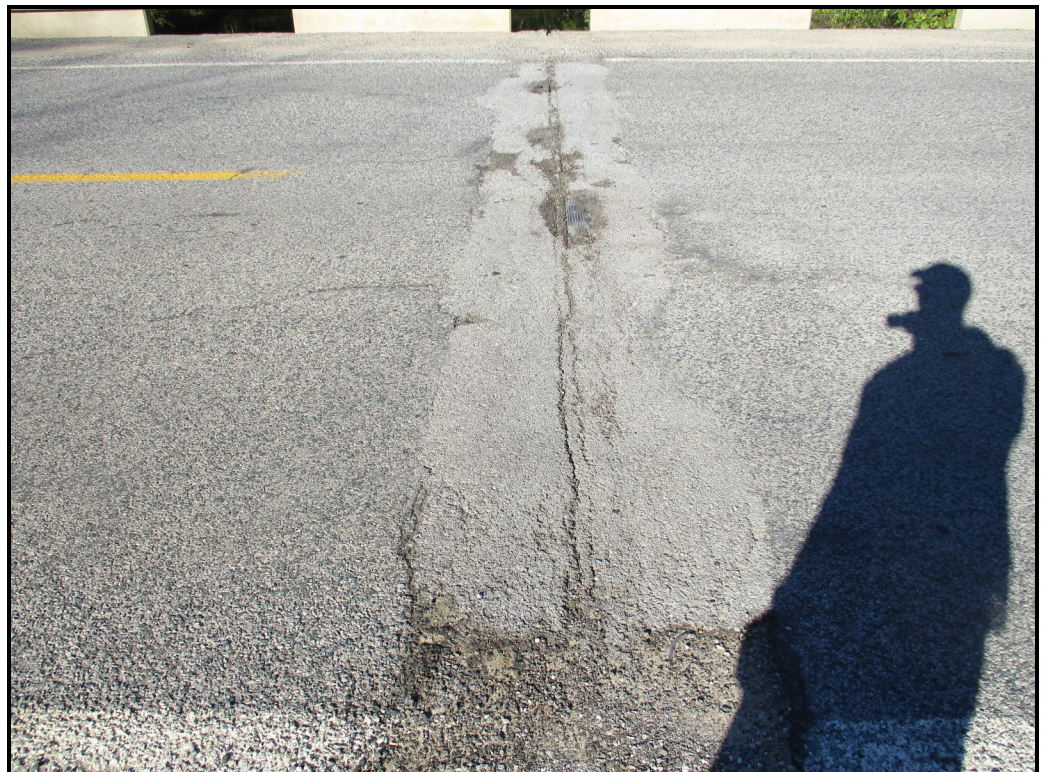
*Patching over  
expansion joint*

<b>Recommendation Type</b>	<b>Priority</b>	<b>Description</b>
Slope Repair	L	Place riprap at north slope and repair eroded areas
Scour Repair	H	Remove debris stuck on pier
Joint Repair	M	Replace joint
Overlay	M	Mill and apply waterproofing membrane and repave
Super Repl.	H	Patch beam ends over pier and replace joint.

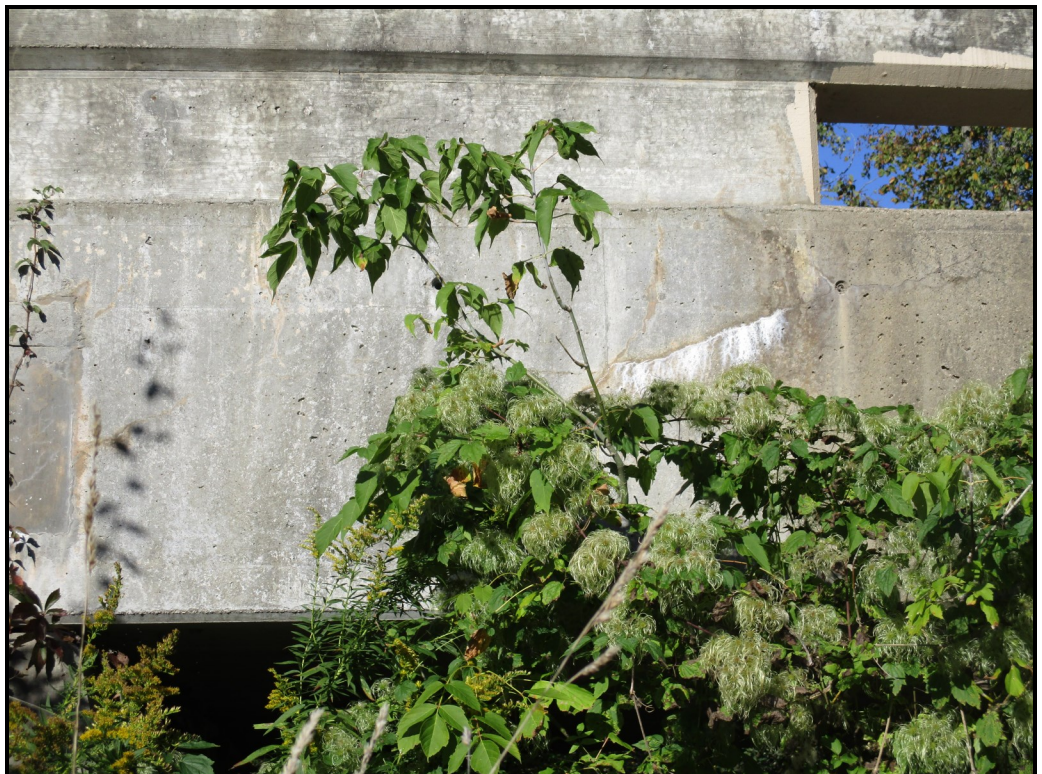
<b>9. Stringer (SIA-59)</b>	5	5	5	Both east and west fascia beams over pier have spalls full beam height with exposed stirrups. Stirrups are rusting with heavy scale. South span: east fascia has a hairline leaching crack, hairline shear crack in west fascia south end and north end, 1'x2' delamination at abutment in west fascia, west fascia has a 1sft spall at north 1/4 point, west fascia post tension pocket 2S has a spall in grout. North span: east fascia has a 1sft spall near south end, hairline shear crack in east fascia north and south ends, east fascia has hairline cracks propagating from post tension pockets 2S, 3S, 4S, spalled grout at east fascia post tension pocket 5S, 2 hairline shear cracks at pier in west fascia. (09/15) Both east and west fascia beams over pier have spalls full beam height with exposed stirrups. Stirrups are rusting with heavy scale. South span: hairline shear crack in west fascia south end and north end, 1'x2' delamination at abutment in west fascia, west fascia post tension pocket 2S has a spall in grout. North span: hairline shear crack in east fascia north end, east fascia has hairline cracks propagating from post tension pockets 2S, 3S, 4S, spalled grout at east fascia post tension pocket 5S, 2 hairline shear cracks at pier in west fascia. (09/13) Both east and west fascia beams over pier have spalls full beam height with exposed stirrups. Stirrups are rusting with heavy scale. South span: hairline shear crack in west fascia southend and northend, 1'x2' delamination at abutment in west fascia, west fascia post tension pocket 2S has a spall in grout. North span: hairline shear crack in east fascia northend, east fascia has hairline cracks propagating from post tension pockets 2S 3S 4S, spalled grout at east fascia post tension pocket 5S, 2 hairline shear cracks at pier in west fascia (09/11)

*Leaching shear  
crack in east  
fascia beam*

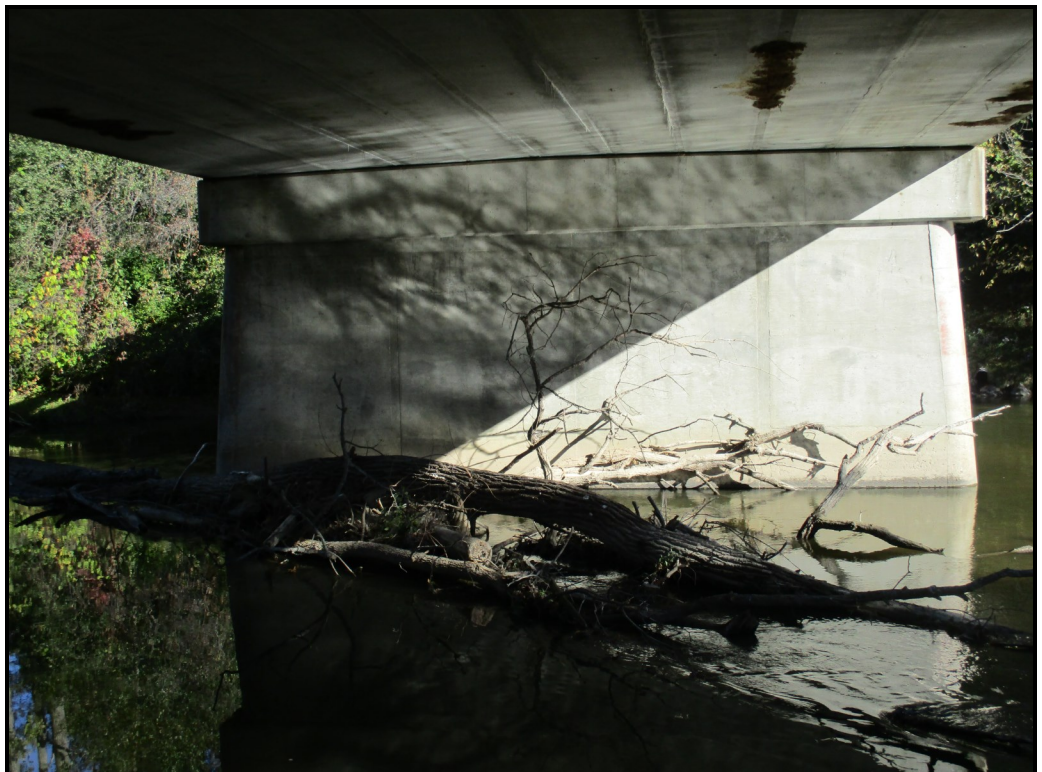
*Pier*

Good/fair. Patch fascia beams over pier. Remove debris on pier.

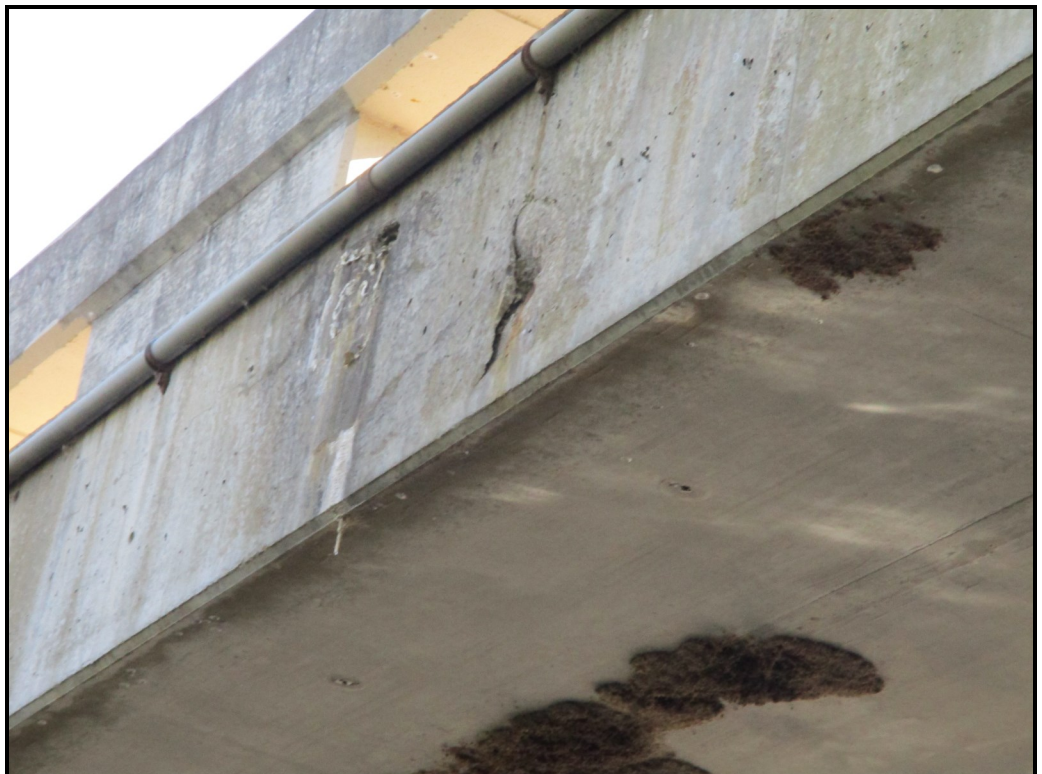
*Spall in west  
fascia, south  
span*

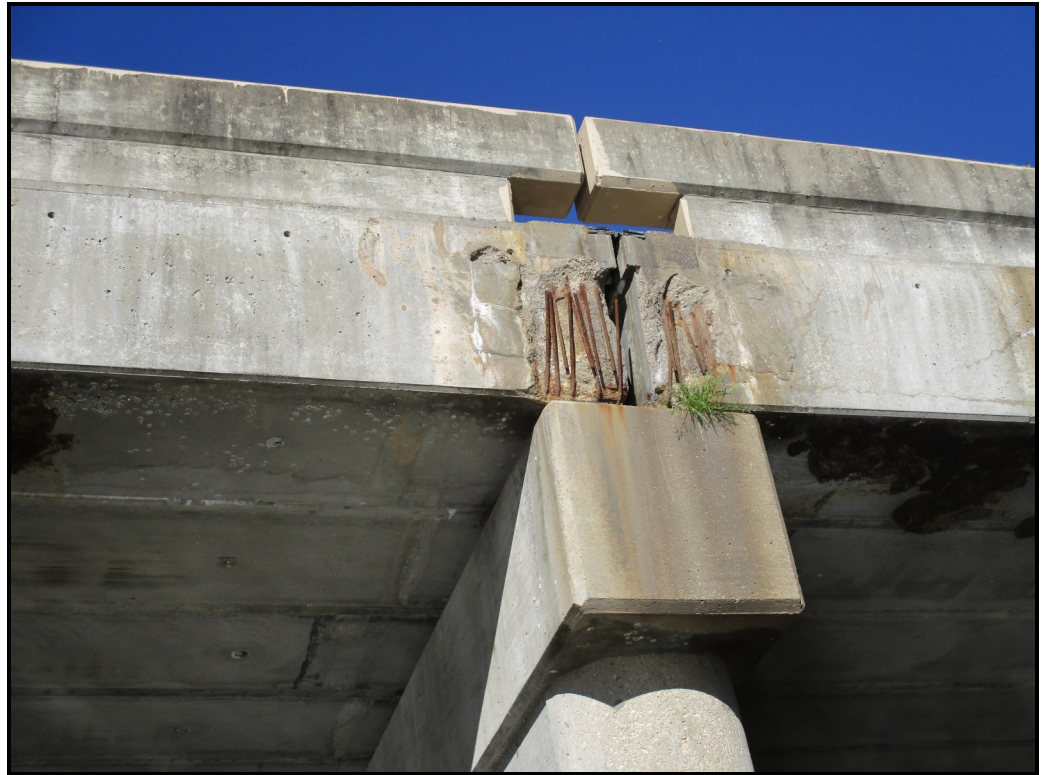
*Exposed resteel  
in east fascia  
over pier*

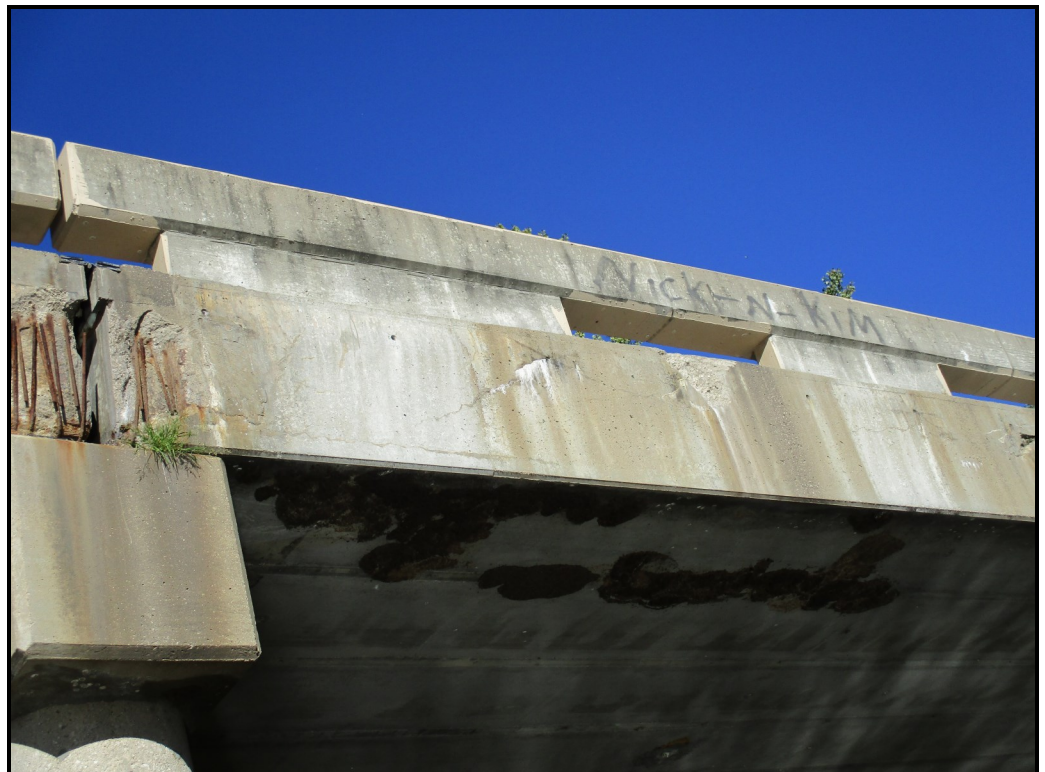
*Spall and  
leaching crack  
in east fascia,  
north span*

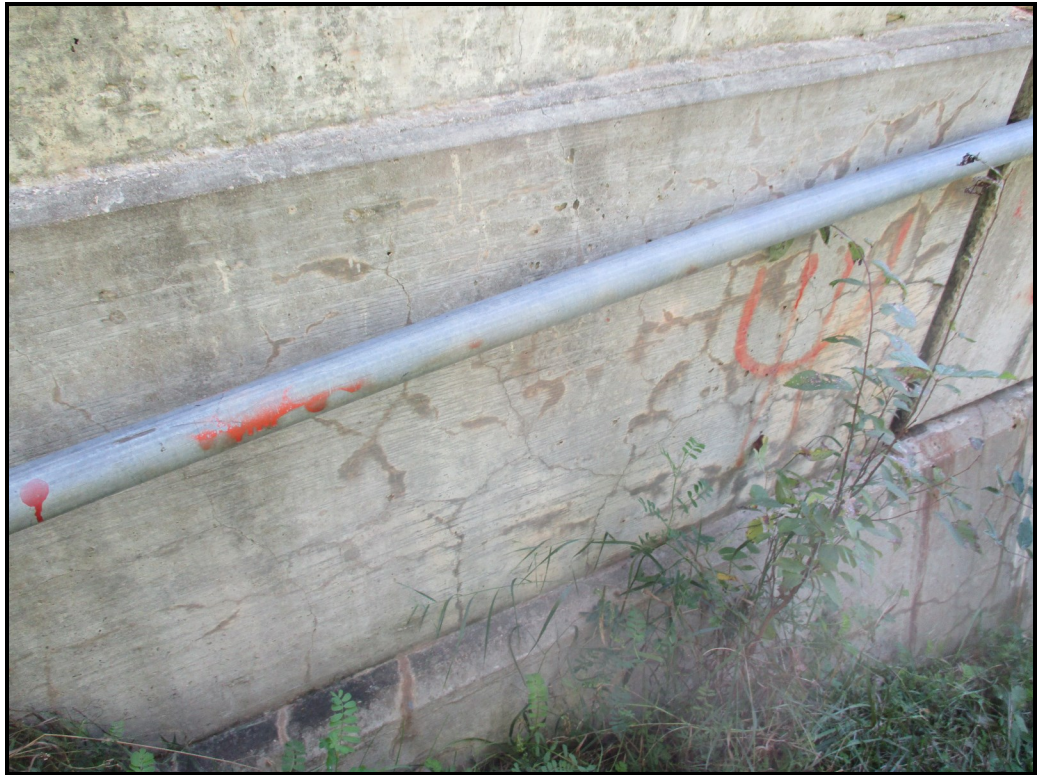
09/11	09/13	09/15	
<b>13. Abutments (SIA-60)</b>	7	7	7	All 4 abutment corners/returnwall have hairline shrinkage/ASR cracks. (09/15) All 4 abutment corners/returnwall have hairline shrinkage/ASR cracks. (09/13) All 4 abutment corners/returnwall have hairline shrinkage/ASR cracks. (09/11)
<b>14. Piers (SIA-60)</b>	7	7	6	Hairline to 1/16" vertical crack at west end. 2 logs stuck on pier (09/15) Hairline to 1/16" vertical crack at west end. (09/13) Hairline to 1/16" vertical crack at westend. (09/11)
<b>15. Slope Protection</b>	5	5	5	Estimate 50% of riprap at north abutment has been moved into stream. Noted erosion along edges of riprap from roadway runoff. At south abutment, 5-10% missing. (09/15) Estimate 50% of riprap at north abutment has been moved into stream. Noted erosion along edges of riprap from roadway runoff. At south abutment, 5-10% missing. (09/13) Estimate 50% of riprap at north abutment has been moved into stream. Noted erosion along edges of riprap from roadway runoff. At south abutment, 5-10% missing (09/11)

*ASR cracks in  
north abutment*
