MICHIGAN DEPARTMENT OF TRANSPORTATION

STR 6976

BRIDGE SAFETY INSPECTION REPORT

Midland County 2015 Bridge Inspections
Brooks Rd over Jo Drain
SN 6976
GLEG Project No. 1015-2-336
August 25, 2015

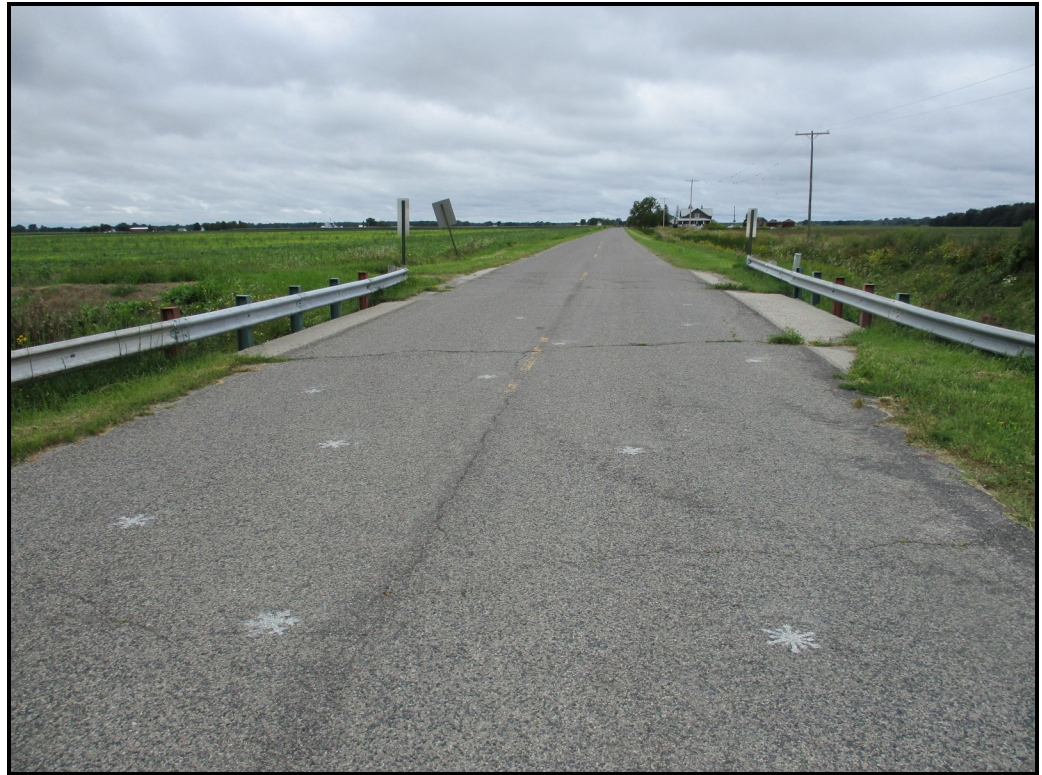
*Road and
bridge section
facing west*

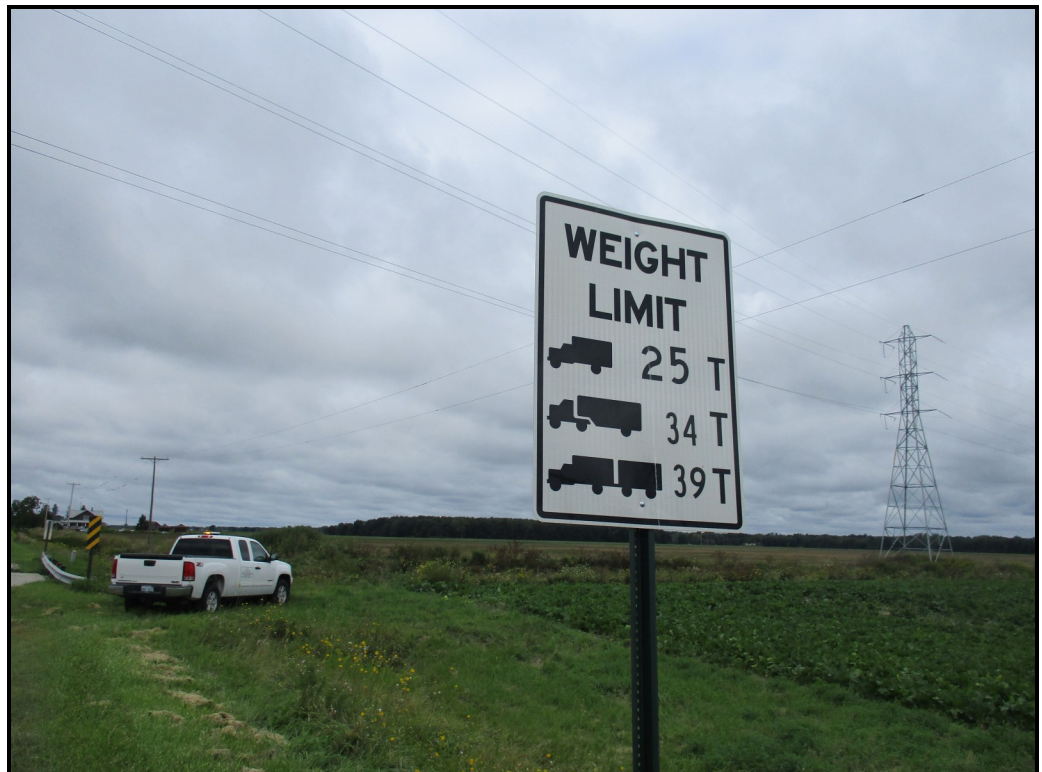
Posting sign

16. Approach Pavement	6	6	6	Chip seal over HMA. Reflective cracks at reference lines. WB posting sign replaced (08/15) Chip seal over HMA. Reflective cracks at reference lines. Missing westbound posting sign. (08/13) HMA has transverse crack at east reference line and in west approach. (08/11)
------------------------------	---	---	---	--

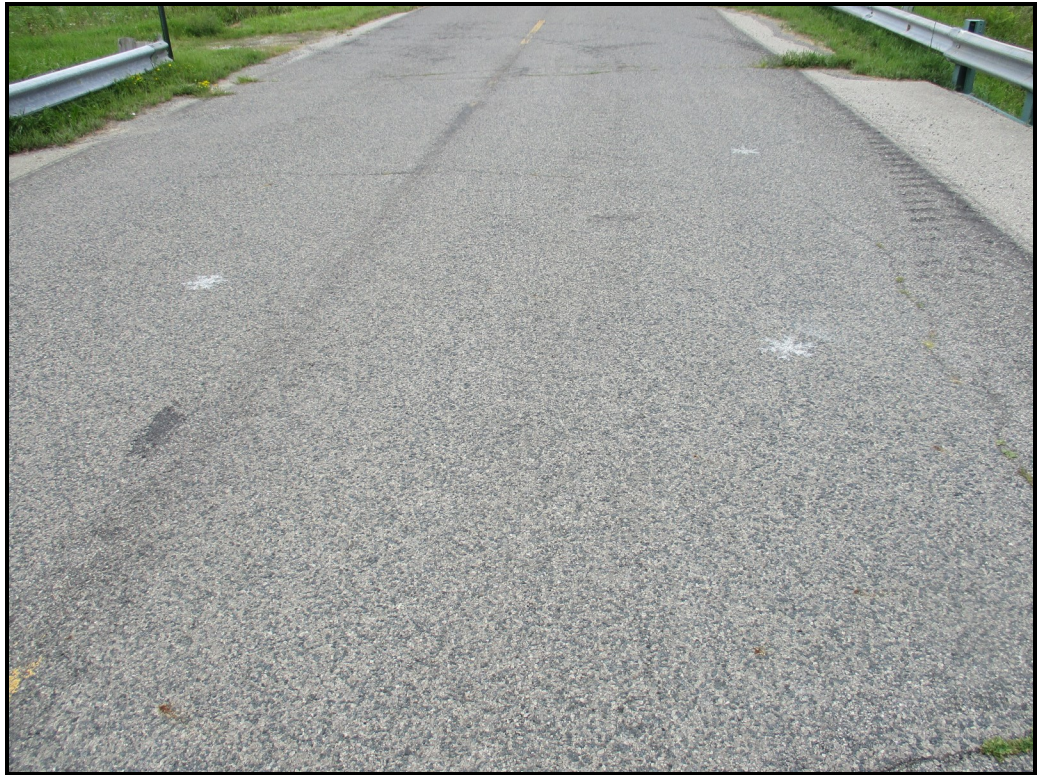
08/11	08/13	08/15	
1. Surface (SIA-58A)	7	7	7	Chip seal over HMA with 1 longitudinal and 3 transverse cracks. Estimate 7" of HMA on deck. (08/15) Chip seal over HMA with 1 longitudinal and 3 transverse cracks. (08/13) 1 longitudinal and 3 transverse crack in bituminous. 7" of HMA on deck (08/11)

*Chip seal
surface*

Recommendation Type	Priority	Description
Railing Repair	M	Install new rail and approach rail
Deck Patching	L	Seal cracks in bituminous
Substr Repair	H	Grout cracks in abutment
Bridge Repl.	M	Full replacement
Other	H	Place riprap at both abutments.

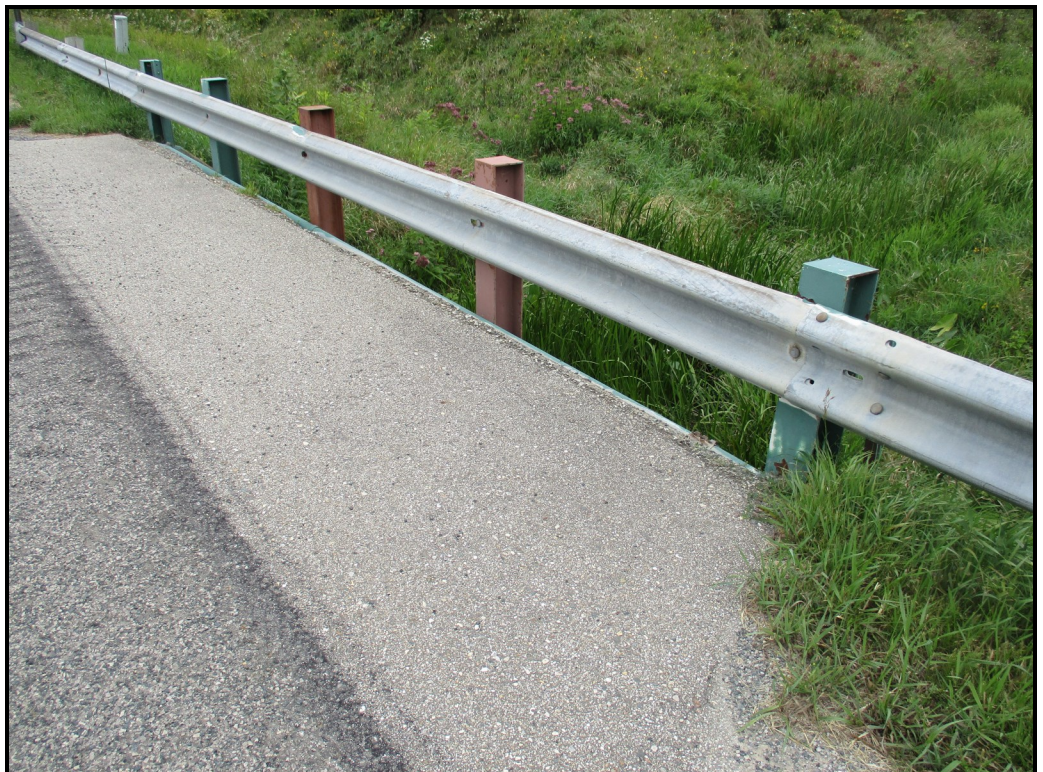
2. Expansion Joints	N	N	N	(08/15) Paved over. (08/13) (08/11)
3. Other Joints	N	N	N	(08/15) (08/13) (08/11)
4. Railings	7	7	6	Painted steel posts with W beam panel. Railing height is too short. Surface rust starting. (08/15) Painted steel posts with W beam panel. Railing height is too short. (08/13) W beam guardrail on painted steel posts. Railing posts have been painted. Bridge railing is vertically too short (08/11)

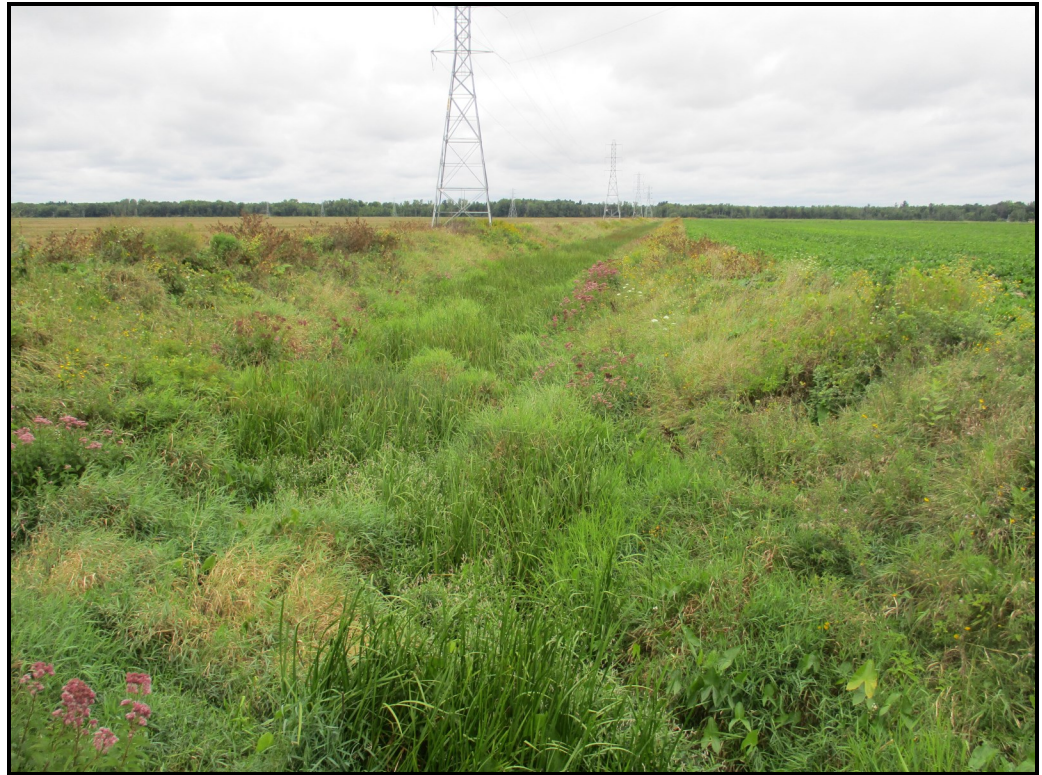
*Upstream
channel section*

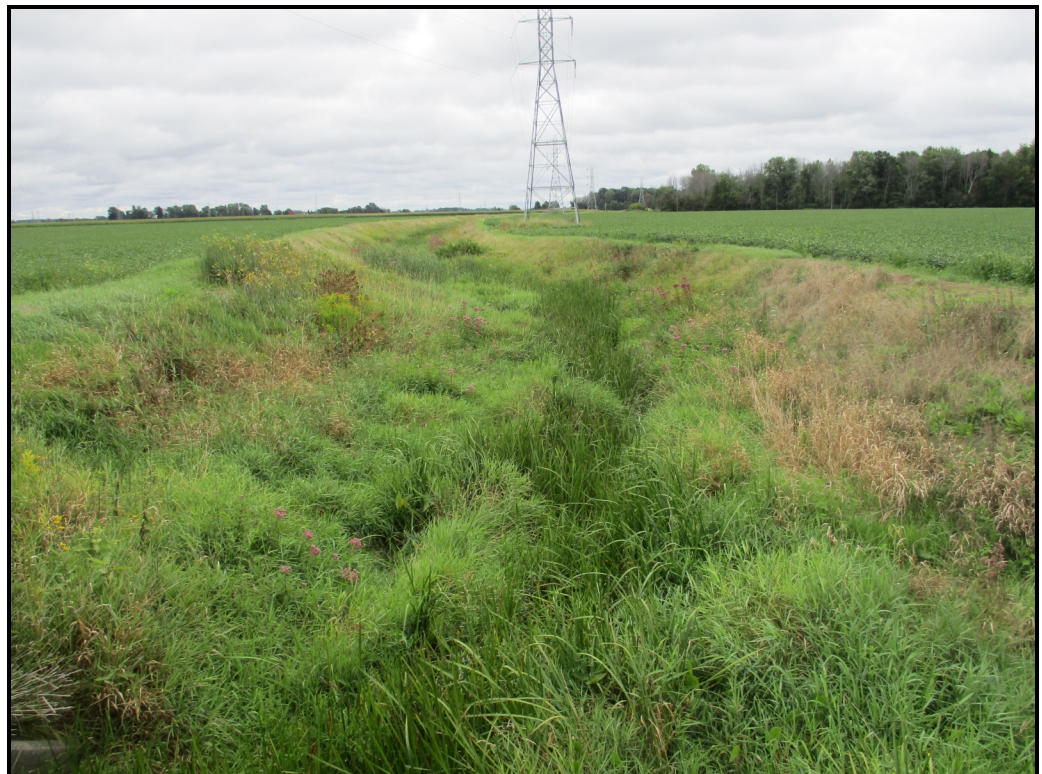
*Downstream
channel section*

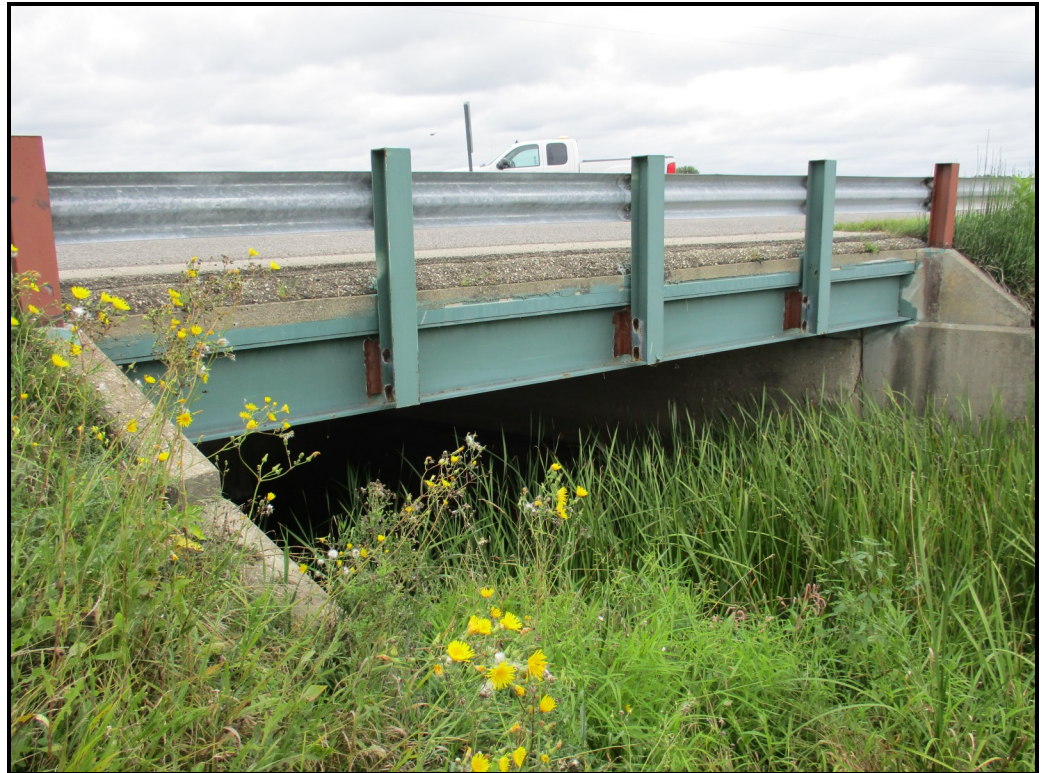
*North elevation
of bridge*

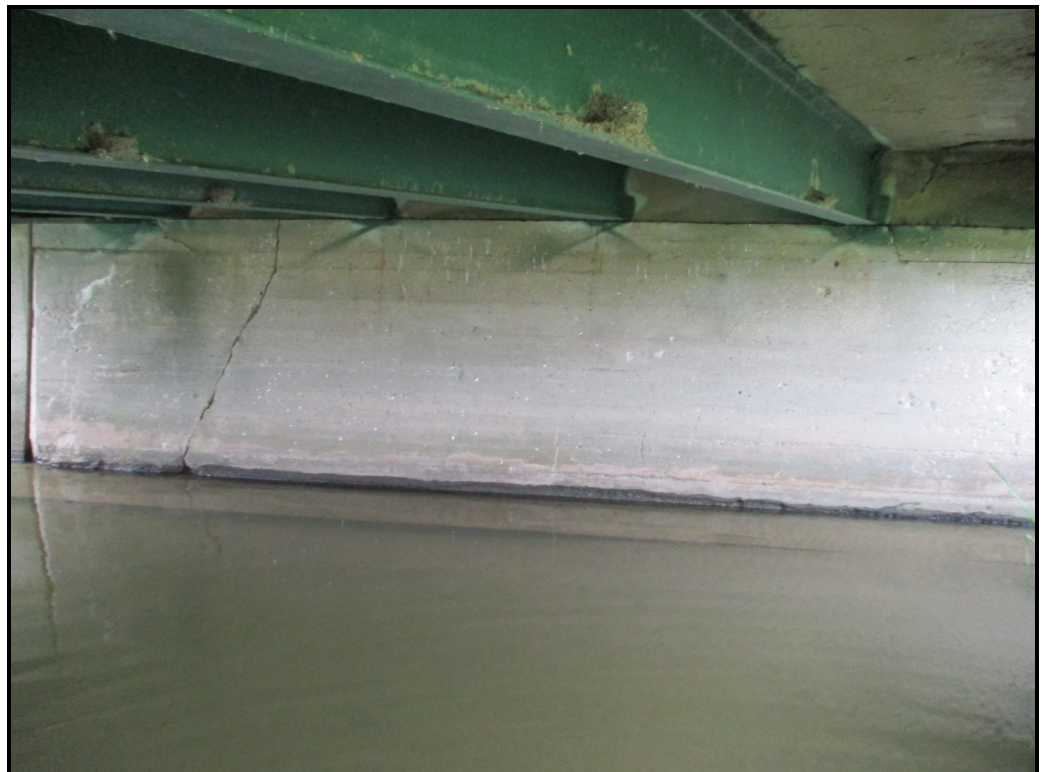
08/11	08/13	08/15	
13. Abutments (SIA-60)	3	3	3	<p>Both abutments have been widened on both ends. In original section, 6 to 12" of footing face is exposed with 1' of soft silt below surface, but no undermining. East abutment has full depth 3/8" vertical crack at beam 5s. West abutment has a 1/16" vertical crack at beam 3s and a 1/4" vertical crack with a spall along the bottom at beam 5s. (08/15)</p> <p>Both abutments have been widened on both ends. In original section, 6 to 12" of footing face is exposed with 1' of soft silt below surface, but no undermining. East abutment has full depth 3/8" vertical crack at beam 5s. West abutment has a 1/16" vertical crack at beam 3s and a 1/4" vertical crack with a spall along the bottom at beam 5s. Keep inspection frequency at 24 months due no change in condition. (08/13)</p> <p>Both abutments, 12"-14" of face of footing exposed, no undermining noted. East abut has full depth crack 3/8" wide at beam 5S. West abut have a 1/16" wide vert crack at beam 3S and a 1/4" wide vert crack with spall along the bottom at beam 5S. Because of low traffic volumes, keep 24 month freq. (08/11)</p>

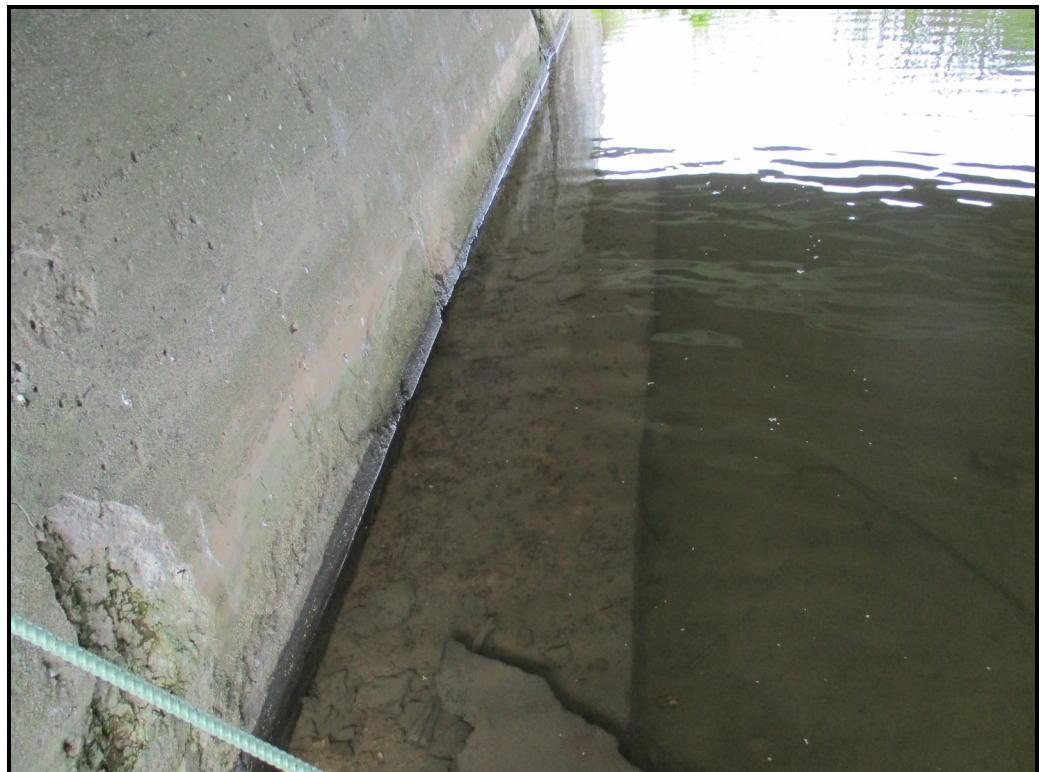
*Exposed
footing, typical*

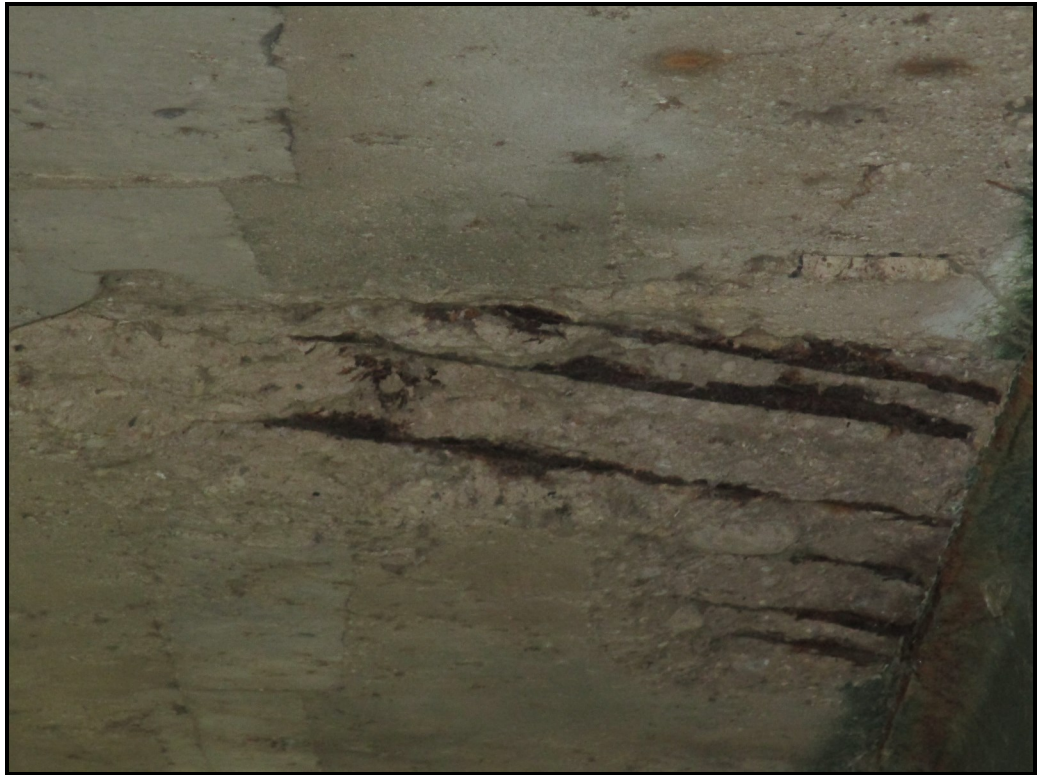
5. Sidewalks or Curbs	N	N	N	(08/15) (08/13) (08/11)
6. Deck Bottom Surface (SIA-58B)	3	3	3	Concrete deck with corrugated steel deck in widened section (bays 1s, 1n and 2n). Concrete deck: original outside bays (2s and 3n) have heavy spalling and delamination with exposed transverse steel. Approximately 30% of original outside bays are spalled or delaminated. Exposed transverse steel has heavy section loss. (08/15) Concrete deck with corrugated steel deck in widened section (bays 1s, 1n and 2n). Concrete deck: original outside bays (2s and 3n) have heavy spalling and delamination with exposed transverse steel. Deep spall in south bay at east end. Approximately 30% of original outside bays are spalled or delaminated. (08/13) Widen section, bays 1S 1N 2N, have corrugated decking. Original deck outside bays, 2S and 3N, have heavy spalling/delaminated concrete with exposed transverse steel. Approx 20-30% of original outside bays spalled delaminated. Deep spall in south bay, eastend. (08/11)

7. Deck (SIA-58)	4	4	4	<p>Surface: Chip seal over HMA with 1 longitudinal and 3 transverse cracks.</p> <p>Bottom Surface: Concrete deck with corrugated steel deck in widened section (bays 1s, 1n and 2n). Concrete deck: original outside bays (2s and 3n) have heavy spalling and delamination with exposed transverse steel. Approximately 30% of original outside bays are spalled or delaminated. Exposed transverse steel has heavy section loss. (08/15)</p> <p>Surface: Chip seal over HMA with 1 longitudinal and 3 transverse cracks.</p> <p>Bottom Surface: Concrete deck with corrugated steel deck in widened section (bays 1s, 1n and 2n). Concrete deck: original outside bays (2s and 3n) have heavy spalling and delamination with exposed transverse steel. Deep spall in south bay at east end. Approximately 30% of original outside bays are spalled or delaminated. (08/13)</p> <p>Original deck outside bays have heavy spalling/delaminated concrete with exposed steel. Deep spall under EBD lane, eastend, local failure possible. (08/11)</p>

*Spall with
exposed steel in
deck bottom*

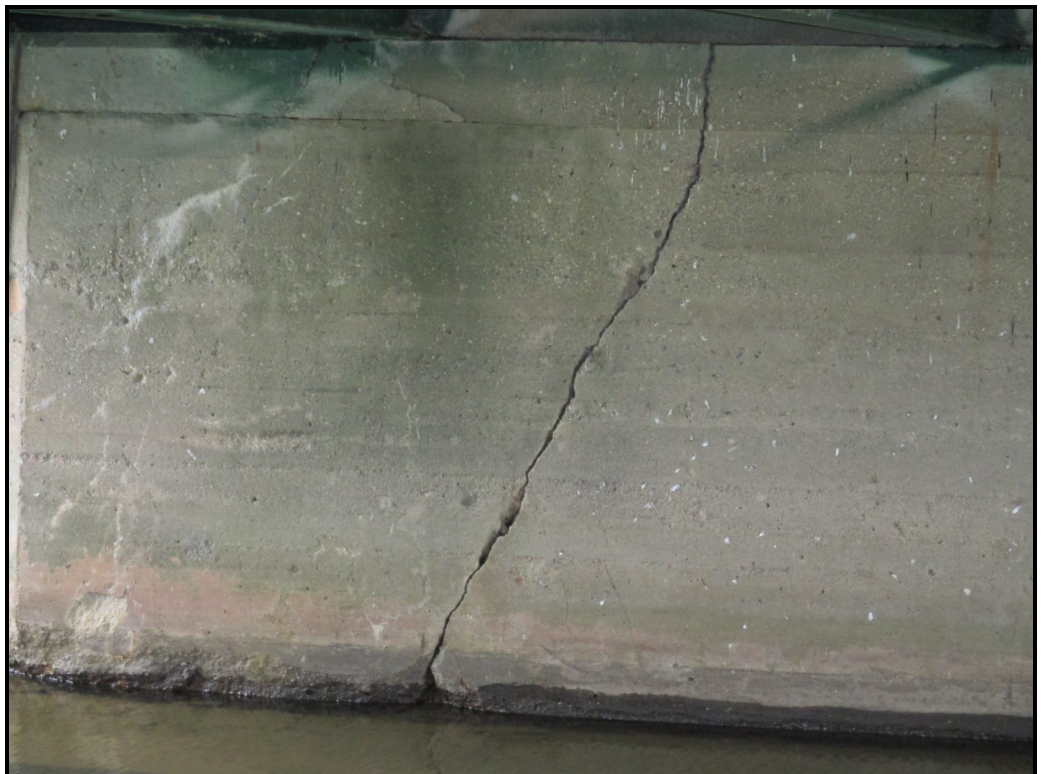
*Vertical crack
in east
abutment*

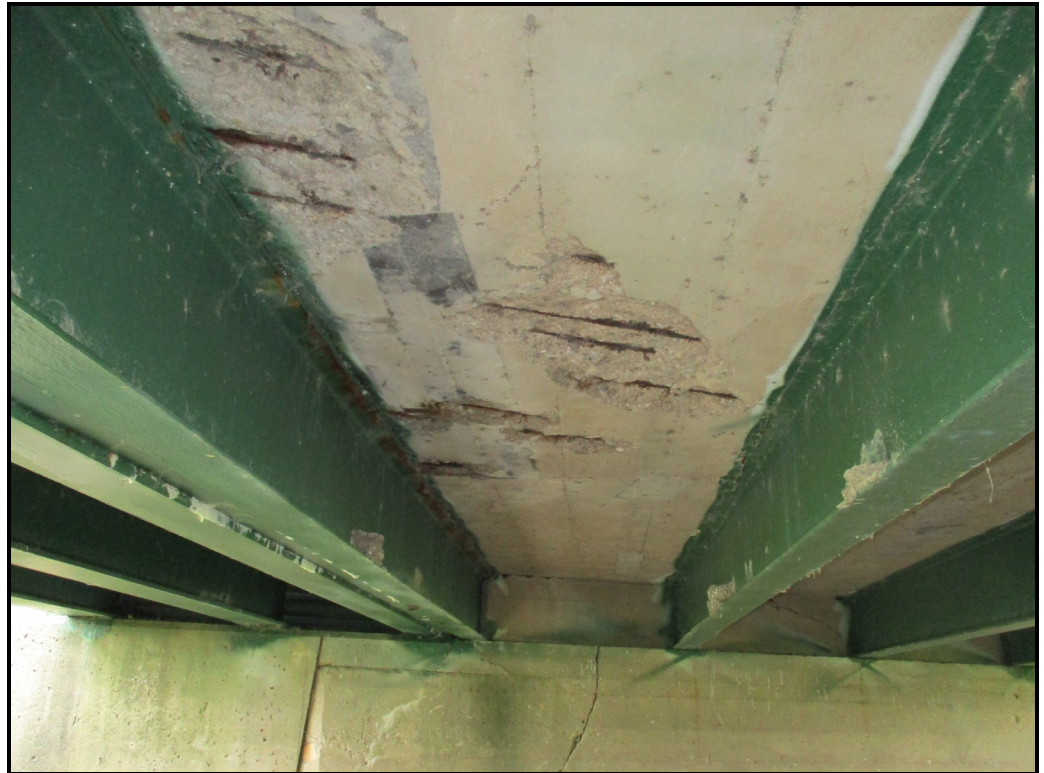
*Spalls in deck
bottom*

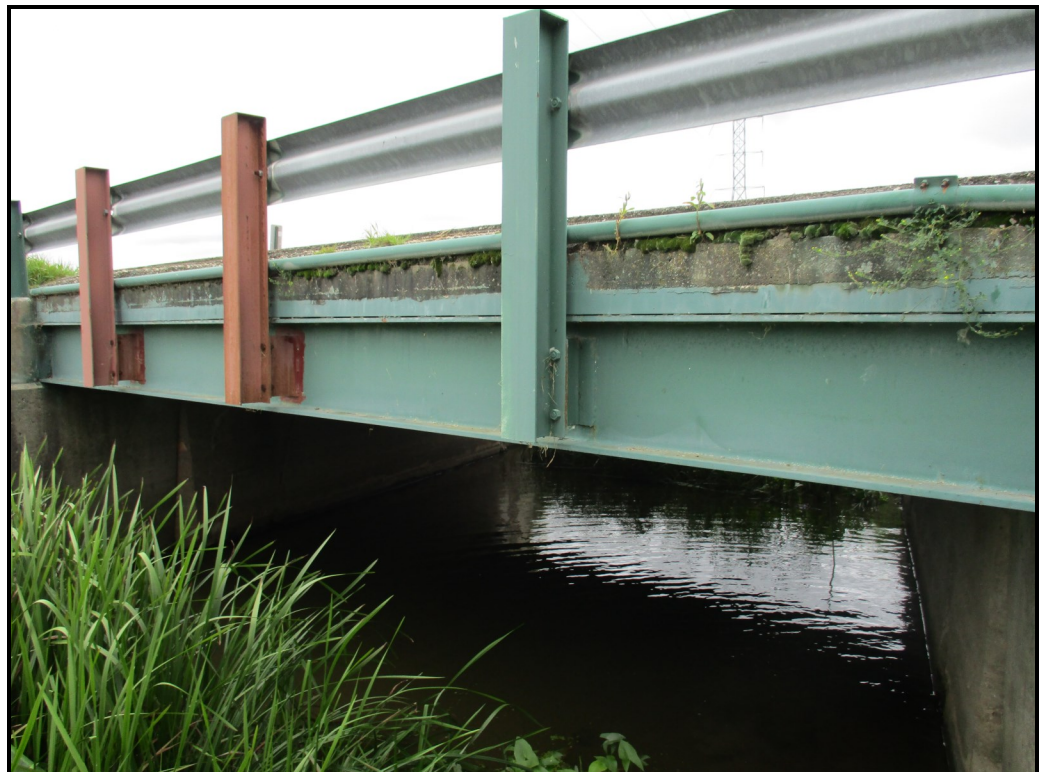
*North elevation
of bridge*
