STR 6982

BRIDGE SAFETY INSPECTION REPORT

SCHREIBER ROAD	43.5332 / -84.2093	56306H00021B010	Serious Condition(3)	
Feature	Length / Width	Owner		
JO DRAIN	28.9 / 18.7	County: Midland(56)		
Location	Built / Recon. / Paint / Ovly.	TSC	Operational Status	
0.4 MI S OF BROOKS RD	1938 / / 2004 /	Mt. Pleasant(4A)	A Open, no restriction(A)	
Region / County	Material / Design	Last NBI Inspection	Scour Evaluation	
Bay(4) / Midland(56)	3 Steel / 02 Stringer/Girder	08/26/2015 / 7PXJ	3 SC - Unstable

Midland County 2015 Bridge Inspections
Schreiber Rd over Jo Drain
SN 6982
GLEG Project No. 1015-2-336
August 26, 2015

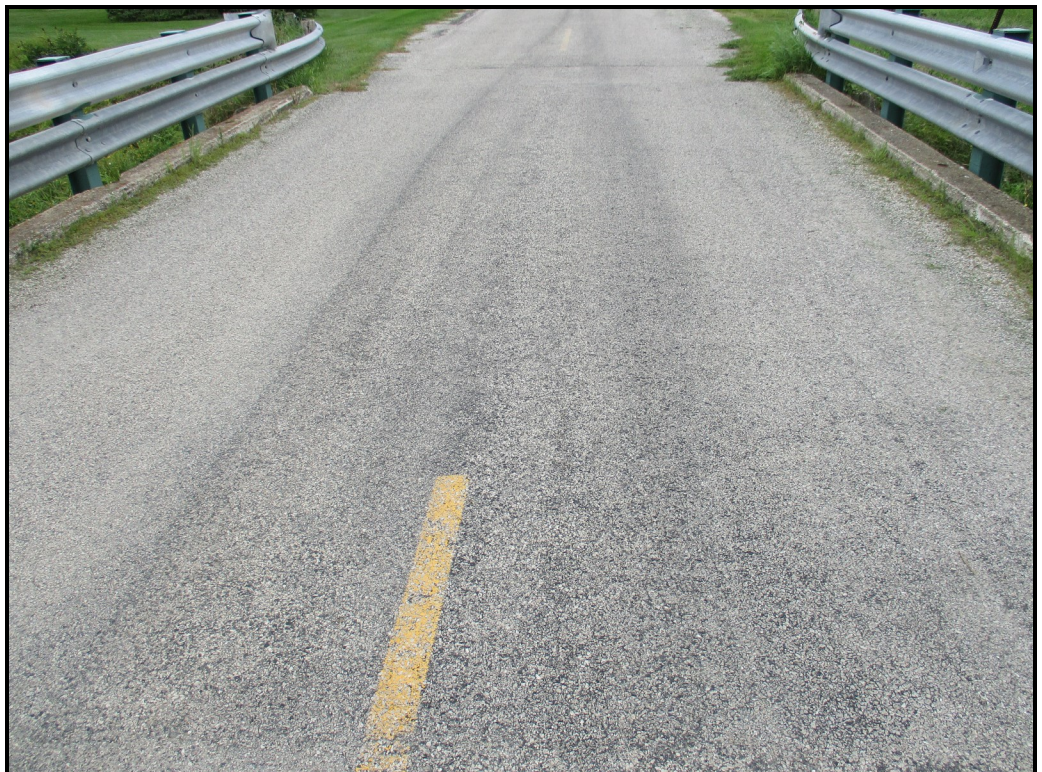
08/11	08/13	08/15	
1. Surface (SIA-58A)	7	7	7	Chip seal surface with no cracks. Vegetation along edges. (08/15) Chip seal surface with no cracks. (08/13) Chip seal surface with no cracks. (08/11)

*Chip seal
surface*

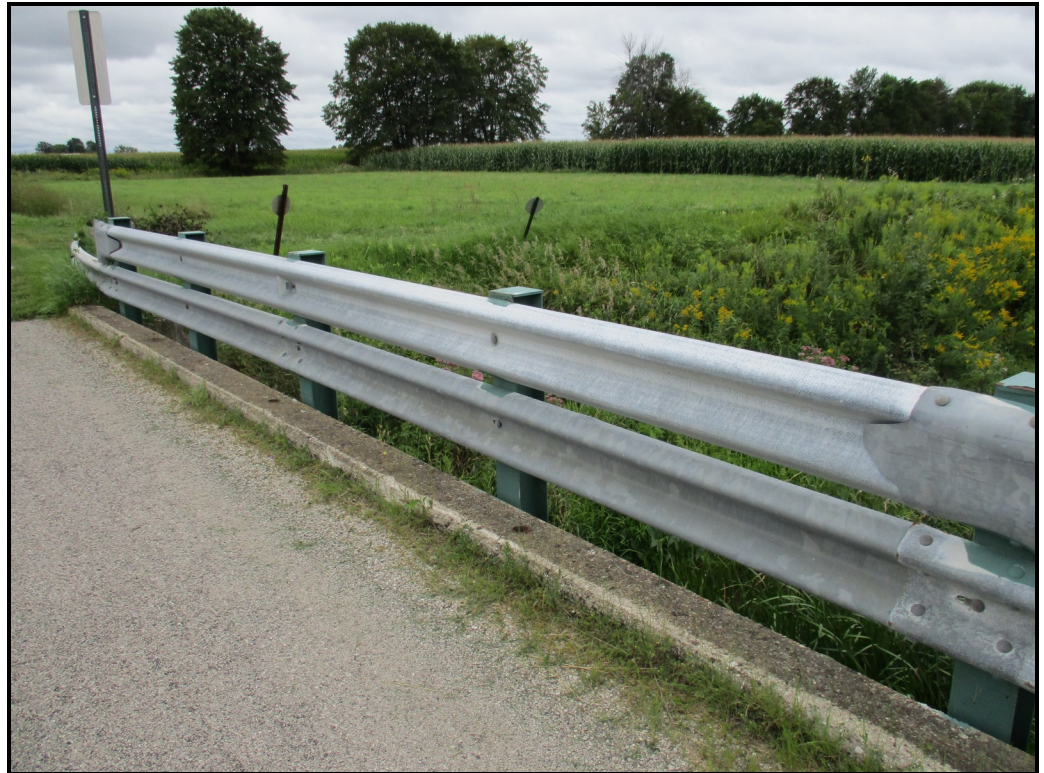
2. Expansion Joints	N	N	N	(08/15) (08/13) (08/11)
3. Other Joints	N	N	N	(08/15) (08/13) (08/11)
4. Railings	7	6	6	Steel posts with 2 W beam panels and concrete brush block. Railing posts painted with rust starting. East concrete brush block spalled at south end and at post 3S, no exposed steel. West brush block fascia spalled at south and north end. 2 cracks in west brush block. (08/15) Steel posts with 2 W beam panels and concrete brush block. Railing posts painted with rust starting. East concrete brush block spalled at south end and at post 3S, no exposed steel. East brush block fascia spalled at north end. 2 cracks in west brush block. (08/13) Steel posts with 2 W beam panels and concrete brush block. Railing posts painted. Eastside concrete brush block spalled at southend and at post 3S, no exposed steel. East brush block fascia spalled at northend. (08/11)

Bridge railing

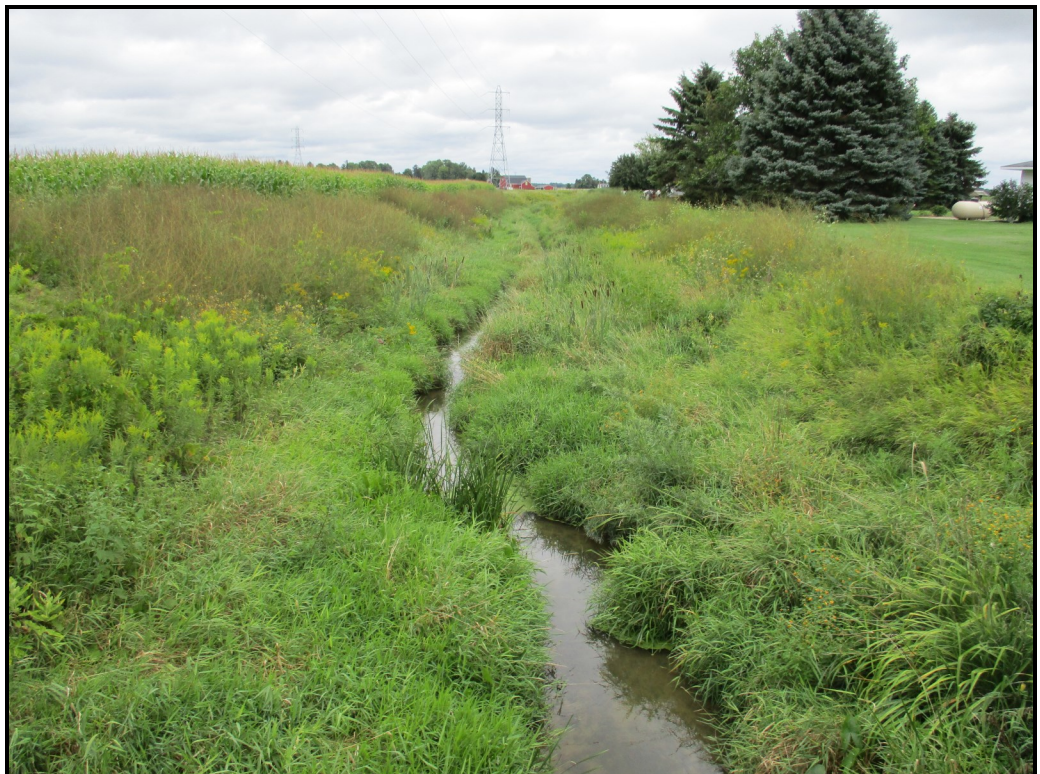
County drain with manmade cross section. All flow along south abutment. (08/15)
County drain with manmade cross section (08/13)
County drain with manmade cross section (08/11)

*Downstream
channel section*

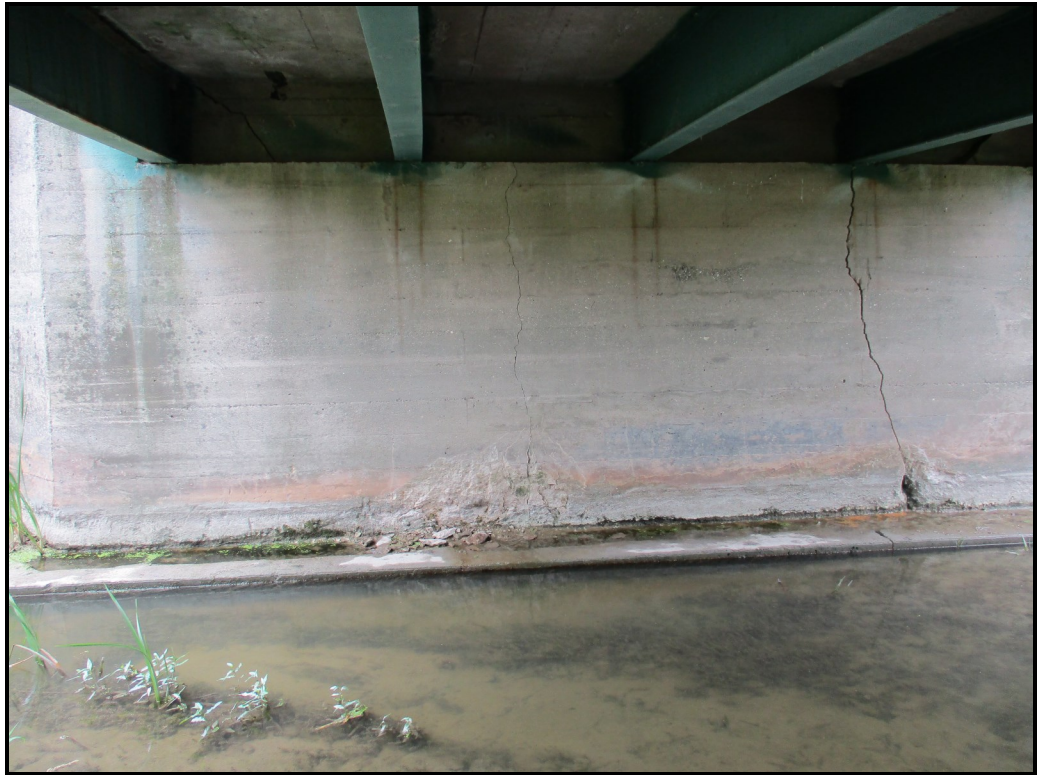
08/11	08/13	08/15	
13. Abutments (SIA-60)	4	4	3	NE, SE, NW and SW backwalls cracked, NE backwall has 3.5" (was 3.25") of movement as measured 6" above top of abutment and SW has 3" (was 2.75"). South abutment has a 1/16" vertical crack in bay 3W, a full depth vertical crack 1/2" wide at beam 2W, and a 1'x3' spall at the footing. West end of both abuts cracked at corners. South abutment, west end has 1/2"-3/4" crack extending from abutment corner to wingwall. South abutment has 10" of footing face exposed at center, 16" exposed under east fascia and 0" at west fascia. North abutment has exposed footing along west 1/2, probed down 14" along footing and no undermining noted. (08/15) NE, SE, NW and SW backwalls cracked, NE backwall has 3.25" (was 3") of movement and SW has 2.75" (was 2.5"). South abutment has a 1/16" vertical crack, a full depth vertical crack 1/2" wide, and a 1'x3' spall at the footing. West end of both abuts cracked at corners. South abutment has 10" of footing face exposed at center, 16" exposed under east fascia and 0" at west fascia. North abutment has exposed footing along west 1/2, probed down 14" along footing and no undermining noted. Because of low traffic, keep 24 month freq. (08/13) NE, SE, NW and SW backwalls cracked, NE backwall has 3" of movement and SW has 2.5". South abut has 2 vert cracks, a 1/16" crack and a full depth crack 1/2" wide. West end of both abuts cracked at corners. South abut has 11" of ftg face exposed at center and 16" exposed under east fascia. North abut has exposed footing along west 1/2, no undermining noted. Because of low traffic, keep 24 month freq. (08/11)

*South
abutment*

Recommendation Type	Priority	Description
Detailed Insp.	M	Watch cracks in abut backwalls
Slope Repair	H	Riprap around the abutments to above footing
Bridge Repl.	H	Replacement is best option

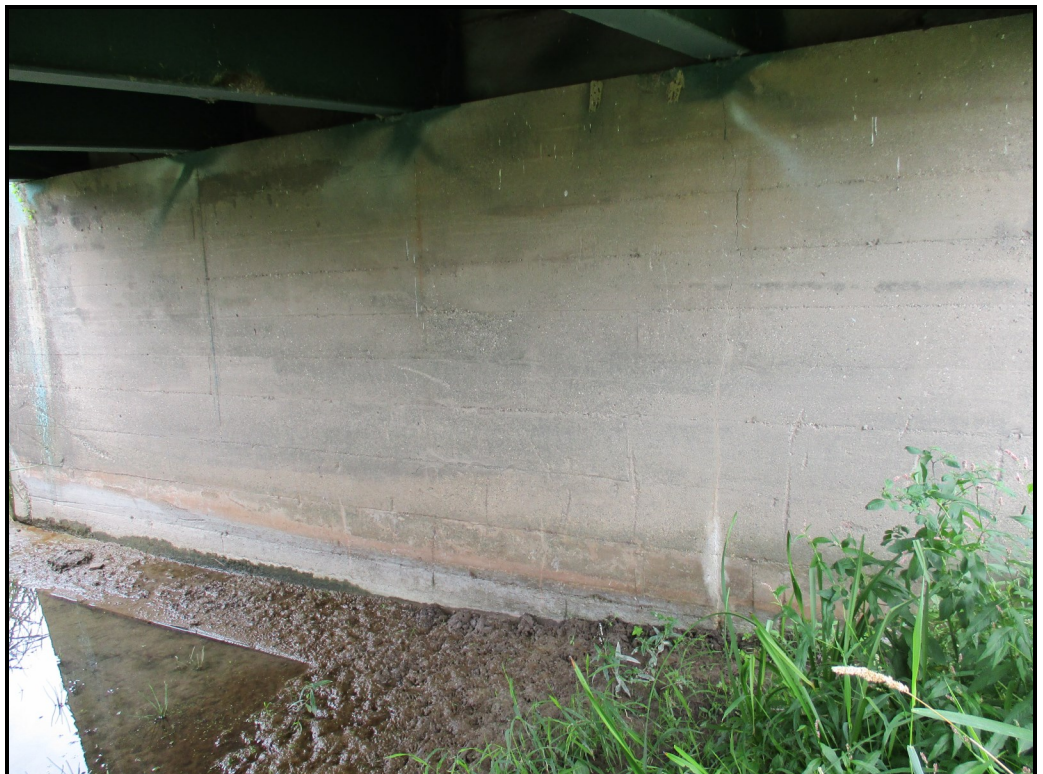
*North
abutment*

The backwalls at the east end of the north abutment and the west end of the south abutment have full depth cracks with movement. Over the past 4 years, the amount of displacement at the cracks has increased. Recommend the bridge be posted because of the possible movement in the abutments. (Eric Rickert 09/11/2015)

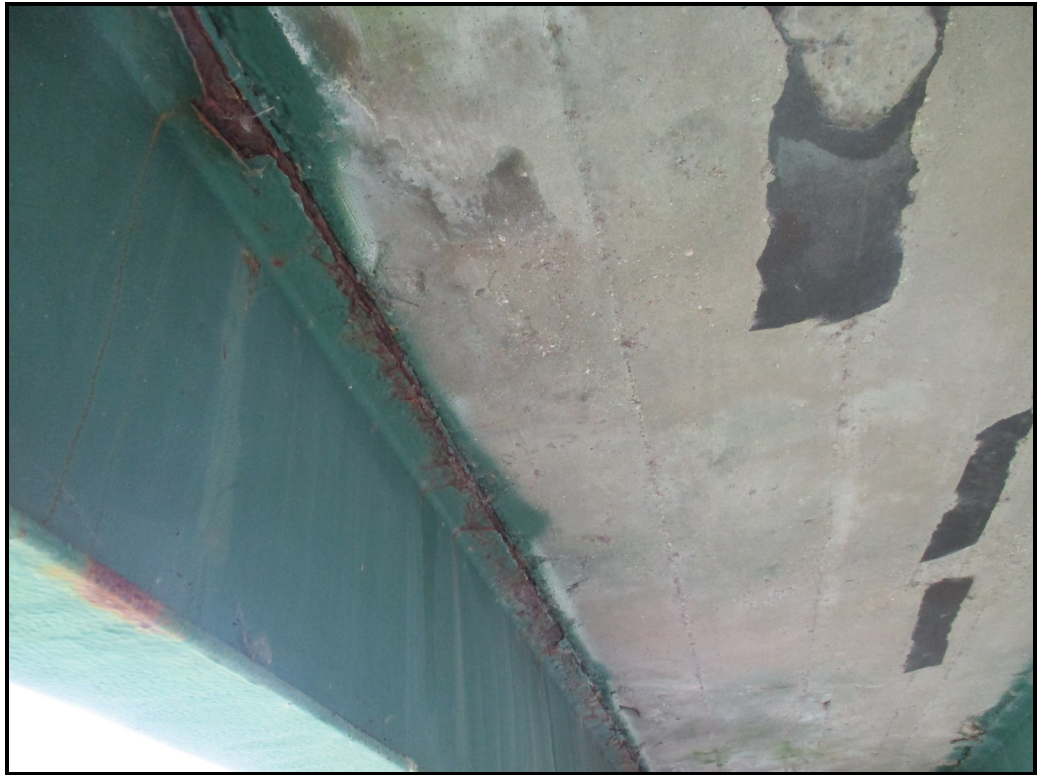
9. Stringer (SIA-59)	5	5	5	Beams have been painted. Noted rust and scale along top flange of east and west fascias. Noted pitted areas along top flange under new paint. (08/15) Beams have been painted. Noted rust starting along top flange of east and west fascias. Noted pitted areas along top flange under new paint. (08/13) Beams have been painted. Noted rust starting along top flange of east and west fascias. Noted pitted areas along top flange under new paint. (08/11)
10. Paint (SIA-59A)	7	7	6	Rust along fascia beams (08/15) Rust starting along fascia beams (08/13) Rust starting along fascia beams (08/11)
11. Section Loss	2	2	2	Rust starting on fascia beams (08/15) Rust starting on fascia beams (08/13) Rust starting on fascia beams (08/11)
12. Bearings	N	N	N	(08/15) (08/13) (08/11)

*Rust and scale
along top
flange*

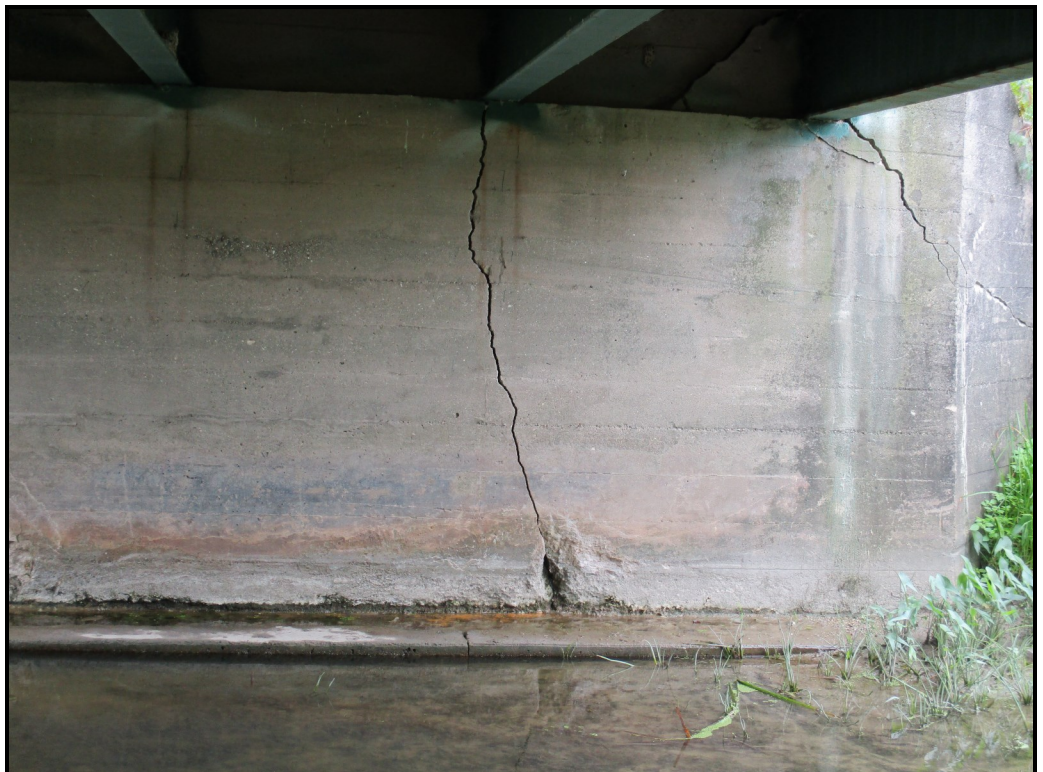
*Crack in south
abutment*

Structure is posted for movement in abutment backwalls. Crack widths in NE and SW backwall have increased since previous inspection. Post bridge at 42/55/65.

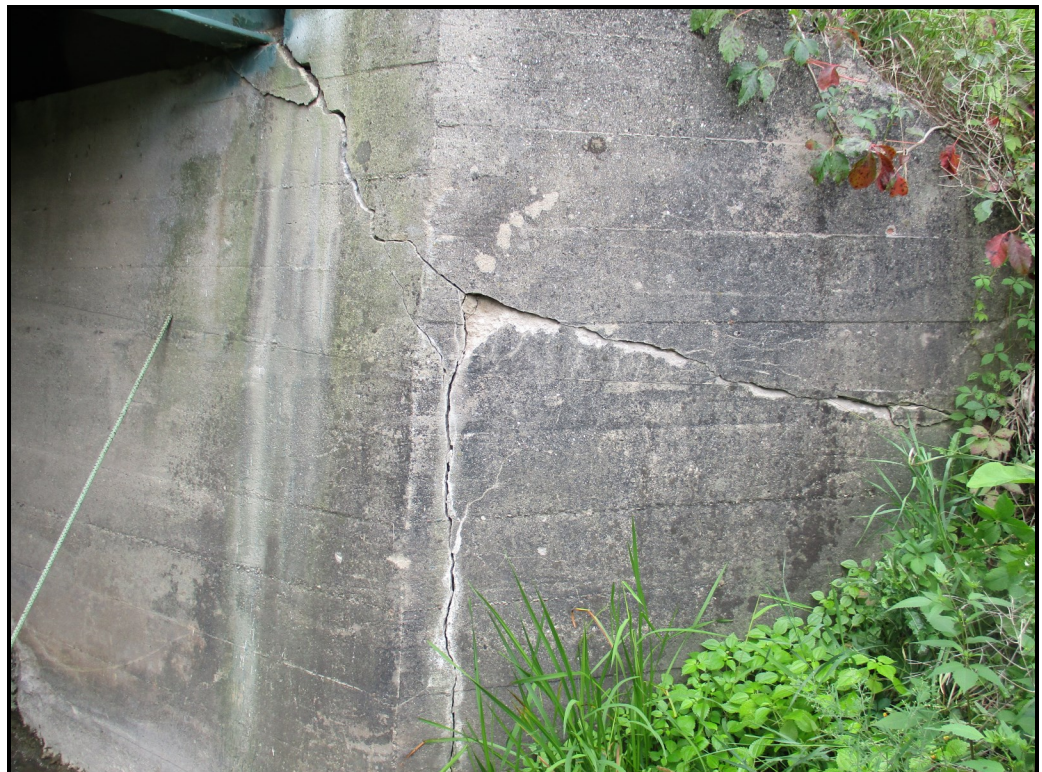
*Crack in SW
wingwall*
