**STR 6961**

**BRIDGE SAFETY INSPECTION REPORT**

Midland County 2015 Bridge Inspections  
Smiths Crossing Rd over Jo Drain  
SN 6961  
GLEG Project No. 1015-2-336  
August 27 2015

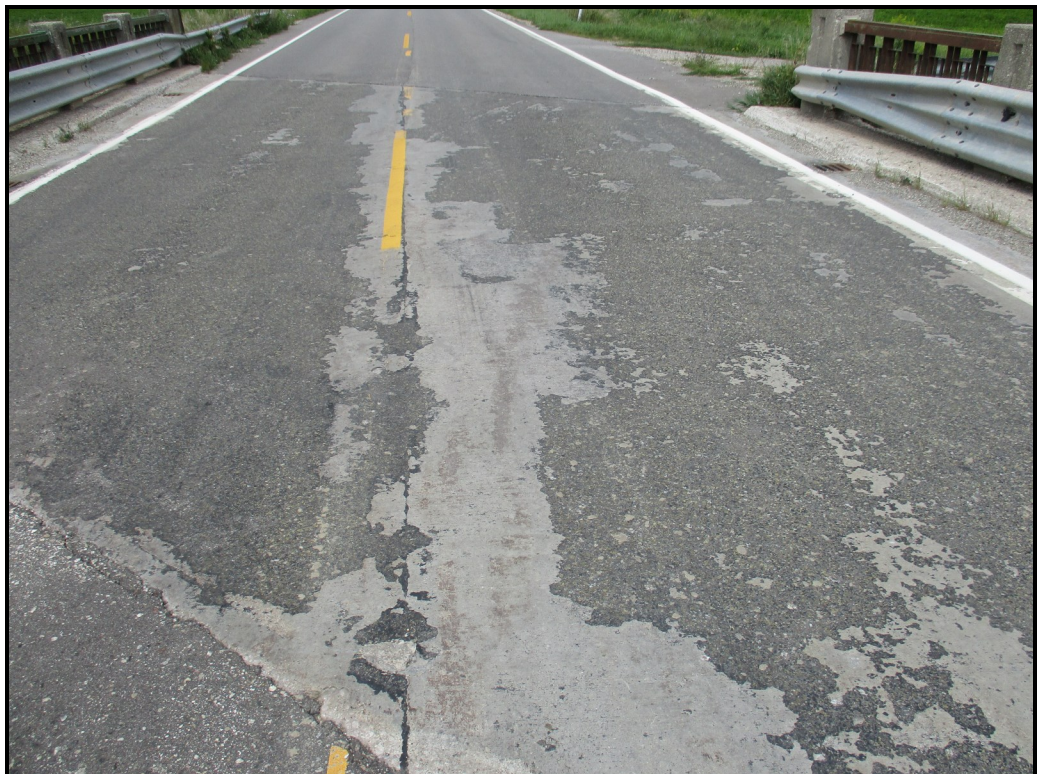
08/11	08/13	08/15	
<b>1. Surface (SIA-58A)</b>	6	6	6	Chip seal over concrete. Estimate 20-30% of chip seal missing, vegetation growing along edges. Visible concrete has 3 transverse cracks. (08/15) Chip seal over concrete. Estimate 10-20% of chip seal missing, vegetation growing along edges. (08/13) Chip seal over concrete. Estimate 10-20% of chip seal missing, vegetation growing along edges. (08/11)
<b>2. Expansion Joints</b>	N	N	N	(08/15) (08/13) (08/11)
<b>3. Other Joints</b>	N	N	N	(08/15) (08/13) (08/11)
<b>4. Railings</b>	7	6	4	Thrie beam retrofit. Original rail sits on concrete brush block. Face of both brush blocks spalled/scaling along length. West brush block has a full depth spall behind a deck drain. (08/15) Thrie beam retrofit. Original rail sits on concrete brush block. Face of both brush blocks spalled/scaling along length. (08/13) Thrie beam retrofit. Original rail sits on concrete brush block. Face of both brush blocks spalled/scaling along length. (08/11)

*Chip seal  
peeling off of  
concrete  
surface*

Recommendation Type	Priority	Description
Apr. Pavement	H	Install advance posting signs
Railing Repair	M	Install newer approach rail. Fix west approach rail
Deck Patching	L	Place new chip seal on deck and clean edges
Super Repl.	M	Patch spalls/delaminated areas on tee beams
Other	M	Place down spouts on deck drains

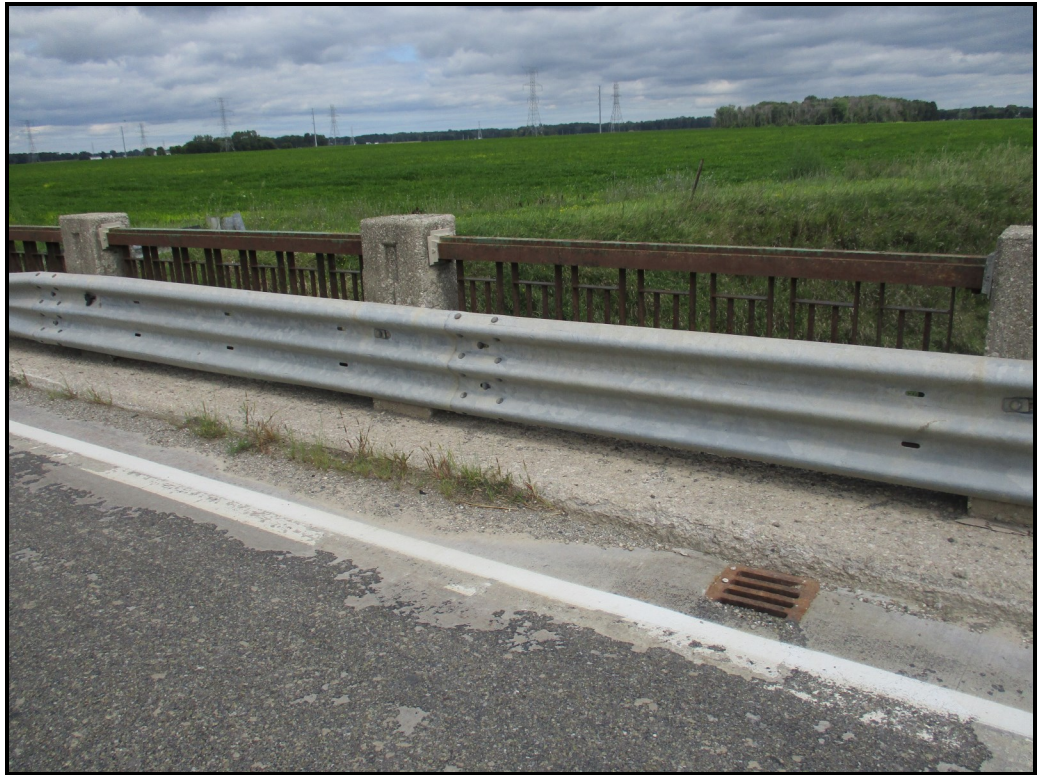
<b>17. Approach Shoulders Sidewalks</b>	6	6	6	HMA/gravel shoulders (08/15) HMA/gravel shoulders (08/13) HMA/gravel shoulders (08/11)
<b>18. Approach Slopes</b>				SW and NW approach rail is damaged, vegetated approach slopes (08/15) SW and NW approach rail is damaged, vegetated approach slopes (08/13) SW and NW approach rail is damaged, vegetated approach slopes (08/11)
<b>19. Utilities</b>				Steel conduit along east side and overhead west of bridge (08/15) Steel conduit along east side and overhead west of bridge (08/13) Steel conduit along eastside (08/11)
<b>20. Channel (SIA-61)</b>	7	7	7	County drain with manmade cross section (08/15) County drain with manmade cross section (08/13) County drain with manmade cross section (08/11)
<b>21. Drainage Culverts</b>				(08/15) (08/13) (08/11)

*Bridge railing*

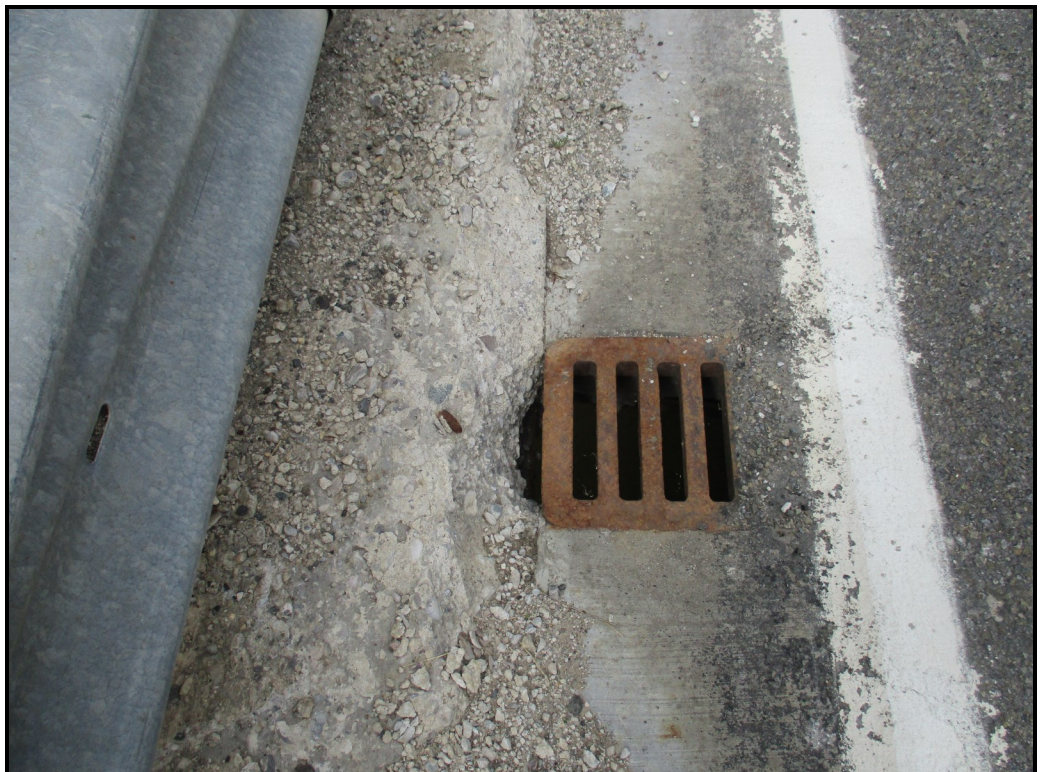
*Spalled brush  
block face at  
deck drain*

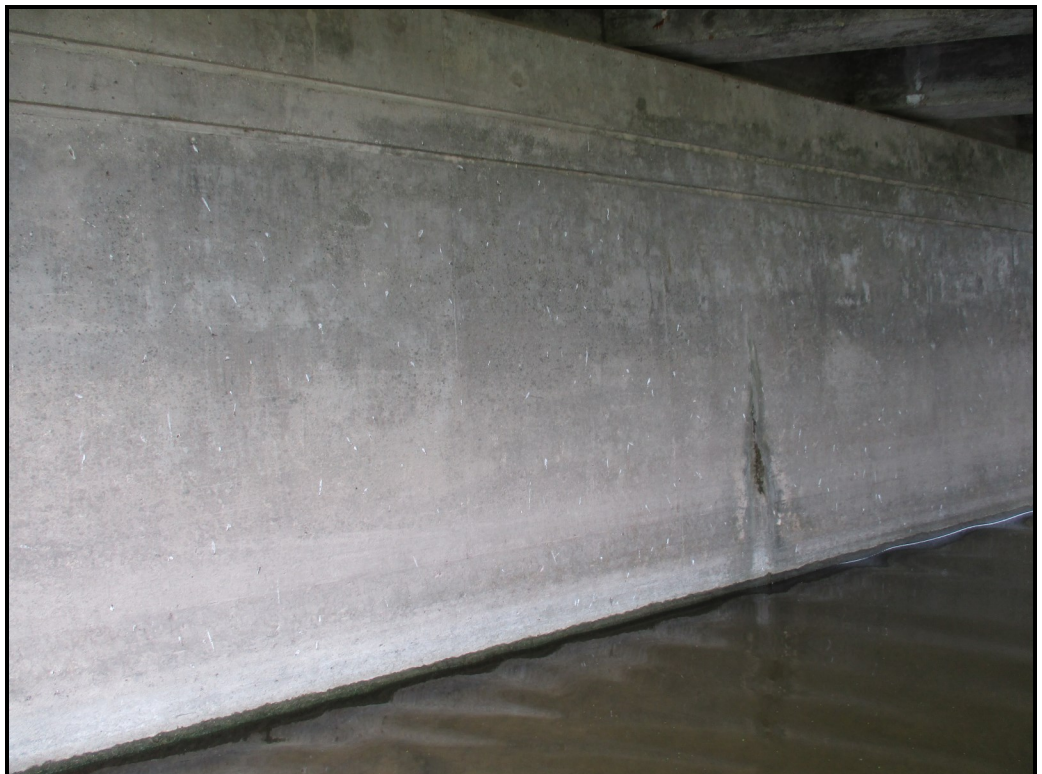
*South  
abutment*

08/11	08/13	08/15	
<b>13. Abutments (SIA-60)</b>	6	6	6	Vertical crack in center of each abutment, 1/16" wide with leakage and hairline-1/16" vertical cracks in SE, NW, NE, and SW abut outside bearing area. (08/15) Vertical crack in center of each abutment, 1/16" wide with leakage and hairline-1/16" vertical cracks in SE, NW, NE, and SW abut outside bearing area. (08/13) Vertical crack in center of each abut, 1/16" wide with leakage and hairline-1/16" vertical cracks in SE, NW, and SW abut outside bearing area. (08/11)
<b>14. Piers (SIA-60)</b>	N	N	N	(08/15) (08/13) (08/11)
<b>15. Slope Protection</b>	N	N	N	(08/15) (08/13) (08/11)

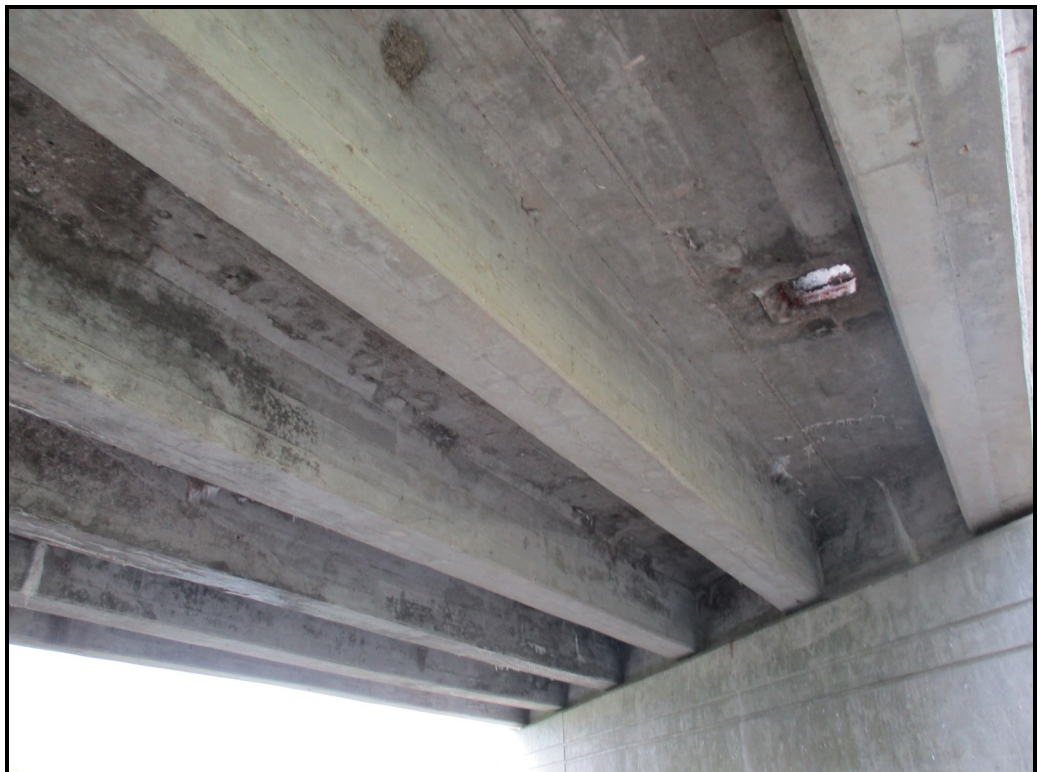
08/11	08/13	08/15	
<b>9. Stringer (SIA-59)</b>	5	5	5	Concrete tee beams are cracked with efflorescence mainly at haunch and sides. Beam 2W has heavy cracking with efflorescence at in south 5'. Beam 3W, at south 1/4 span, 12' section delaminated/spalled along bottom and the north 5' has heavy cracking with efflorescence along btm. Beam 4W, south 10' has heavy cracking with efflorescence and spalls along bottom. (08/15) Concrete tee beams are cracked with efflorescence mainly at haunch and sides. Beam 2W has heavy cracking with efflorescence at in south 5'. Beam 3W, at south 1/4 span, 12' section delaminated along bottom and the north 5' has heavy cracking with efflorescence along btm. Beam 4W, south 10' has heavy cracking with efflorescence and delaminations along bottom. (08/13) Concrete tee beams are cracked with efflorescence mainly at haunch and sides. Beam 3W, at south 1/4 span, 10' section delaminated along btm and the north 5' has heavy cracking with efflorescence along btm. Beam 4W, south 10' has heavy cracking with efflorescence and delaminations along btm. (08/11)

*Concrete tee  
beams*

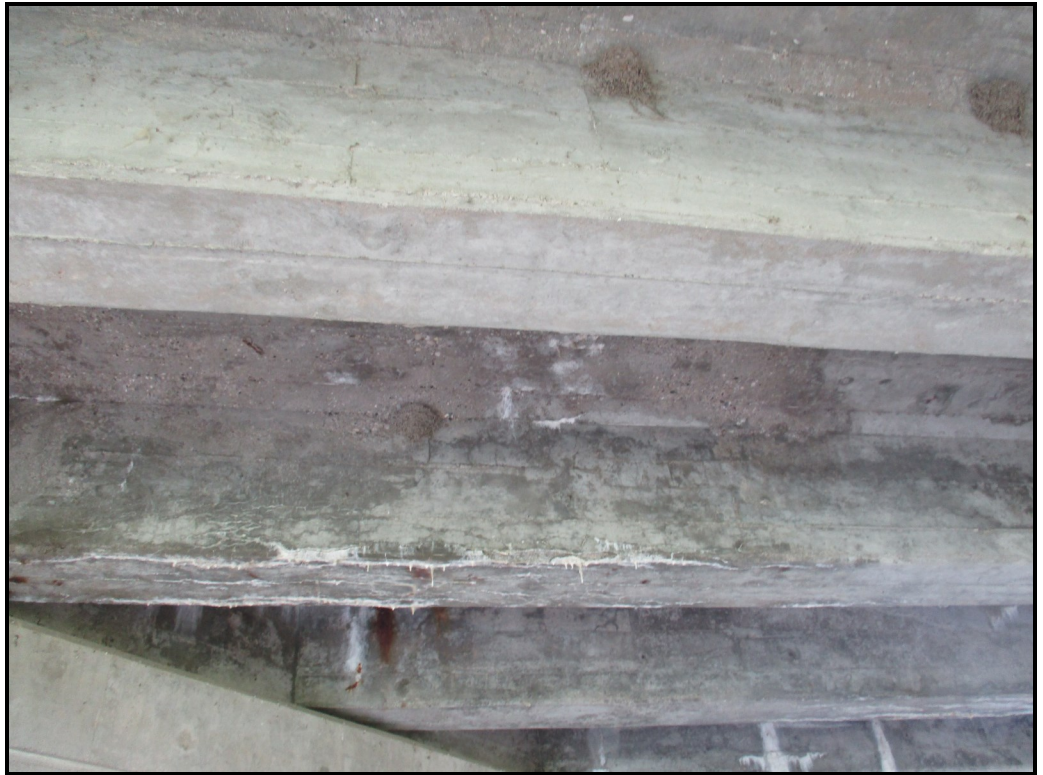
*Leaching in tee  
beam*

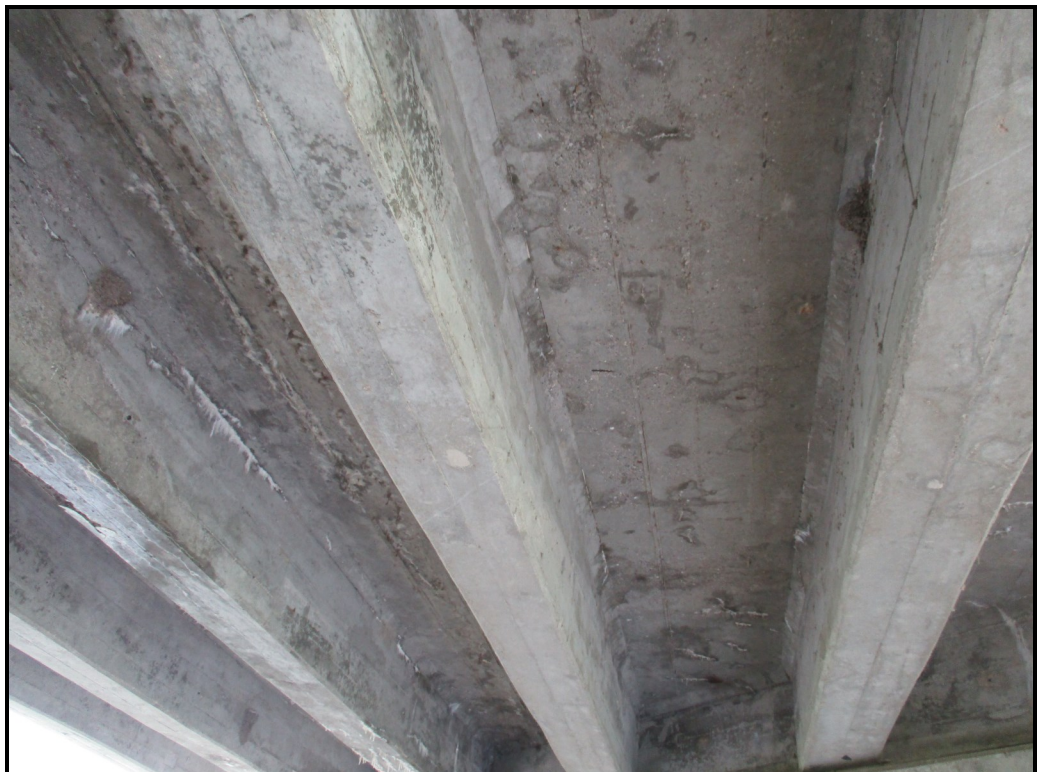
<b>5. Sidewalks or Curbs</b>	N	N	N	(08/15) (08/13) (08/11)
<b>6. Deck Bottom Surface (SIA-58B)</b>	5	5	5	Every bay has hairline cracks with efflorescence. Approximately 5% cracked with leakage. Deck drains have exposed resteel with delaminated concrete along bottom. In center bay, longitudinal crack with efflorescence along length of bay and southend has spall/delaminated area approximately 3'x3'. (08/15) Every bay has hairline cracks with efflorescence. Approximately 5% cracked with leakage. Deck drains have exposed resteel with delaminated concrete along bottom. In center bay, longitudinal crack with efflorescence along length of bay and southend has spall/delaminated area approximately 3'x3'. (08/13) Every bay has hairline cracks with efflorescence. Approx 2-5% cracked with leakage. Deck drains have exposed resteel with delaminated concrete along bottom. In center bay, longitudinal crack with efflorescence along length of bay and southend has spall/delaminated area approx 2'x2' (08/11)

*Deck bottom*

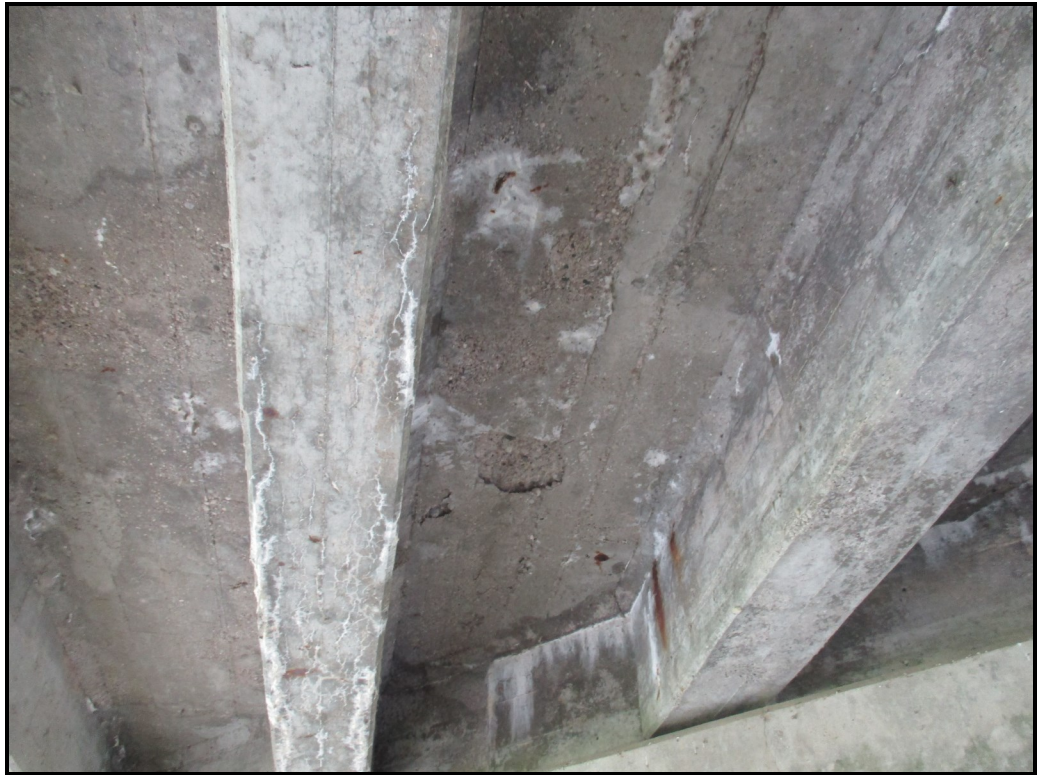
*Leaching in tee  
beam*

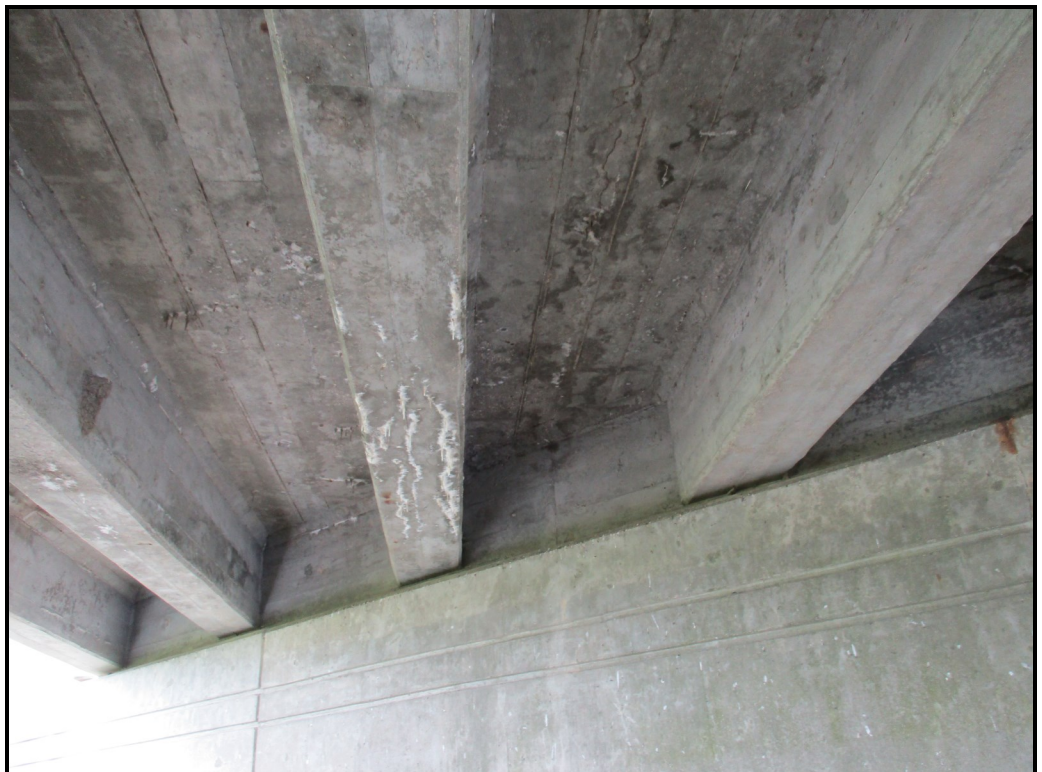
*Leaching  
cracks in  
bottom of tee  
beam*

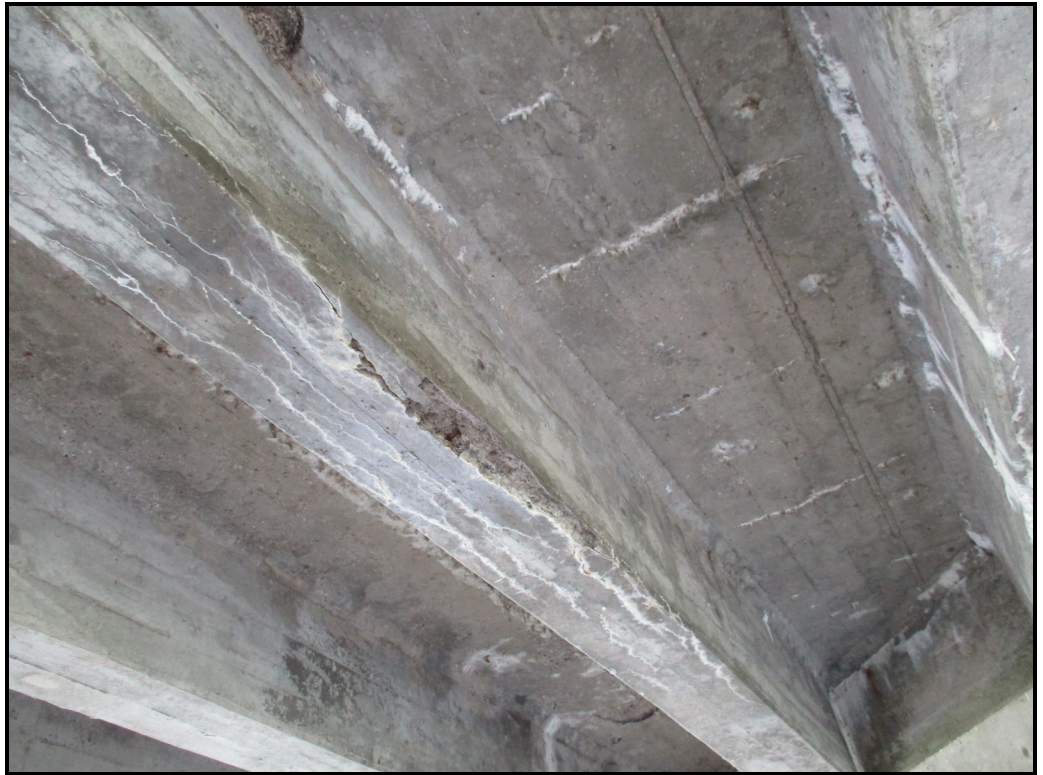
*Spall with  
exposed steel in  
beam 3W*

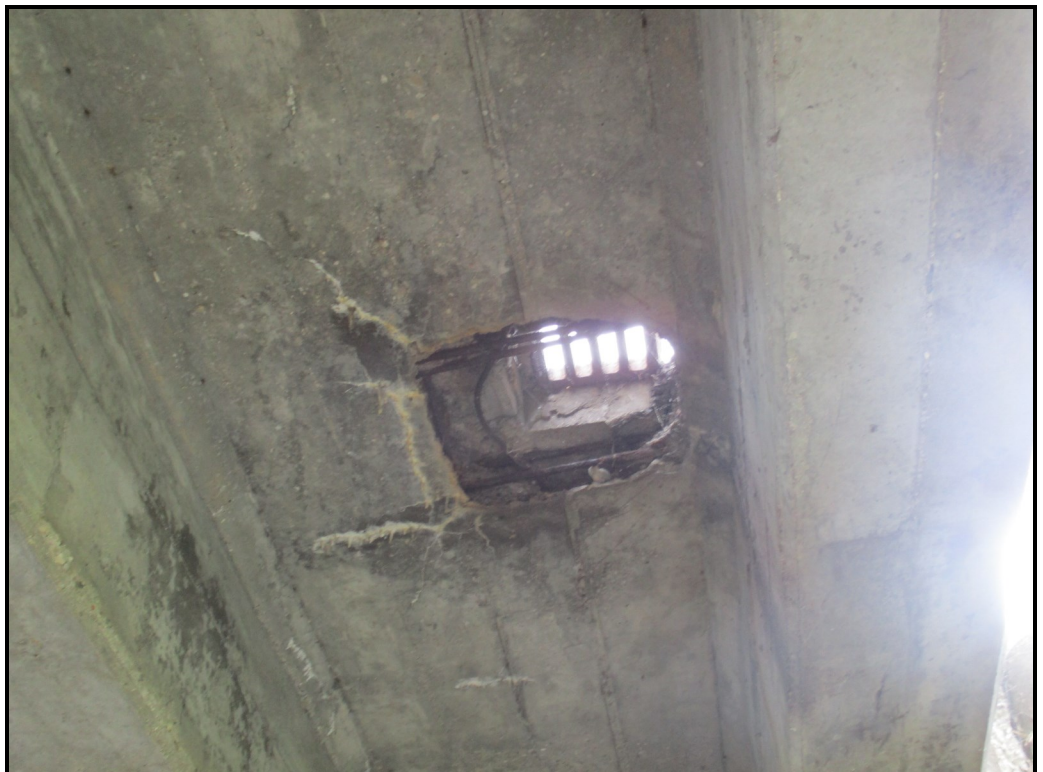
*Spall in deck  
bottom with  
exposed steel*
