STR 6938

BRIDGE SAFETY INSPECTION REPORT

Midland County 2015 Bridge Inspections
N Saginaw Rd over Big Salt River
SN 6938
GLEG Project No. 1015-2-336
September 10, 2015

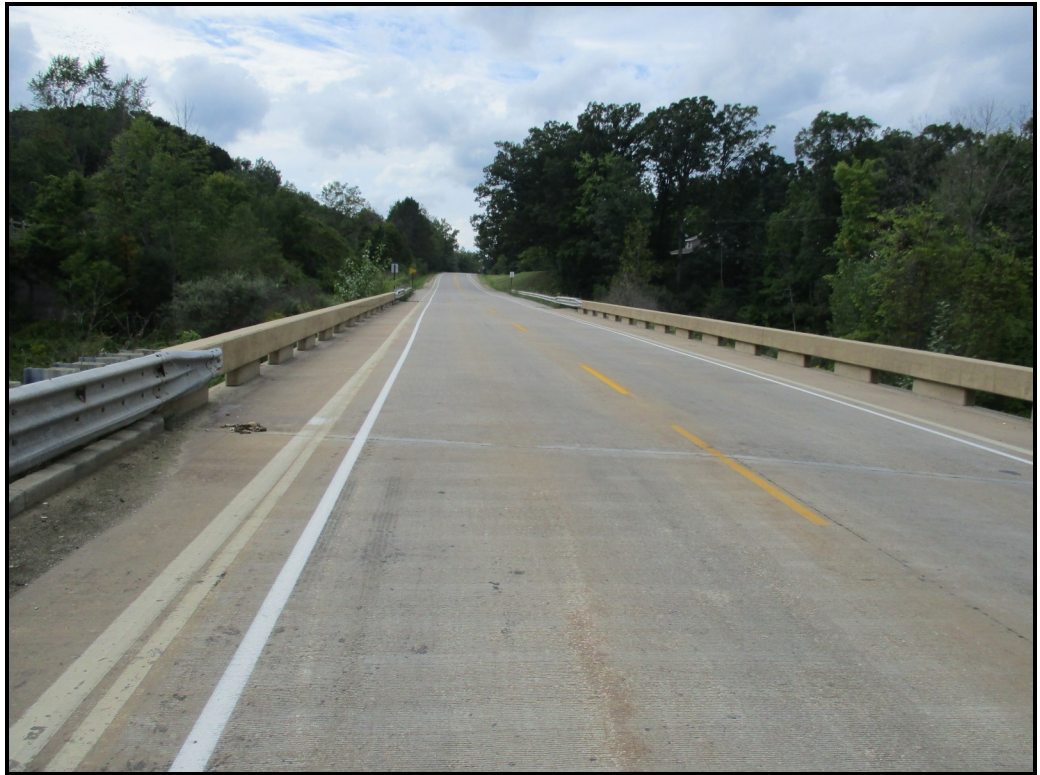
09/11	09/13	09/15	
1. Surface (SIA-58A)	7	8	7	Healer/sealer on concrete deck, 50% worn off, hairline map cracks still visible mainly in span 1W. (09/15) New healer/sealer on concrete deck, hairline map cracks still visible. (09/13) West 20' of deck has hairline map cracking throughout both lanes. Hairline transverse cracks along north and southsides outside of tining every 1'-5'. West 1/2 of center span has map cracks spaced 1'-4'. (09/11)

*Healer/sealer
on concrete
deck*

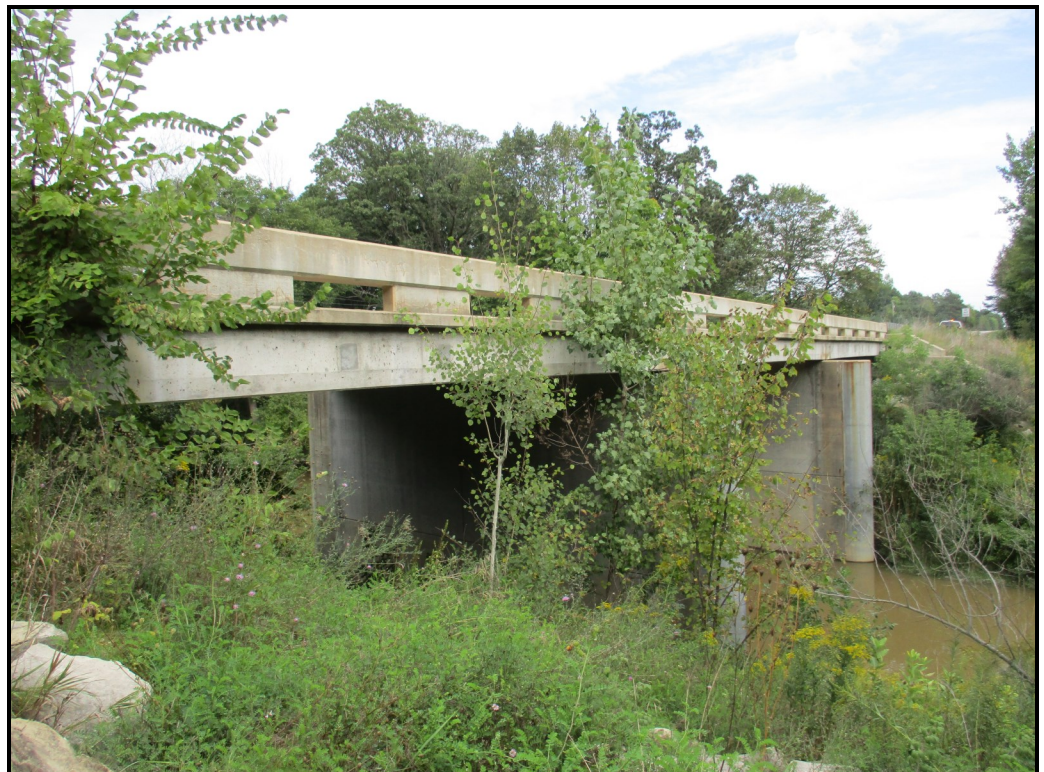
West abutment

09/11	09/13	09/15	
13. Abutments (SIA-60)	8	8	8	Concrete abutments, no visible cracks (09/15) Concrete abutments, no visible cracks (09/13) Concrete stub abutments, no visible cracks (09/11)
14. Piers (SIA-60)	7	7	7	Solid wall piers. East pier has 3 hairline vertical cracks in east face, south end and tight map cracks at north end. (09/15) Solid wall piers. East pier has 3 hairline vertical cracks in east face, south end and tight map cracks at north end. (09/13) Solid wall piers. East pier has 3 hairline vertical cracks in east face, southend. (09/11)
15. Slope Protection	8	8	8	Riprap in place (09/15) Riprap in place (09/13) Riprap in place (09/11)
